Final Accident Report

Registration of aircraft:
ST-TYB

Type of aircraft: AN-28

Location: Sarif-Umra
180 km west of
Elfasher

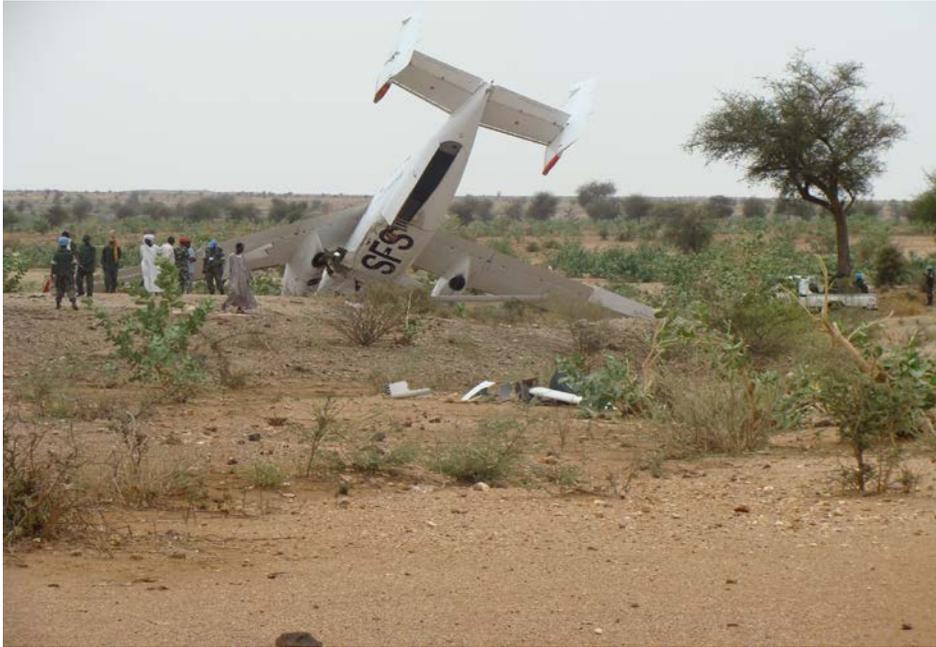
The crew managed to control the aircraft, but in few minutes its altitude decreased rapidly. At time 0650 UTC the aircraft impacted with the ground and rolled, there after struck a small rock and bounced, finally the aircraft impacted the ground by the left main gear and nose, and stopped at a distance of 1850meters from the beginning of strip 05 coordinates N 13 29.527 — E 023 16.794.

Crews (2) were safe and the aircraft sustained substantial damage.

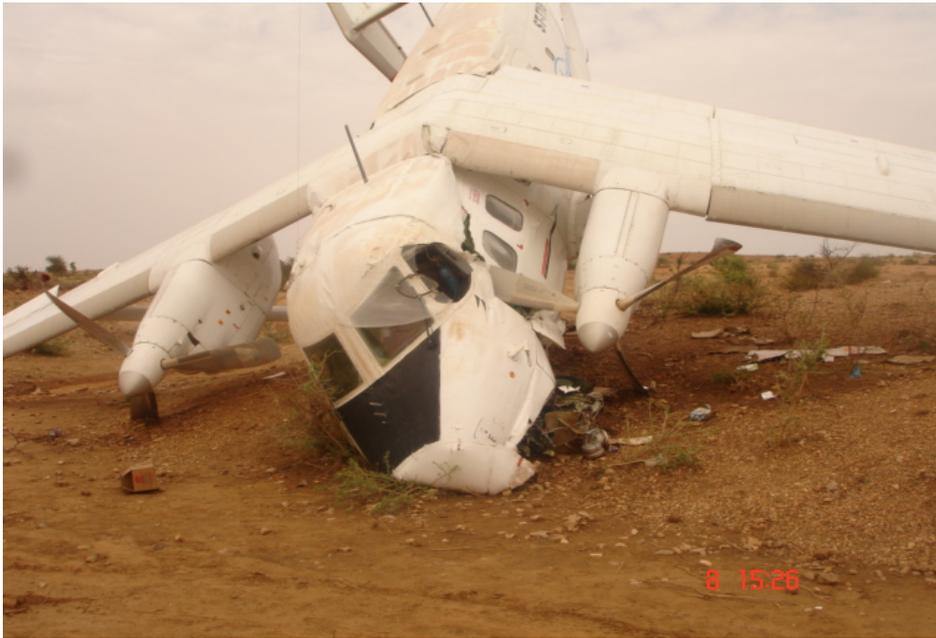
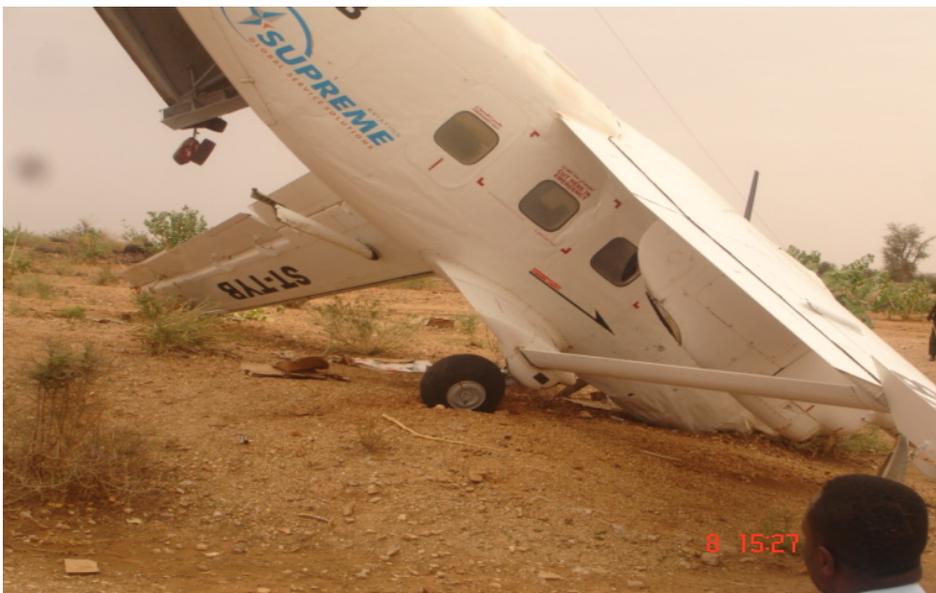
1.3 Damage to aircraft:-

Major parts sustained serious damages, excluding the engines. Some parts detached due to impact and friction with the ground.
