PRELIMINARY REPORT

AIC 14-1003

PAPUA NEW GUINEA
ACCIDENT INVESTIGATION COMMISSION
AIRCRAFT ACCIDENT REPORT

P2-RNB

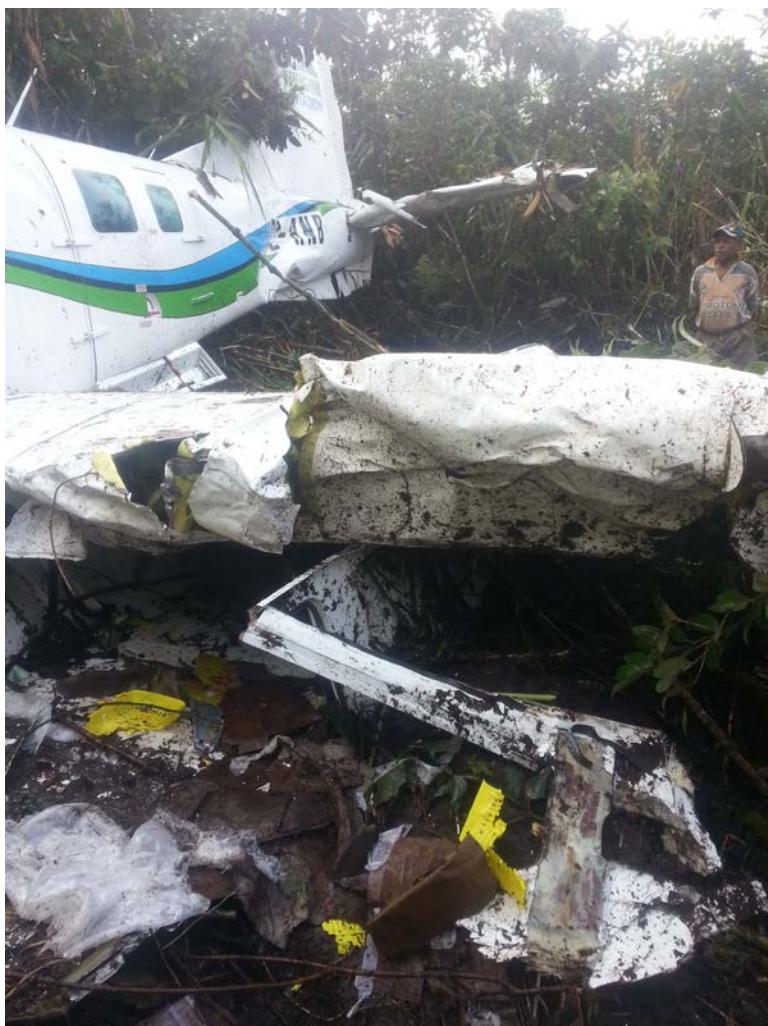
The aircraft was damaged beyond repair by the impact. The most severely damaged parts were the aircraft nose, propeller, engine, undercarriage, and wings, which bore most of the impact forces.

Figure 2: general view of the wreckage of P2-RNB

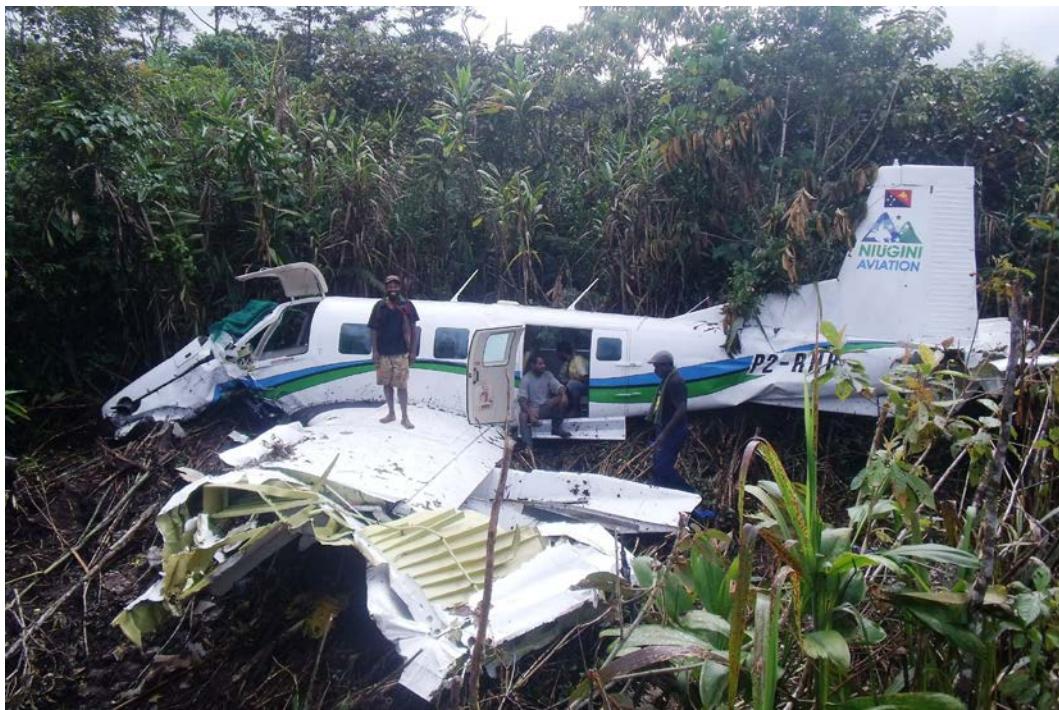
Figure 3: general view of the wreckage of RNB from left

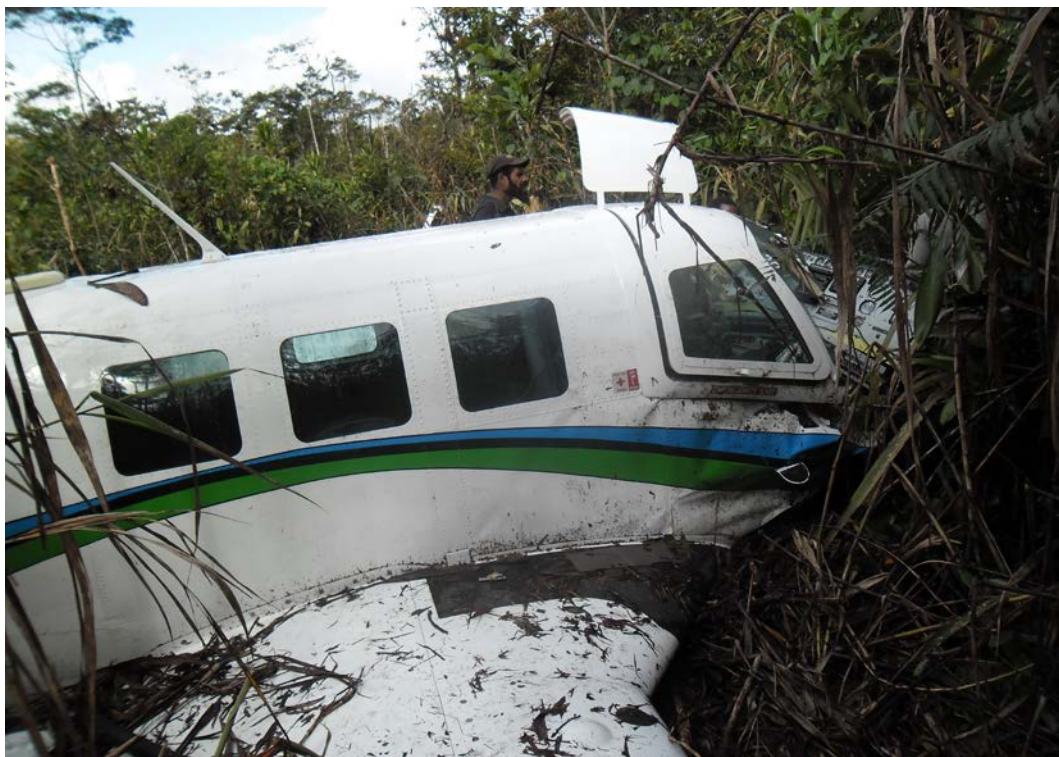
Figure 4: general view of the wreckage of RNB from the left
