File No. 3525-43

Docket No. SA-82

REPORT OF THE CIVIL AERONAUTICS BOARD  
on the  
Investigation of an Accident Involving Aircraft in  
Scheduled Air Carrier Operation

An accident involving an aircraft of United States registry, NC 16014, a Douglas DC3, which was being operated by American Airlines, Inc., occurred about one mile west of Trammel, Kentucky (approximately 15 miles southeast of Bowling Green, Kentucky), about 10:43 p.m. (CWT) on July 28, 1943. The flight was identified by the air carrier as Flight 63 and was being operated in scheduled air carrier service between Cleveland, Ohio and Memphis, Tennessee, with intermediate stops at Columbus, Dayton, Cincinnati, Louisville, and Nashville. All four members of the crew and sixteen passengers (including an infant) were fatally injured. The two remaining passengers escaped with serious injuries. The aircraft struck the ground in nearly level flight and proceeded forward about 1000 feet, during which time both engines, the right wing, and various smaller components were torn away. It was completely destroyed by impact and fire.

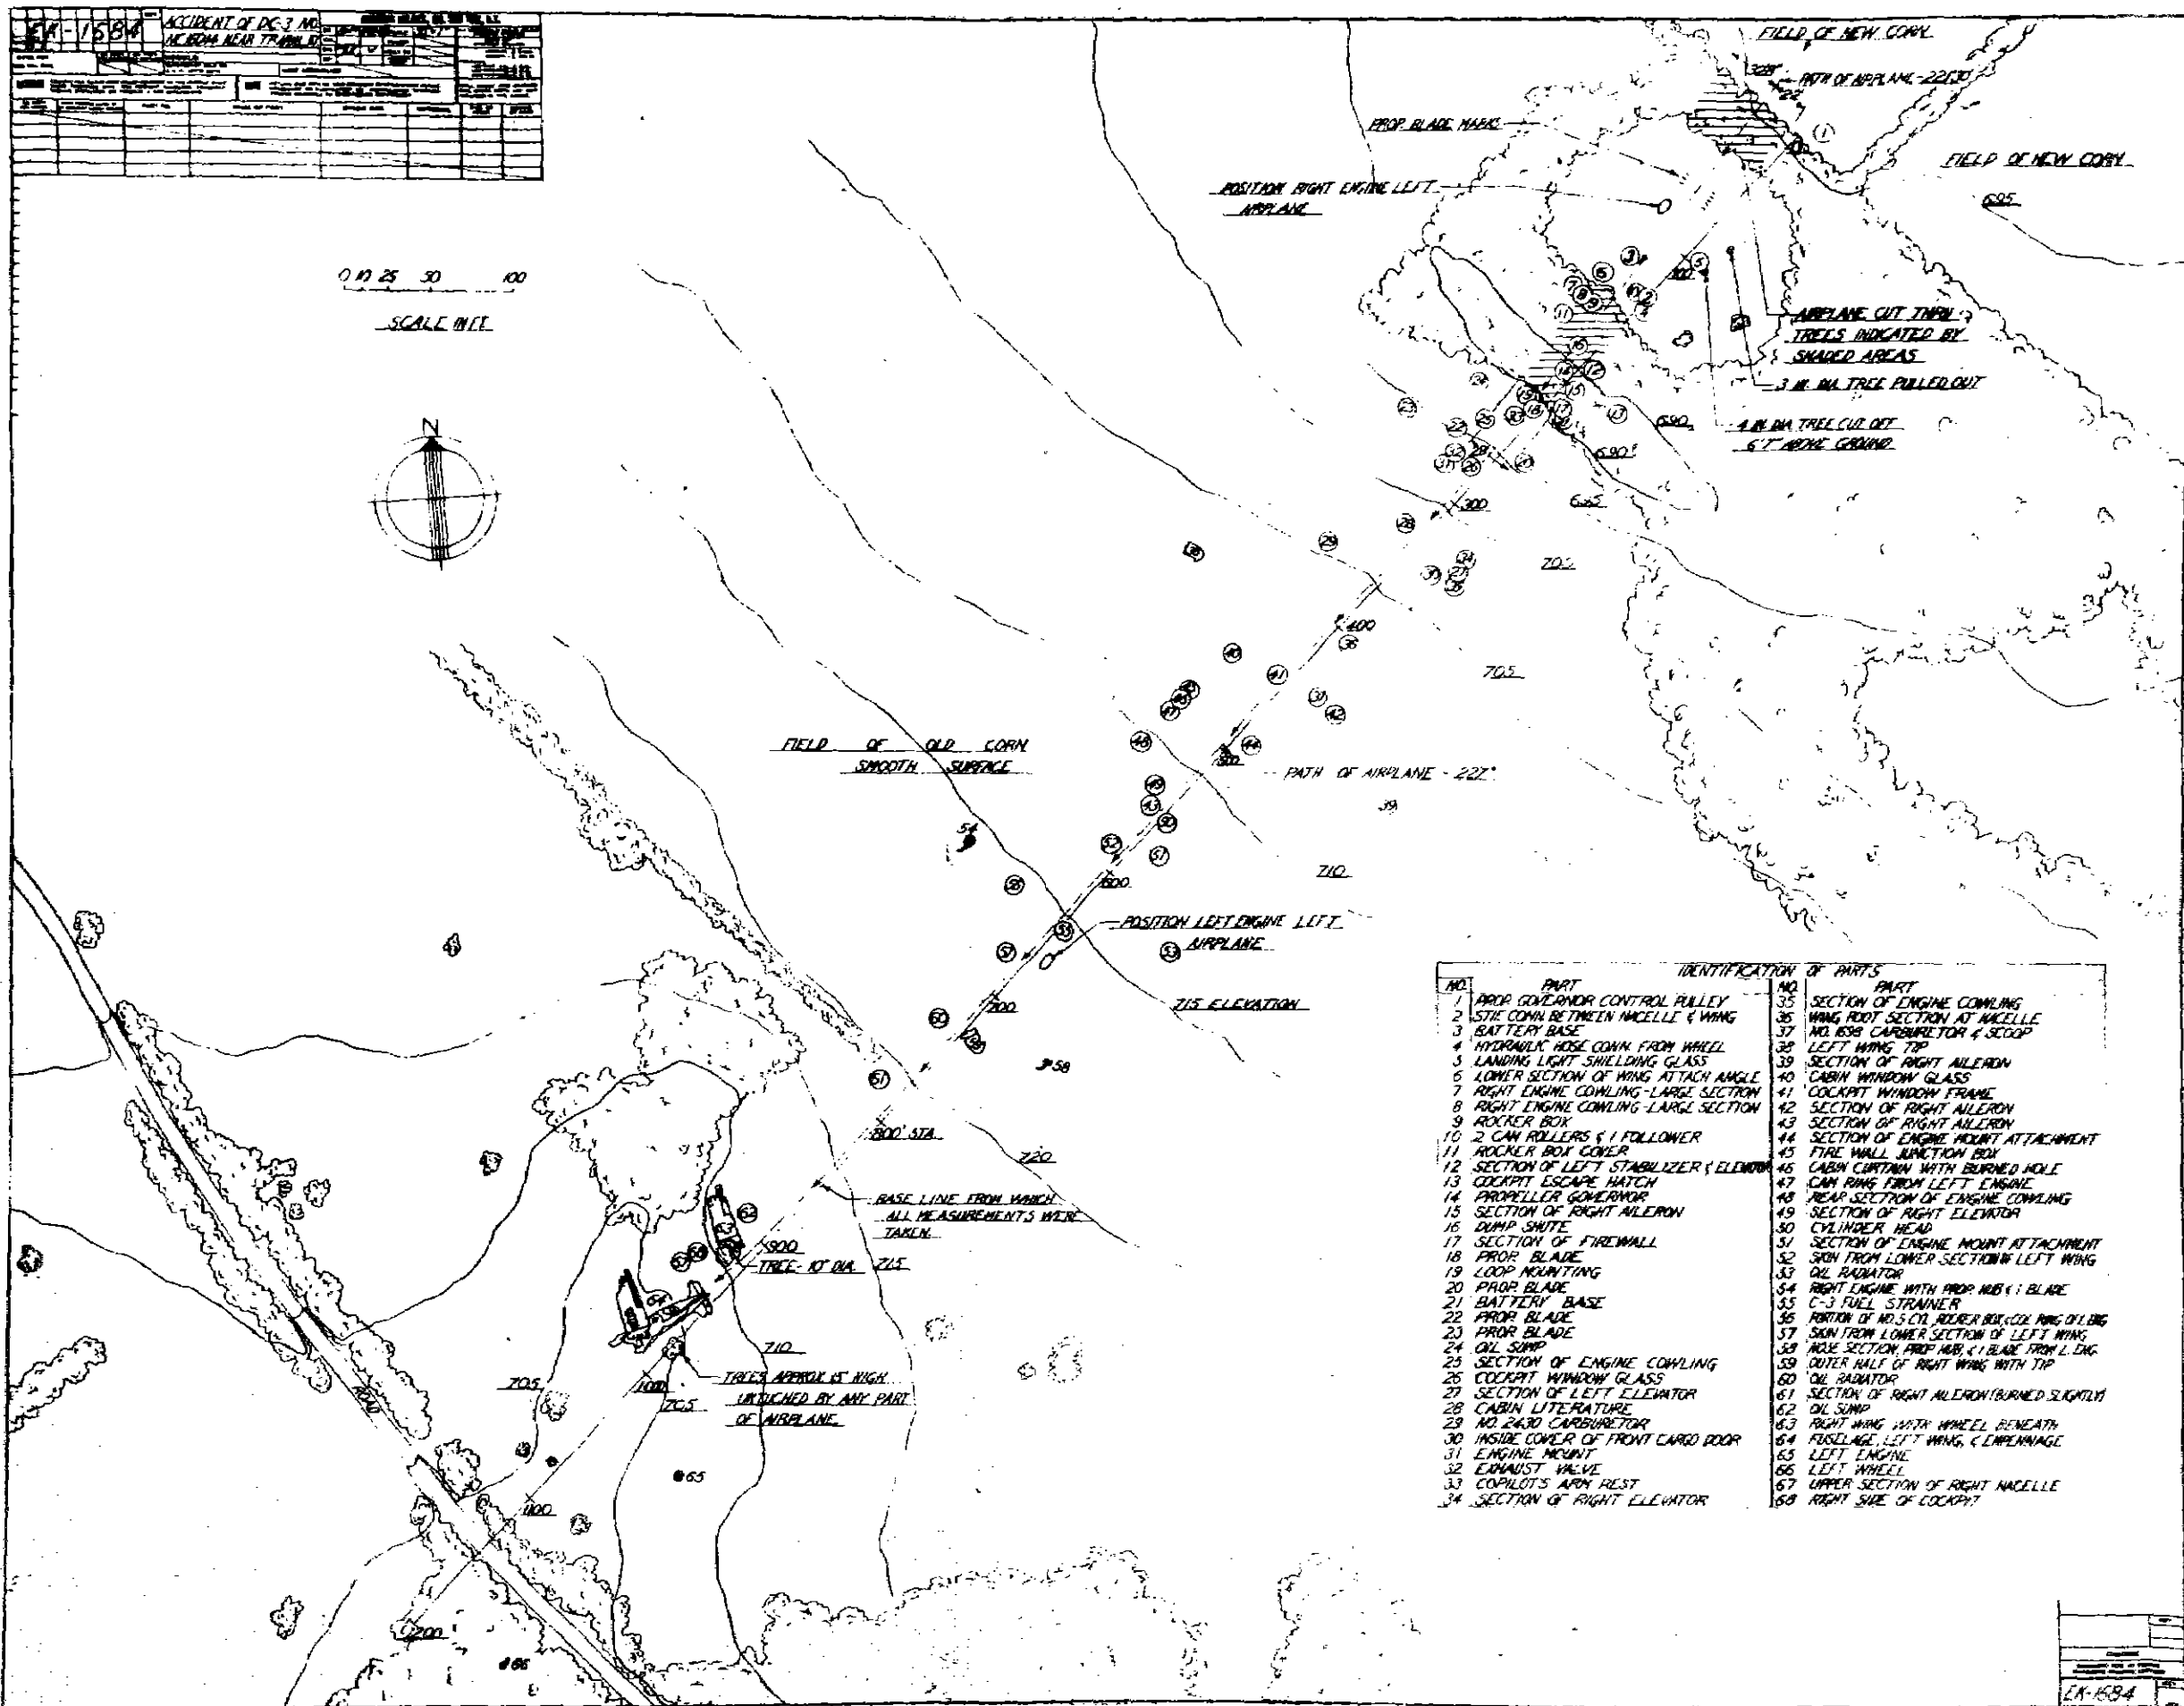
| EX-1584 | ACCIDENT OF DC-3 NO. 10000 | NEAR TRAILER |

Examination of the wreckage did not reveal any evidence whatsoever which would indicate any mechanical or structural failure of the aircraft in flight. Examination of both engines revealed that they were functioning normally at the time of impact. There was adequate fuel aboard. Inspection

of the propellers disclosed settings of  $23\frac{1}{2}^{\circ}$  on the left propeller and  $24^{\circ}$  on the right. It appears probable that these settings were indicative of the settings immediately prior to impact. The wreckage was found on the airway less than 2 miles from the "on course" signal of the Smiths Grove Radio Range. The rolling terrain of the locale varies from 695 to 720 feet above sea level. Examination of the wreckage and of marks and cuts on the ground and trees revealed that the aircraft, while level laterally and descending about  $11^{\circ}$  from horizontal, initially struck and cut a path through a small grove of trees, 35 feet in depth about 16 feet above the ground. It struck the ground approximately 85 feet beyond the point of first contact with the trees, continued on an almost straight course ( $221^{\circ}$ ) through another small clump of trees, then across an open field and stopped in an upright position among several larger trees, about 1000 feet beyond the point of first impact. Just prior to coming to rest, the right wing was sheared from the fuselage by impact with a large tree and it was found approximately 25 feet behind the fuselage. The left wing, minus the tip, with portions of the center section, had been bent upward and over and was found lying across the top of the fuselage. Pieces of the wreckage, including the left wing tip, were scattered over the entire distance, indicating that the airplane disintegrated all along its path from impact with trees and the ground. The right engine struck the ground around 90 feet beyond the point of first impact of the aircraft with the trees, tore loose and rolled forward about 500 feet. The left engine struck the ground approximately 650 feet beyond the point of impact with the trees, tore loose and rolled forward about 375 feet, coming to rest some 25 feet beyond the wrecked fuselage. The left wheel was found still farther forward and across a road, almost 1200 feet beyond the point where the aircraft first struck the trees. There was no indication that fire had started on the aircraft before the initial impact, as all parts of the wreckage which gave indication of fire were found at or near the final resting place of the fuselage and the two wings. (See sketch, opposite page, prepared by engineers of American in collaboration with investigators of the Board.)
