CIVIL AERONAUTICS BOARD

ACCIDENT INVESTIGATION REPORT

AMERICAN AIRLINES, INC.—LAGUARDIA FIELD, NEW YORK—AUGUST 8, 1947

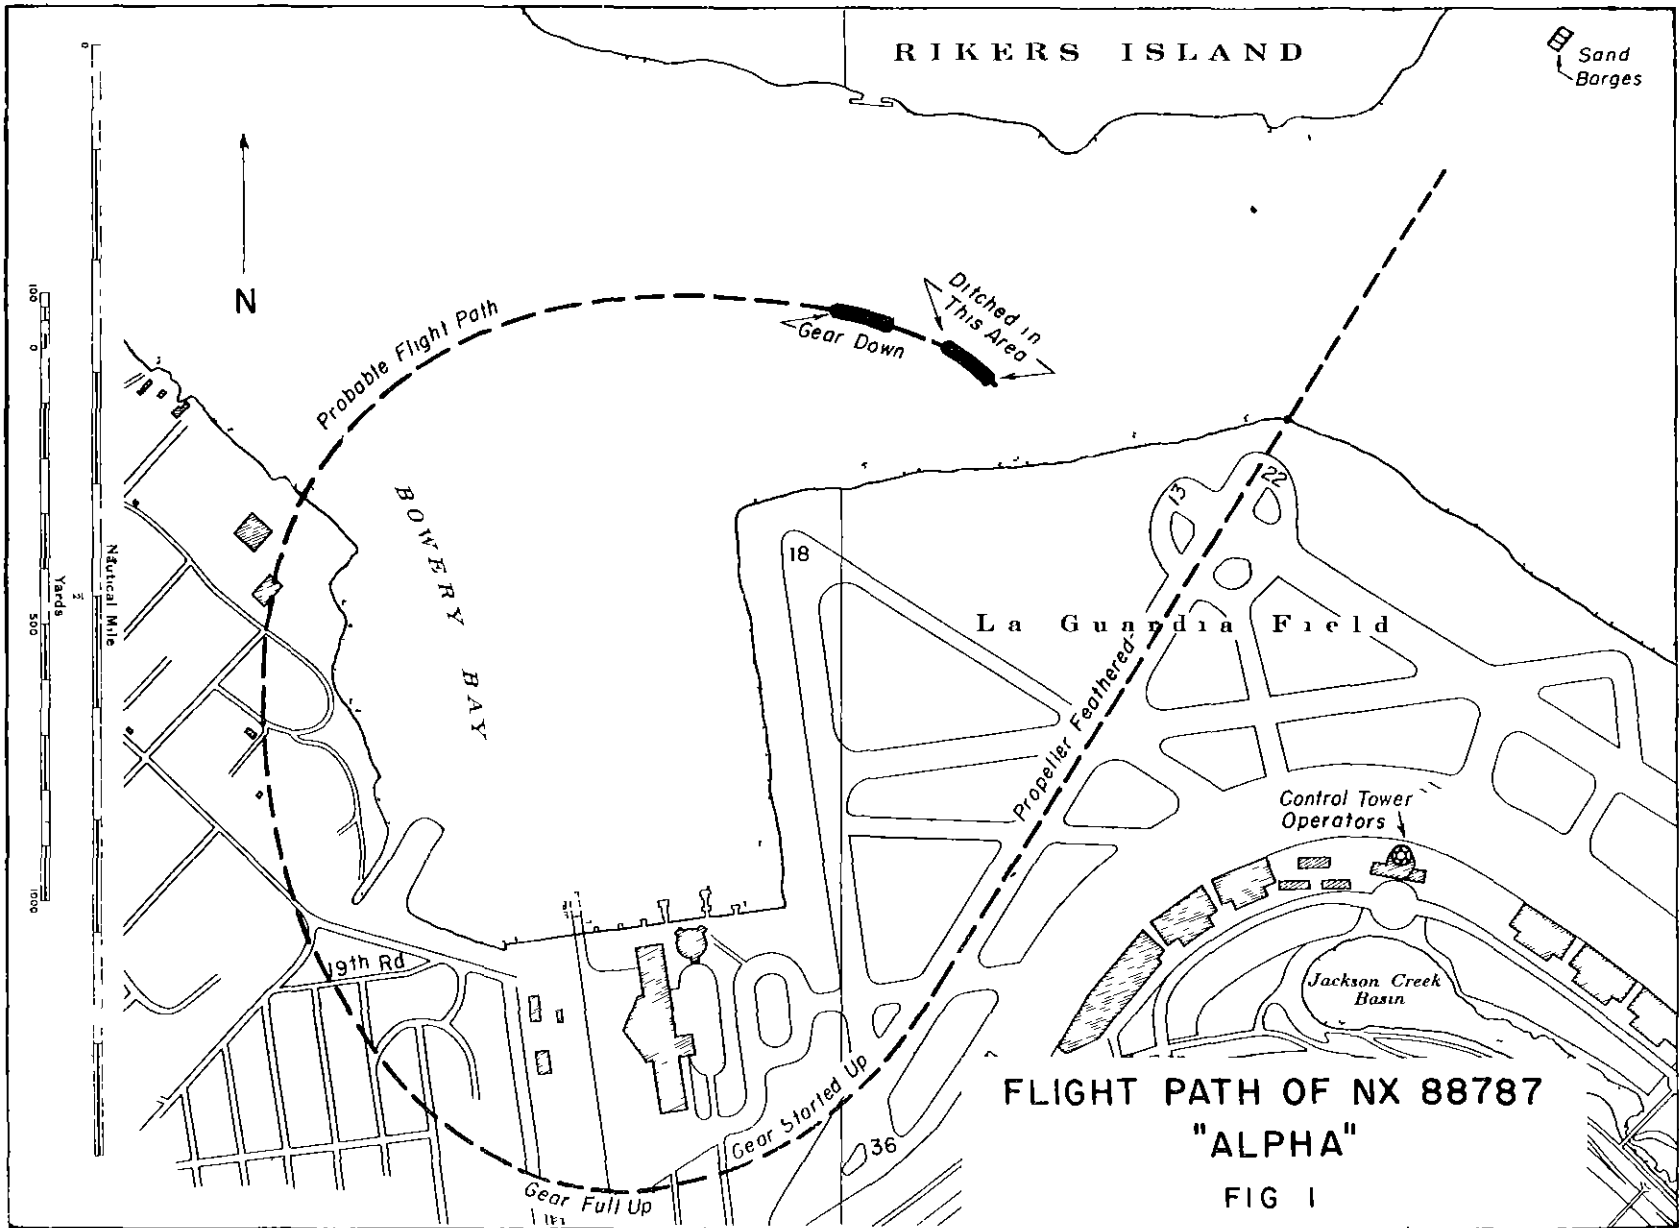
⁵See attached chart of flight path

NX-88787, also known by the name Alpha, a C-47 converted to a research aircraft, took off on runway 13 of LaGuardia Airport at 1843, having been cleared on an instrument flight plan to Rochester, New York, with Toronto, Ontario, as an alternate. Approximately 2 minutes after take-off the flight called LaGuardia Tower and reported that it was in the vicinity of the south end of Whitestone Bridge, approximately 2 1/2 miles northeast of LaGuardia Airport. The flight advised that the oil pressure was low on one engine, and requested clearance to land on runway 22. The request was approved, and the tower informed the crew that the wind was calm. When asked if emergency equipment was desired to stand by, the flight replied in the negative. Shortly thereafter, NX-88787 reported that it was on the final approach, and that it was over the sand barges, located approximately one-half mile off the approach end of runway 22. In reply the flight was again given clearance to land.

The aircraft was first seen at an altitude of approximately 800 feet, and about 1,300 feet off the approach end of runway 22 with the landing gear extended. The flaps were lowered, and the aircraft

started a steep descent to runway 22, but it passed over the approach end of the runway at an altitude of approximately 300 feet. The flight then requested and was granted permission by the tower to make a right turn, however, the aircraft continued straight ahead over the runway, gradually losing altitude.

When one-third of the way down the runway, the right propeller was feathered. When over the intersection of runways 22 and 18 and at an altitude of 200 feet the flaps were raised, which resulted in an additional loss of altitude. During or directly after raising the flaps, a right turn was initiated, and the landing gear was observed to retract slowly. Competent witnesses stated that the right turn was made at a very slow speed, at a high angle of attack, and at an altitude appearing never to have exceeded 200 feet.

Over Bowery Bay the aircraft on two occasions almost settled into the water. When in a flat right turn toward runway 13 it lost altitude to about 50 feet. Approximately 2,000 feet from the end of the runway, the landing gear started to extend, and became fully extended when the aircraft was aligned with runway 13. At this time the airplane attitude appeared to be that of a steep climb. The wings were seen to wobble slightly, then the left wing and nose dropped, and the airplane struck the water at an angle of approximately 20 degrees. The forward movement of the aircraft continued on the surface of the water for 40 to 50 feet, throwing up a great spray as the tail rose to a vertical position, after which the aircraft continued over on its back and sank in about 5 minutes.
