CIVIL AERONAUTICS BOARD

ACCIDENT INVESTIGATION REPORT

UNITED AIR LINES, INC., FORT WAYNE, INDIANA, APRIL 28, 1951

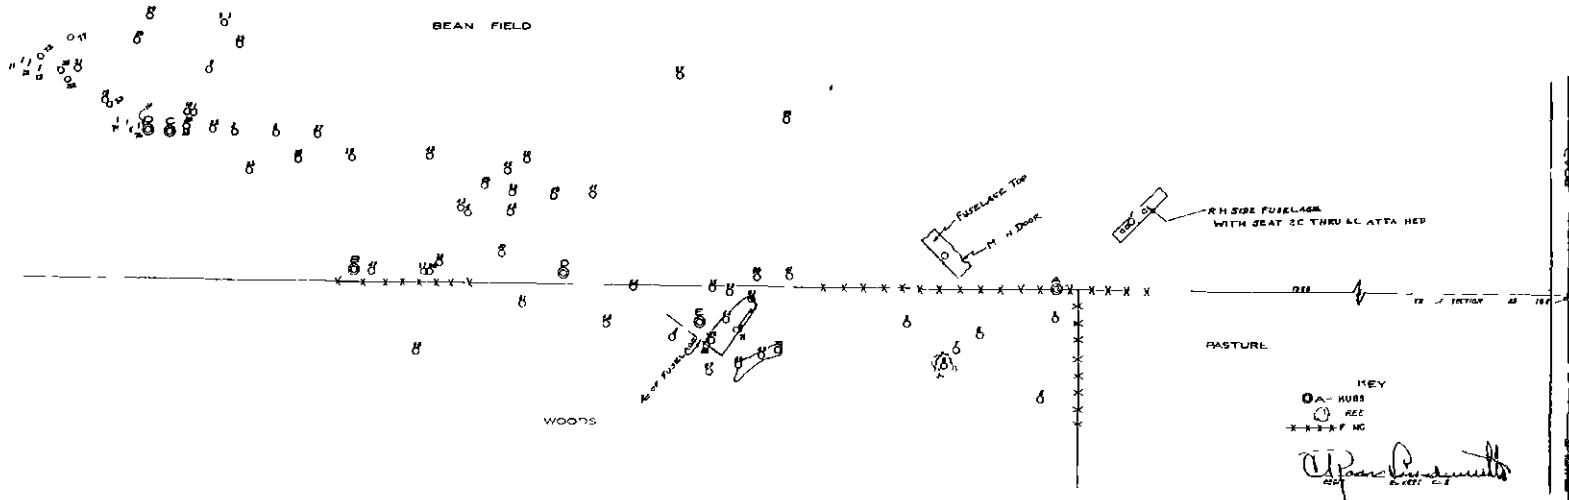
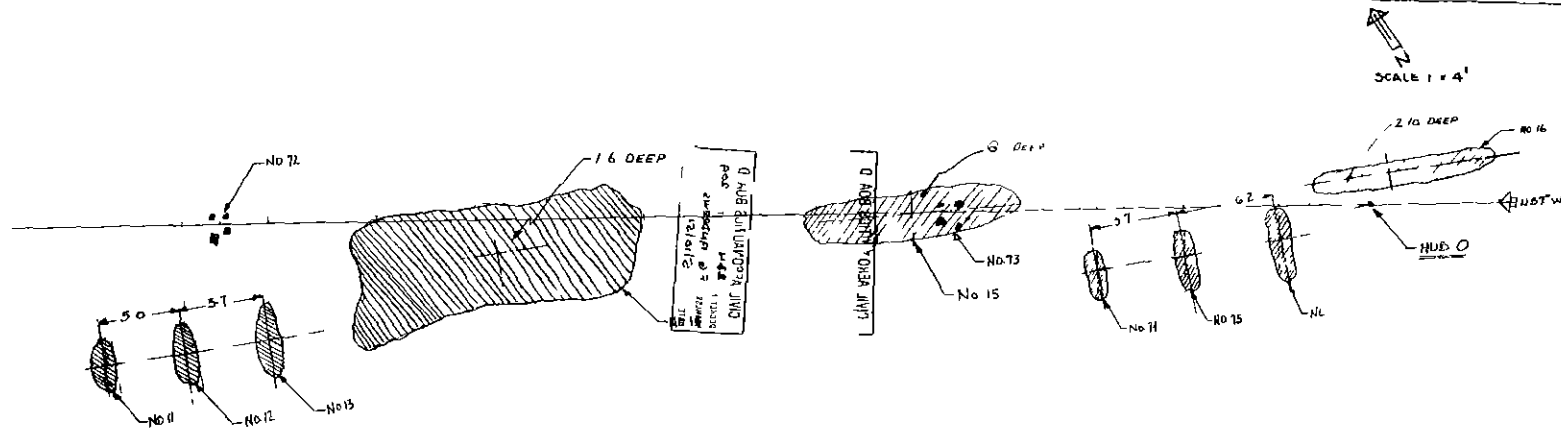
"WRECKAGE DISTRIBUTION CHART 1"

Investigation disclosed that N-16088 was flying on an approximate heading of 120 degrees when it struck the ground and that at the time of impact it was in a near level attitude with the left wing slightly low. Initial ground contact was made by the aircraft's left wing tip. Wreckage was strewn over the ground a distance of 720 feet and the main wreckage came to rest in a wooded area several hundred feet distant from the point of initial impact.²

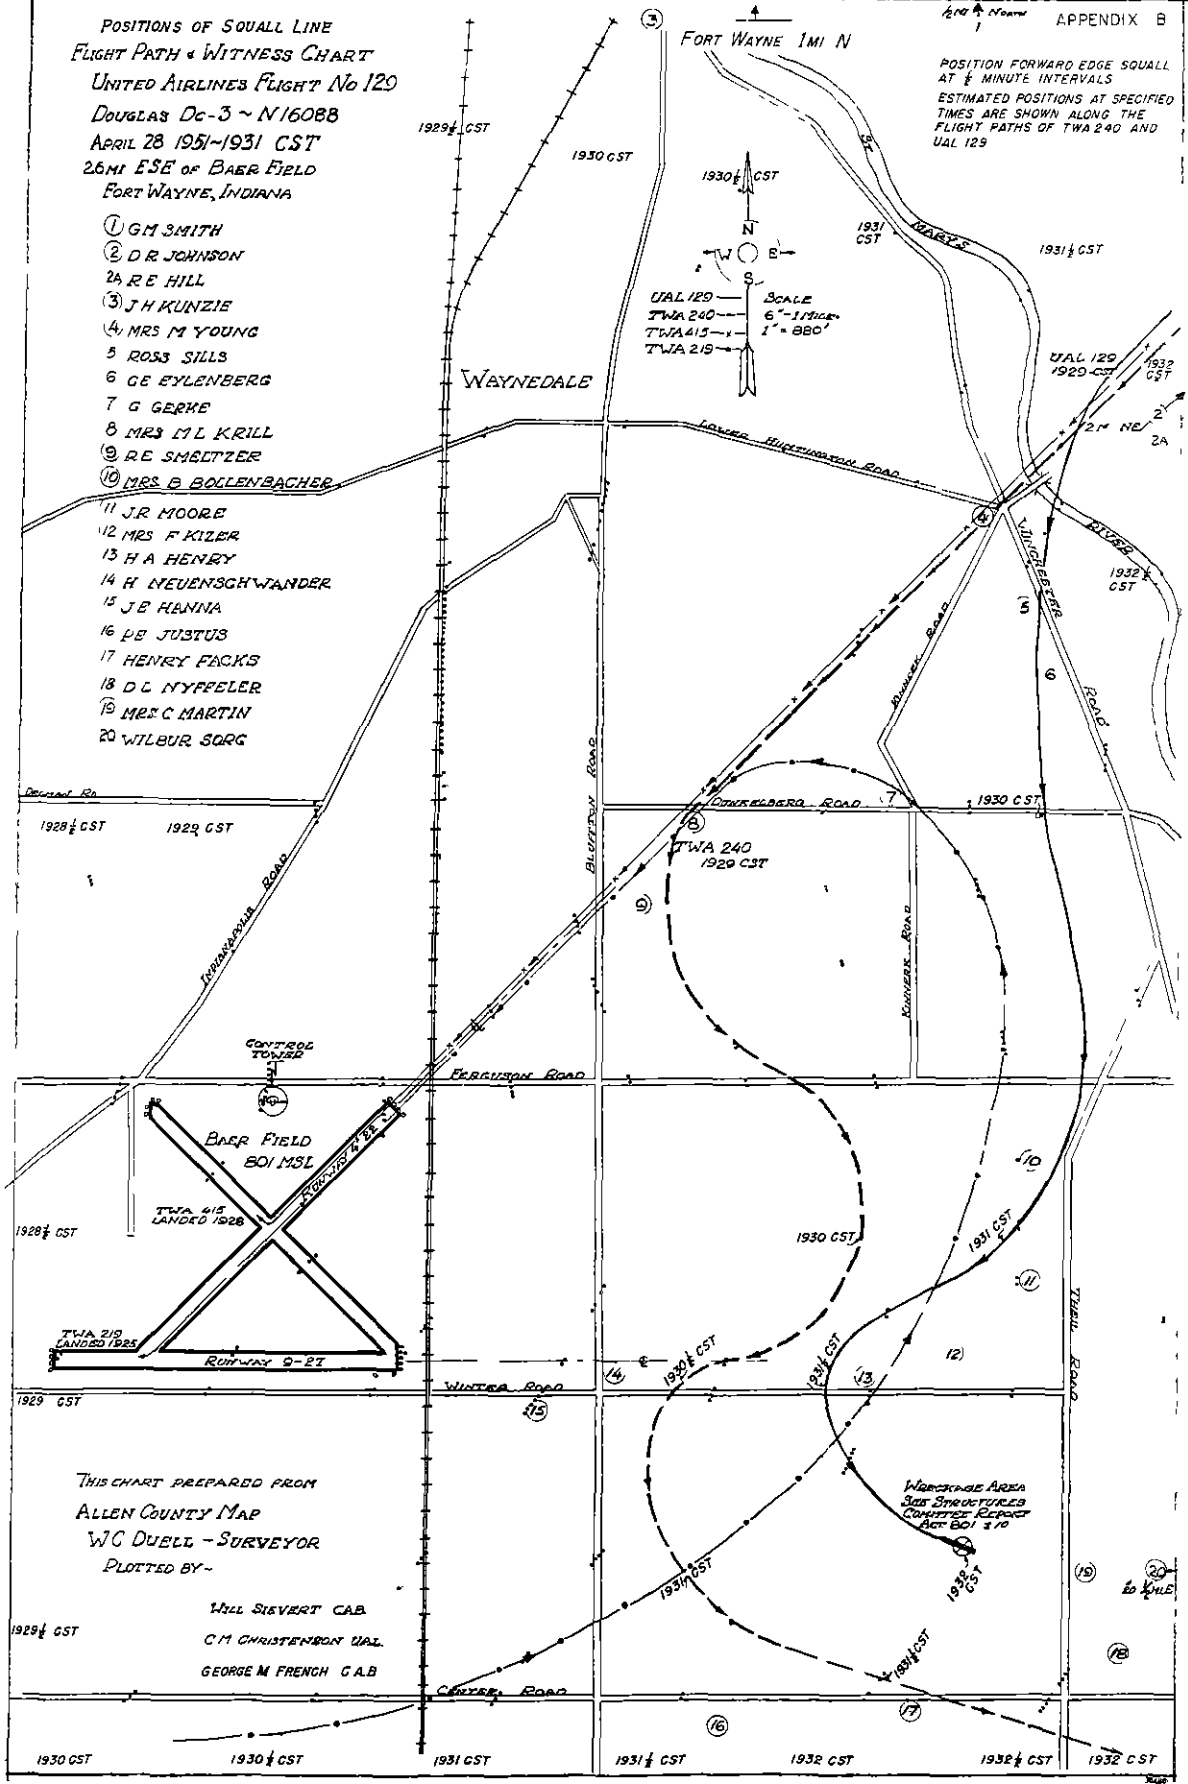
POSITIONS OF SQUALL LINE
 FLIGHT PATH & WITNESS CHART
 UNITED AIRLINES FLIGHT No 129
 DOUGLAS DC-3 ~ N16088
 APRIL 28 1951-1931 CST
 26 MI ESE OF BAER FIELD
 FORT WAYNE, INDIANA

Referring to Appendix B, the eastward movement of the forward edge of the squall line is shown in one-half minute intervals by means of dotted lines. The path of TWA's Flight 240 is shown by a dashed line with time locations noted. It is seen that at all times this flight was ahead of the squall line, but by a very narrow margin of less than a mile during a portion of the turn. The solid line on the chart indicates the flight path of UAL's 129 with time locations. This also shows that at 1931 1/2, the flight had penetrated the forward edge of the squall line and was still at that relative position at the time of the crash.

squall line and was subjected to a severe down draft from which recovery could not be made
