CIVIL AERONAUTICS BOARD

ACCIDENT INVESTIGATION REPORT

UNITED AIR LINES, INC., NEAR OAKLAND, CALIFORNIA, AUGUST 24, 1951

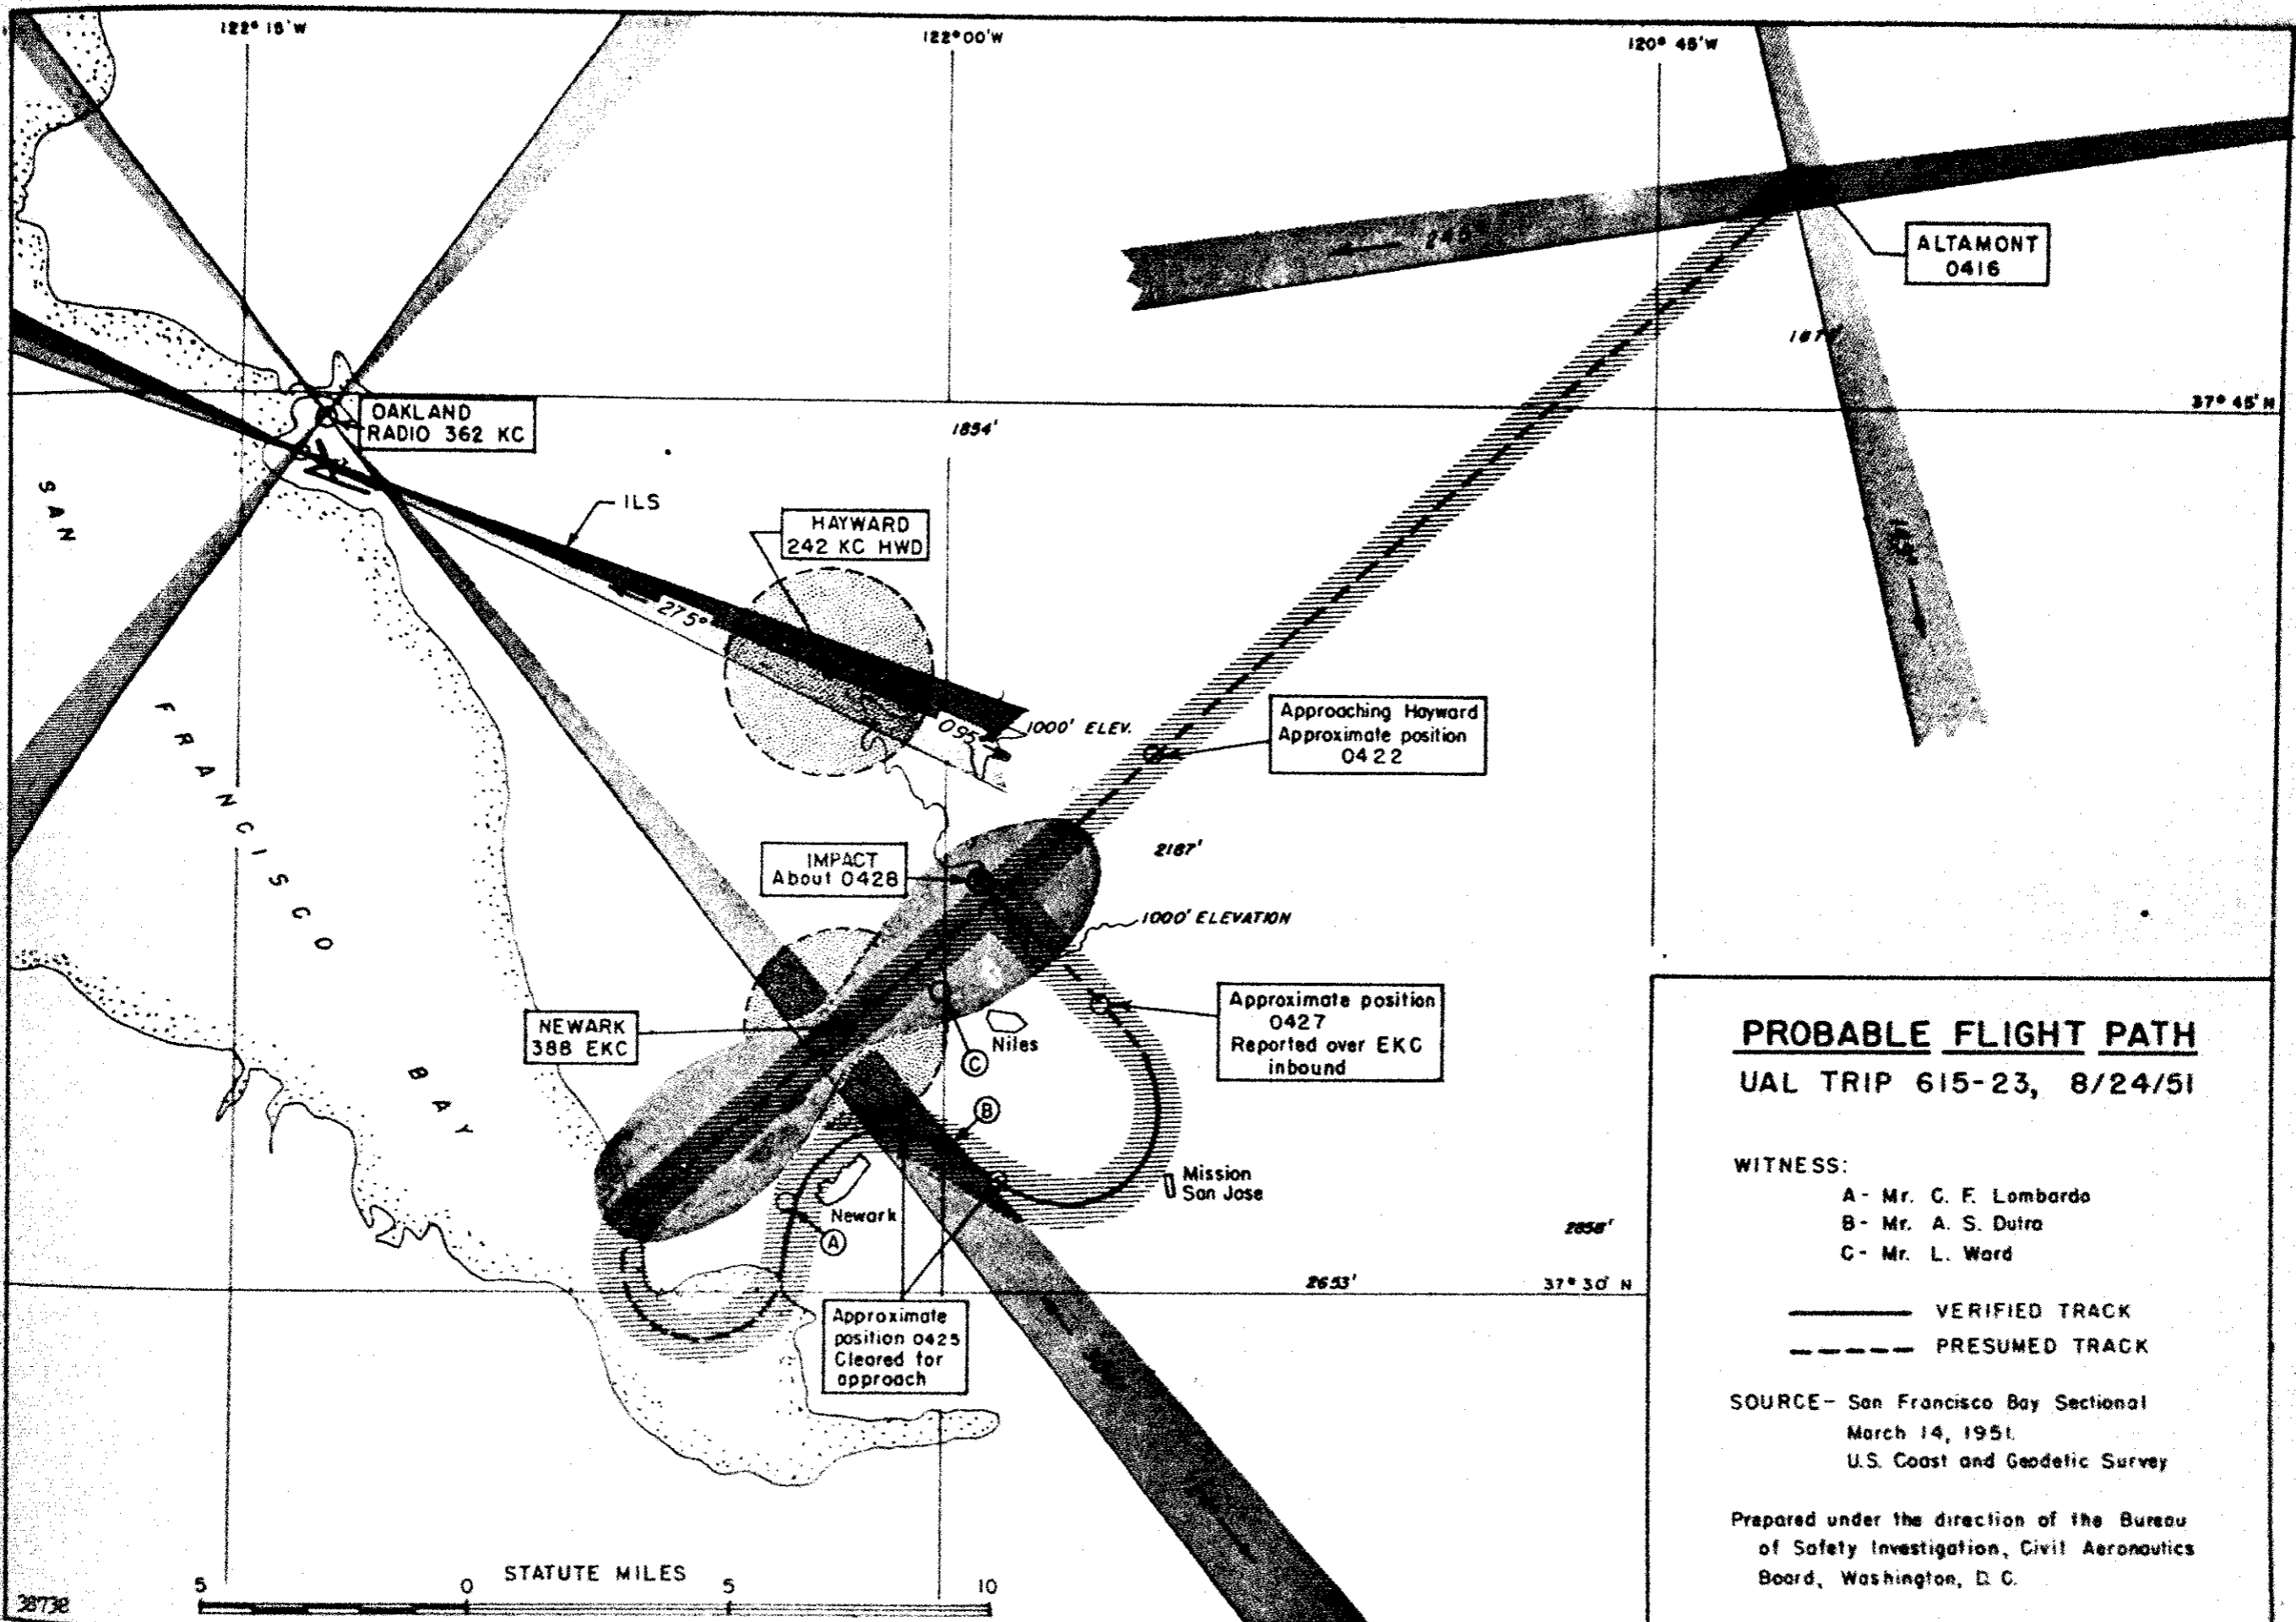
PROBABLE FLIGHT PATH
UAL TRIP 615-23, 8/24/51

It should be noted that all witnesses stated the aircraft was flying at low altitude in the Newark area and reconstruction of the flight path indicated the altitude was in the neighborhood of 1,500 to 2,000 feet prior to the final, straight descent. It has been pointed out that the flight was still on an IFR flight plan at the time it crashed, and the minimum prescribed altitude prior to leaving Newark is 3,500 feet. Flight 615 was neither at least 500 feet above the top of the stratus layer nor adhering to the minimum altitude of 3,500 feet as it maneuvered awaiting clearance to Oakland. Witnesses reported that it was below, or just skirting, the lower side of the clouds.

A radio transmission was made by the flight one minute before the accident, advising that it was leaving Newark inbound. Final letdown to 500 feet is permissible past that point, and according to the last witness, the aircraft was descending during the time it was in his view. Plotting back one minute from the crash site, using the probable speed of the aircraft it is noted that the flight would have been slightly to the east of the town of Niles at the time the transmission was made. Niles could readily be confused with Newark under conditions of restricted visibility such as obtained at the time. The main section of Newark lies slightly to the left of the southeast course of the Oakland radio range, and occupies the same relative position with the southeast course as does Niles with the probable flight path.

The final left turn near Mission San Jose cannot be explained by any of the instrument procedures in force. By turning left from a southeast heading to northwest, the pilot may have planned to intercept the Oakland southeast course and proceed inbound. However, it will be recalled that neither of the two available radio range receivers was tuned to the Oakland radio range frequency. This turn, it is believed, was begun at about the time the flight was cleared by Approach Control for a straight-in approach.
