CIVIL AERONAUTICS BOARD

ACCIDENT INVESTIGATION REPORT

NORTHWEST AIRLINES, INC., - SANDSPIT, BRITISH COLUMBIA,
JANUARY 19, 1952

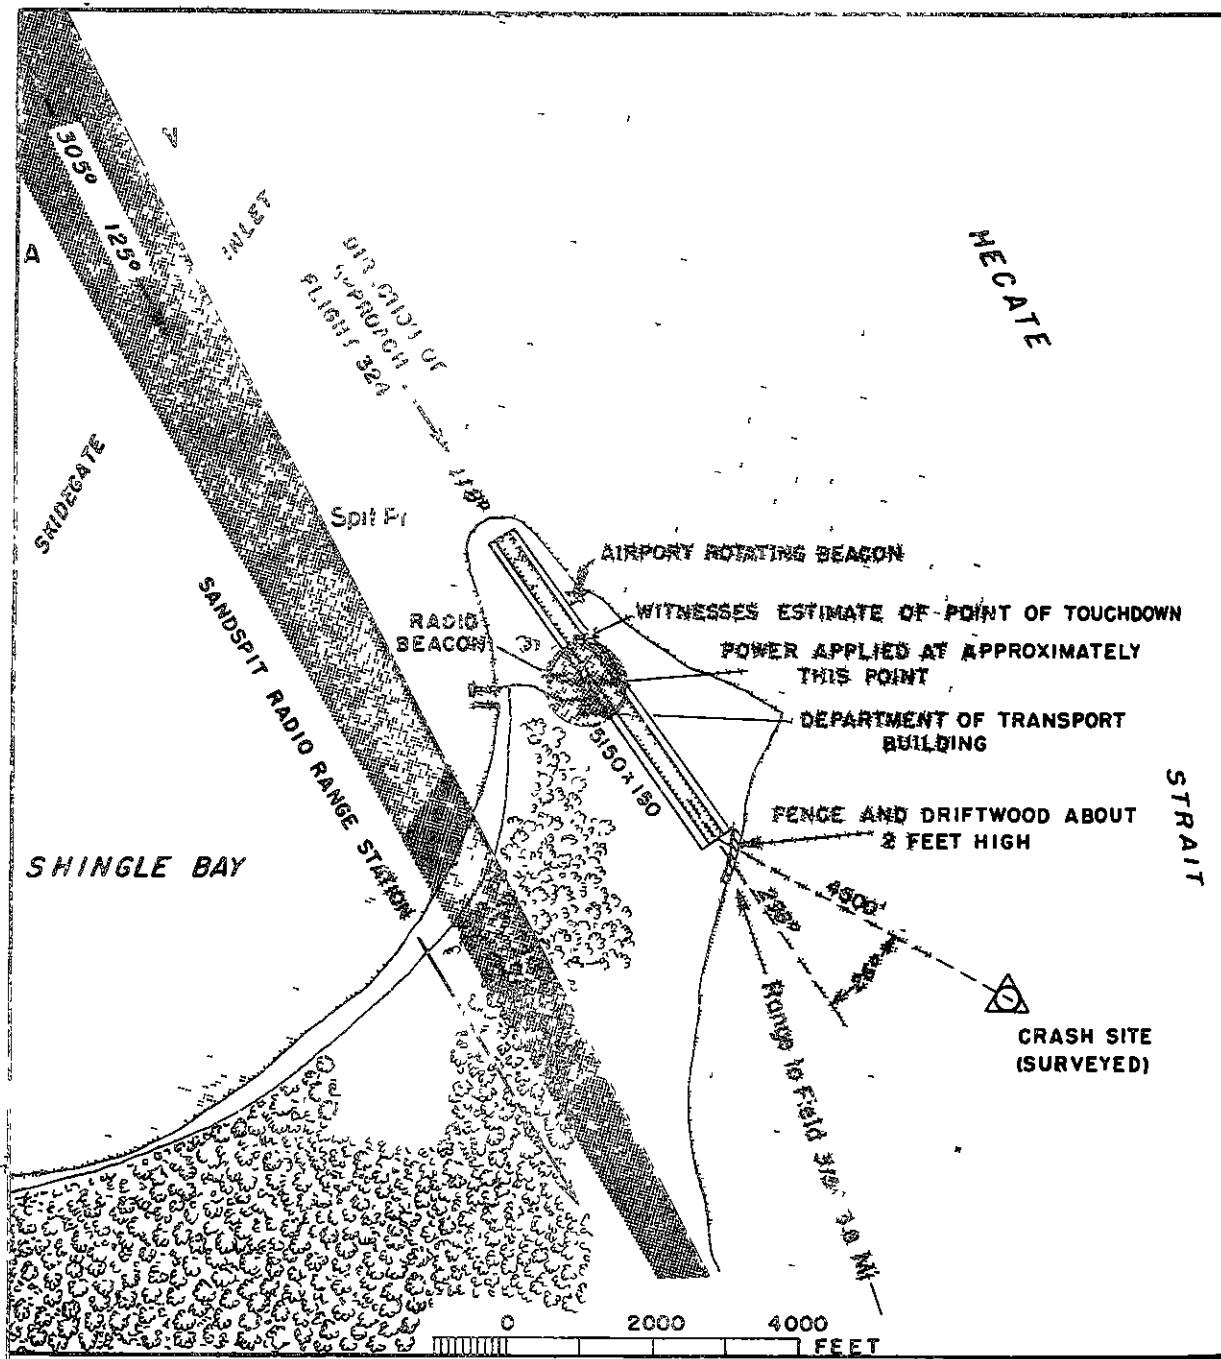
ATTACHMENT II

**NORTHWEST AIRLINES, INC., ACCIDENT SANDSPIT, B. C.
 JANUARY 19, 1952
 SANDSPIT FLIGHT STRIP**

Crash site data furnished by R. T. Johnson, Aviation Safety Agent,
 Civil Aeronautics Administration.

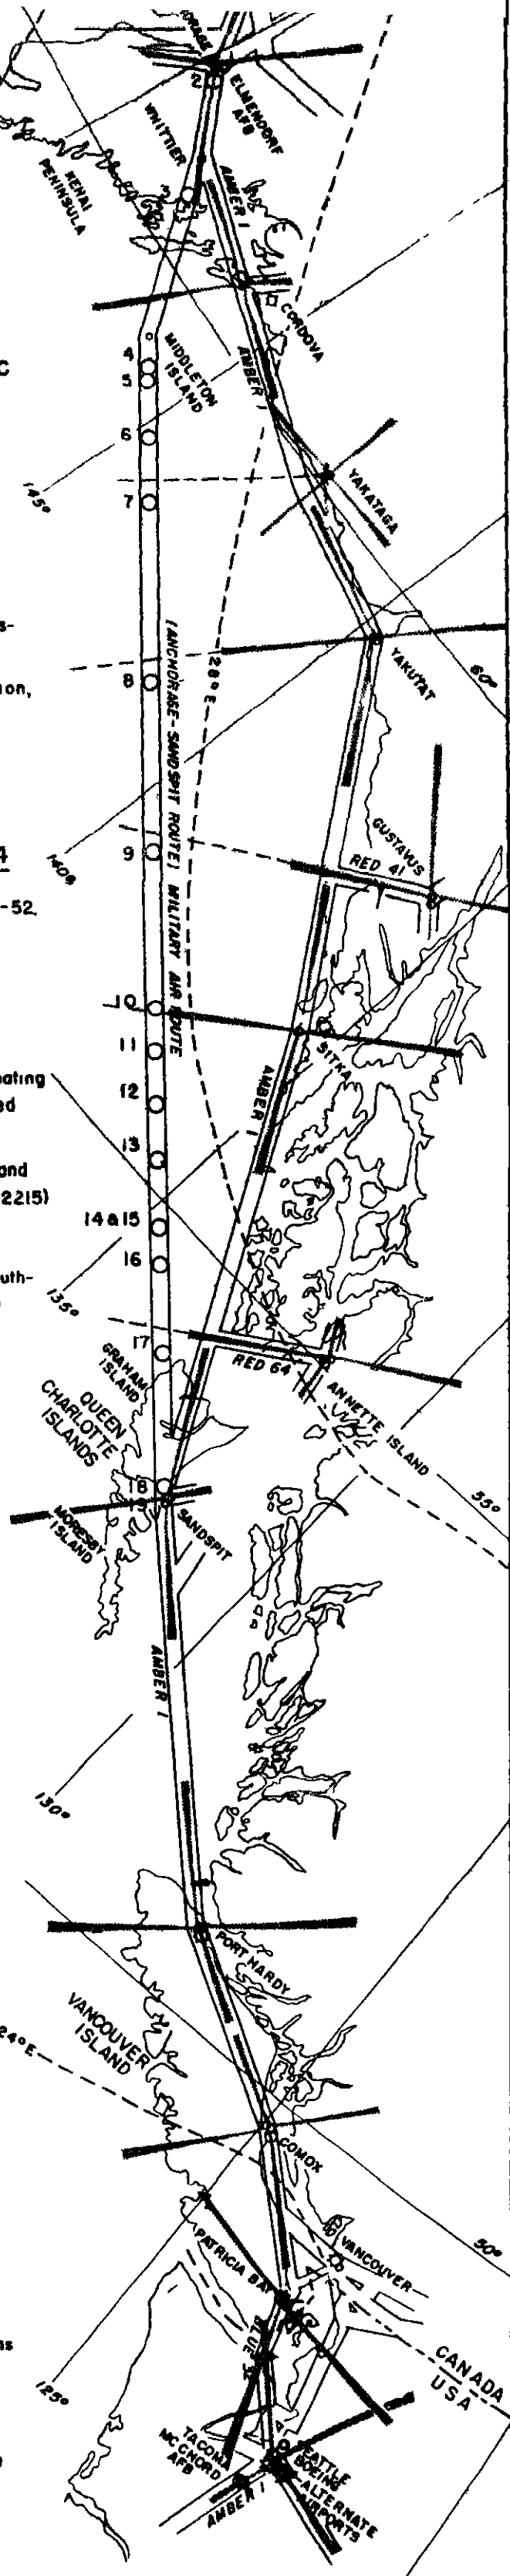
ATTACHMENT I

- 1- Takeoff, Elmendorf Air Force Base, 2111, 1-18-52.
- 2- Over Anchorage range station 2123, climbing VFR, estimating Whittier 2138. (2127)
- 3- Over Whittier 2138, 10,000' estimating Middleton Island 2210 (2145)

- 4- Over Middleton Island 2209, 10,000', estimating 90 degrees abeam Yakutat 2230, requested change of altitude to 8,000'. (2213)
- 5- ARTC cleared Flight 324 to descend to and maintain 8,000' Descent begun immediately (2215)

- 6- Cruising at 8,000' at 2222 (2224)
- 7- Abeam Yakutat 2230, 8,000', estimating southwest leg of Yakutat range at 2259 (2234)
- 8- Southwest leg Yakutat range 2302, 8,000', estimating southwest leg of Gustavus range at 2231 (2305)

- 9- Southwest leg Gustavus range 2330, 8,000', estimating southwest leg of Sitka range at 2357 (2335)
- 10- No. 1 propeller feathered, proceeding to Sandspit (0003, 1-19-52)

- 11- Southwest leg Sitka range 0004, 8,000', estimating southwest leg of Annette range at 0059 (0010)
- 12- CAA INSAC at Yakutat relayed information that No. 1 propeller feathered to NWA Flight Control, Seattle (0020)

- 13- Oil cooler No. 1 engine broken Proceeding to Sandspit (0029)
- 14- NWA Flight Control, through CAA communications relay, asked Flight 324 if it was proceeding to Sandspit and advised that Seattle weather was satisfactory Message not delivered to flight. (0040)

- 15- Annette radio, upon request from the flight, furnished 0030 Sandspit, Annette, and Port Hardy weather (0041)
- 16- Flight 324, at 0047, requested terminal forecasts for Annette, Sandspit, and Port Hardy Message relayed to NWA, Seattle, and forecasts relayed back PAA Flight 908 overheard weather being relayed to Flight 324 only a few minutes before the accident

- 17- Southwest leg of Annette range 0059, estimating Sandspit at 0128 (0103)
- 18- Flight 324 advised Annette radio that it was leaving 8,000' and would thereafter be in communication with Sandspit (0126)

- 19- Flight 324 contacted Sandspit radio during initial approach. Last radio contact with the flight Crashed at approximately 0138
