CIVIL AERONAUTICS BOARD

ACCIDENT INVESTIGATION REPORT

NATIONAL AIRLINES, INC., ELIZABETH, NEW JERSEY, FEBRUARY 11, 1952

AIRCRAFT ACCIDENT - NATIONAL AIRLINES' DC-6 N90891 AT ELIZABETH, N. J., FEB. 11, 1952 ANALYSIS OF PROGRESSIVE DISINTEGRATION OF AIRCRAFT

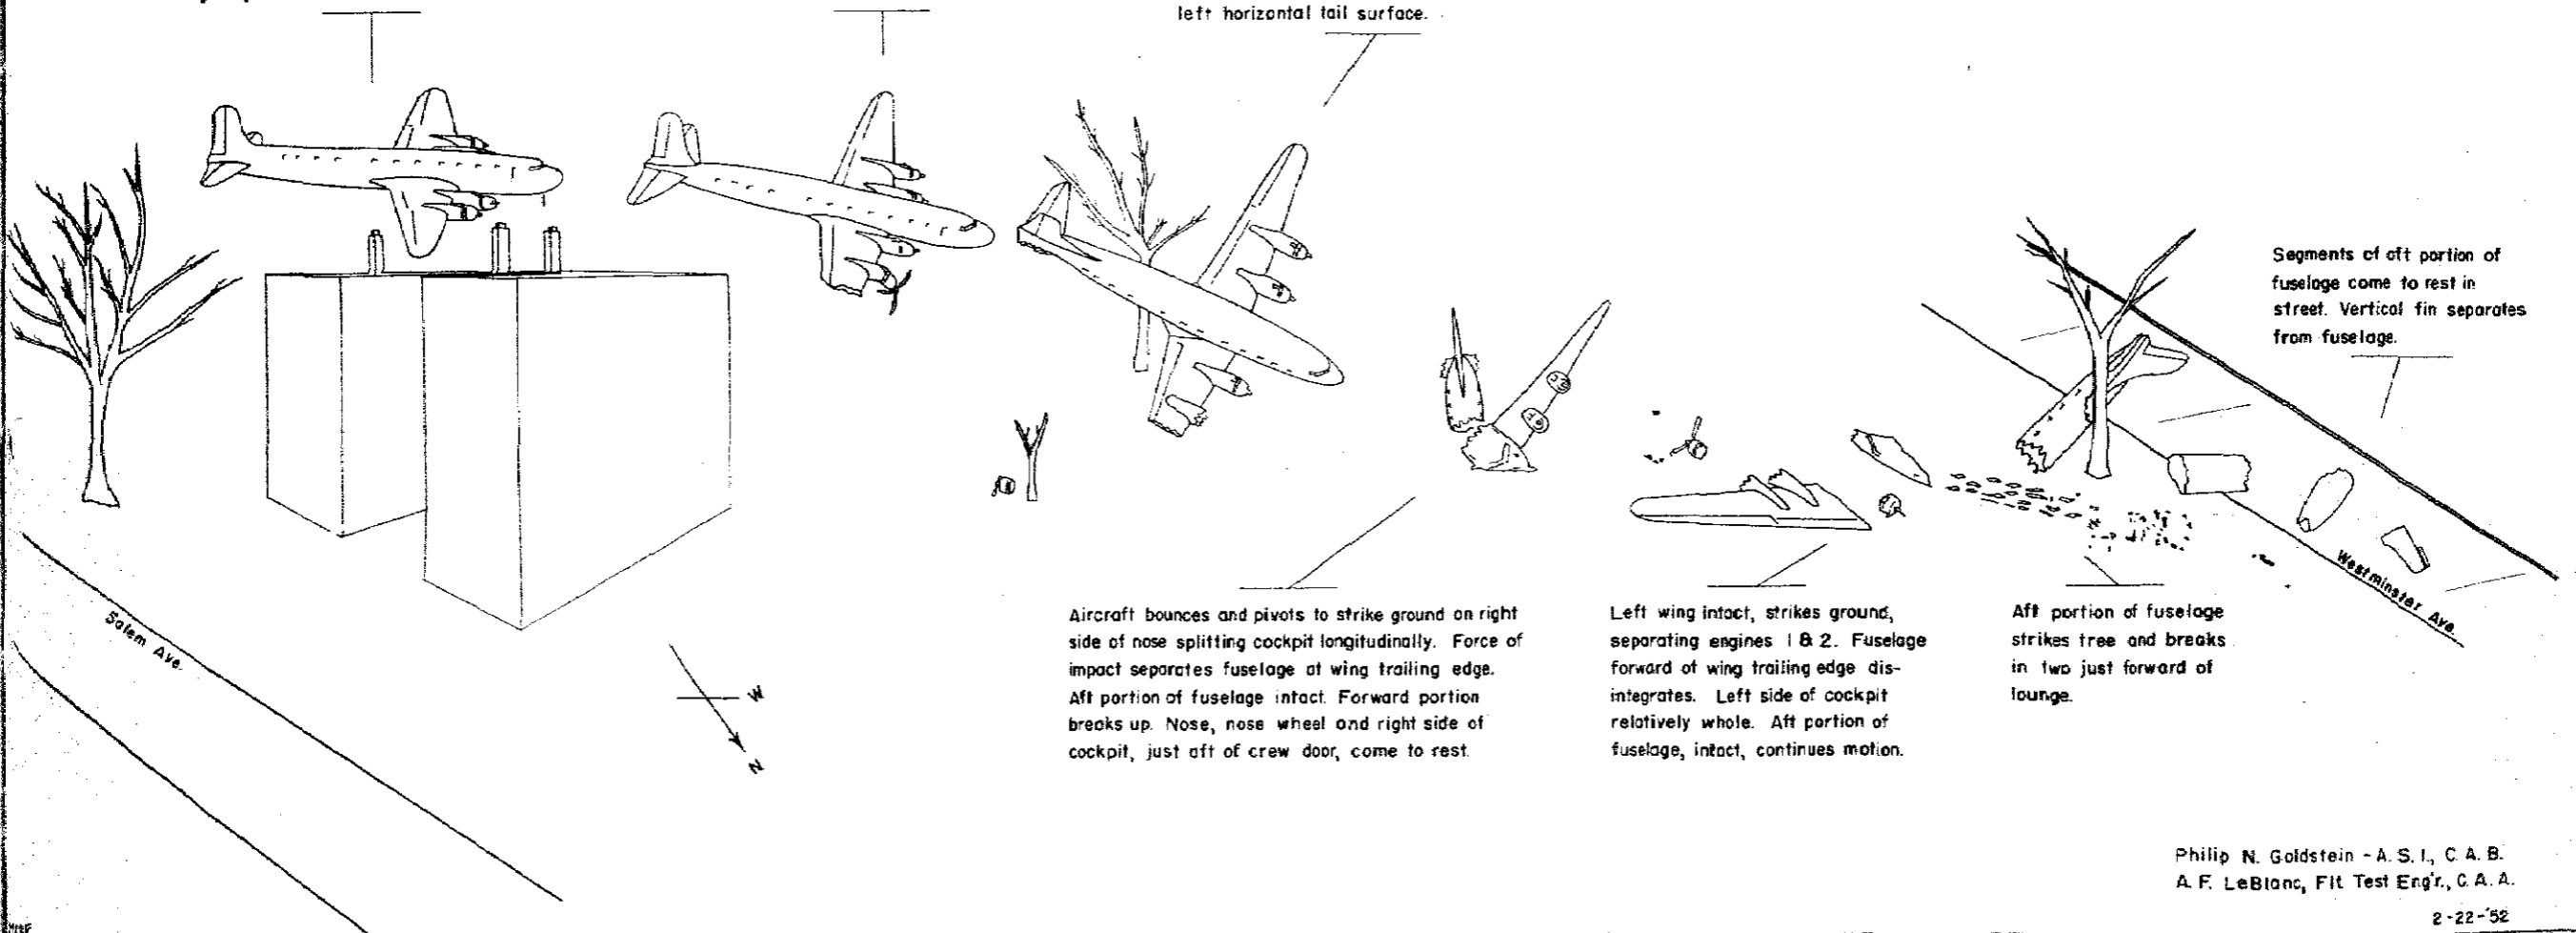
Aircraft strikes upper 10' of tree. Right wing strikes roof ladder, center chimney and parapet. No. 4 engine partly dislodged. Part of right wing drops into court.

Right horizontal tail strikes house, falls to ground. No. 4 engine separates prior to initial ground impact.

Initial ground impact by No. 4 nacelle and wing stub. Right center section and No. 3 engine break off. As aircraft pivots about right wing, tail strikes tree breaking off left horizontal tail surface.

Aircraft bounces and pivots to strike ground on right side of nose splitting cockpit longitudinally. Force of impact separates fuselage at wing trailing edge. Aft portion of fuselage intact. Forward portion breaks up. Nose, nose wheel and right side of cockpit, just aft of crew door, come to rest.

Left wing intact, strikes ground, separating engines 1 & 2. Fuselage forward of wing trailing edge disintegrates. Left side of cockpit relatively whole. Aft portion of fuselage, intact, continues motion.

Aft portion of fuselage strikes tree and breaks in two just forward of lounge.

Segments of aft portion of fuselage come to rest in street. Vertical fin separates from fuselage.
