CIVIL AERONAUTICS BOARD

ACCIDENT INVESTIGATION REPORT

PAN AMERICAN WORLD AIRWAYS, INC., - NEAR CAROLINA, BRAZIL,
APRIL 29, 1952

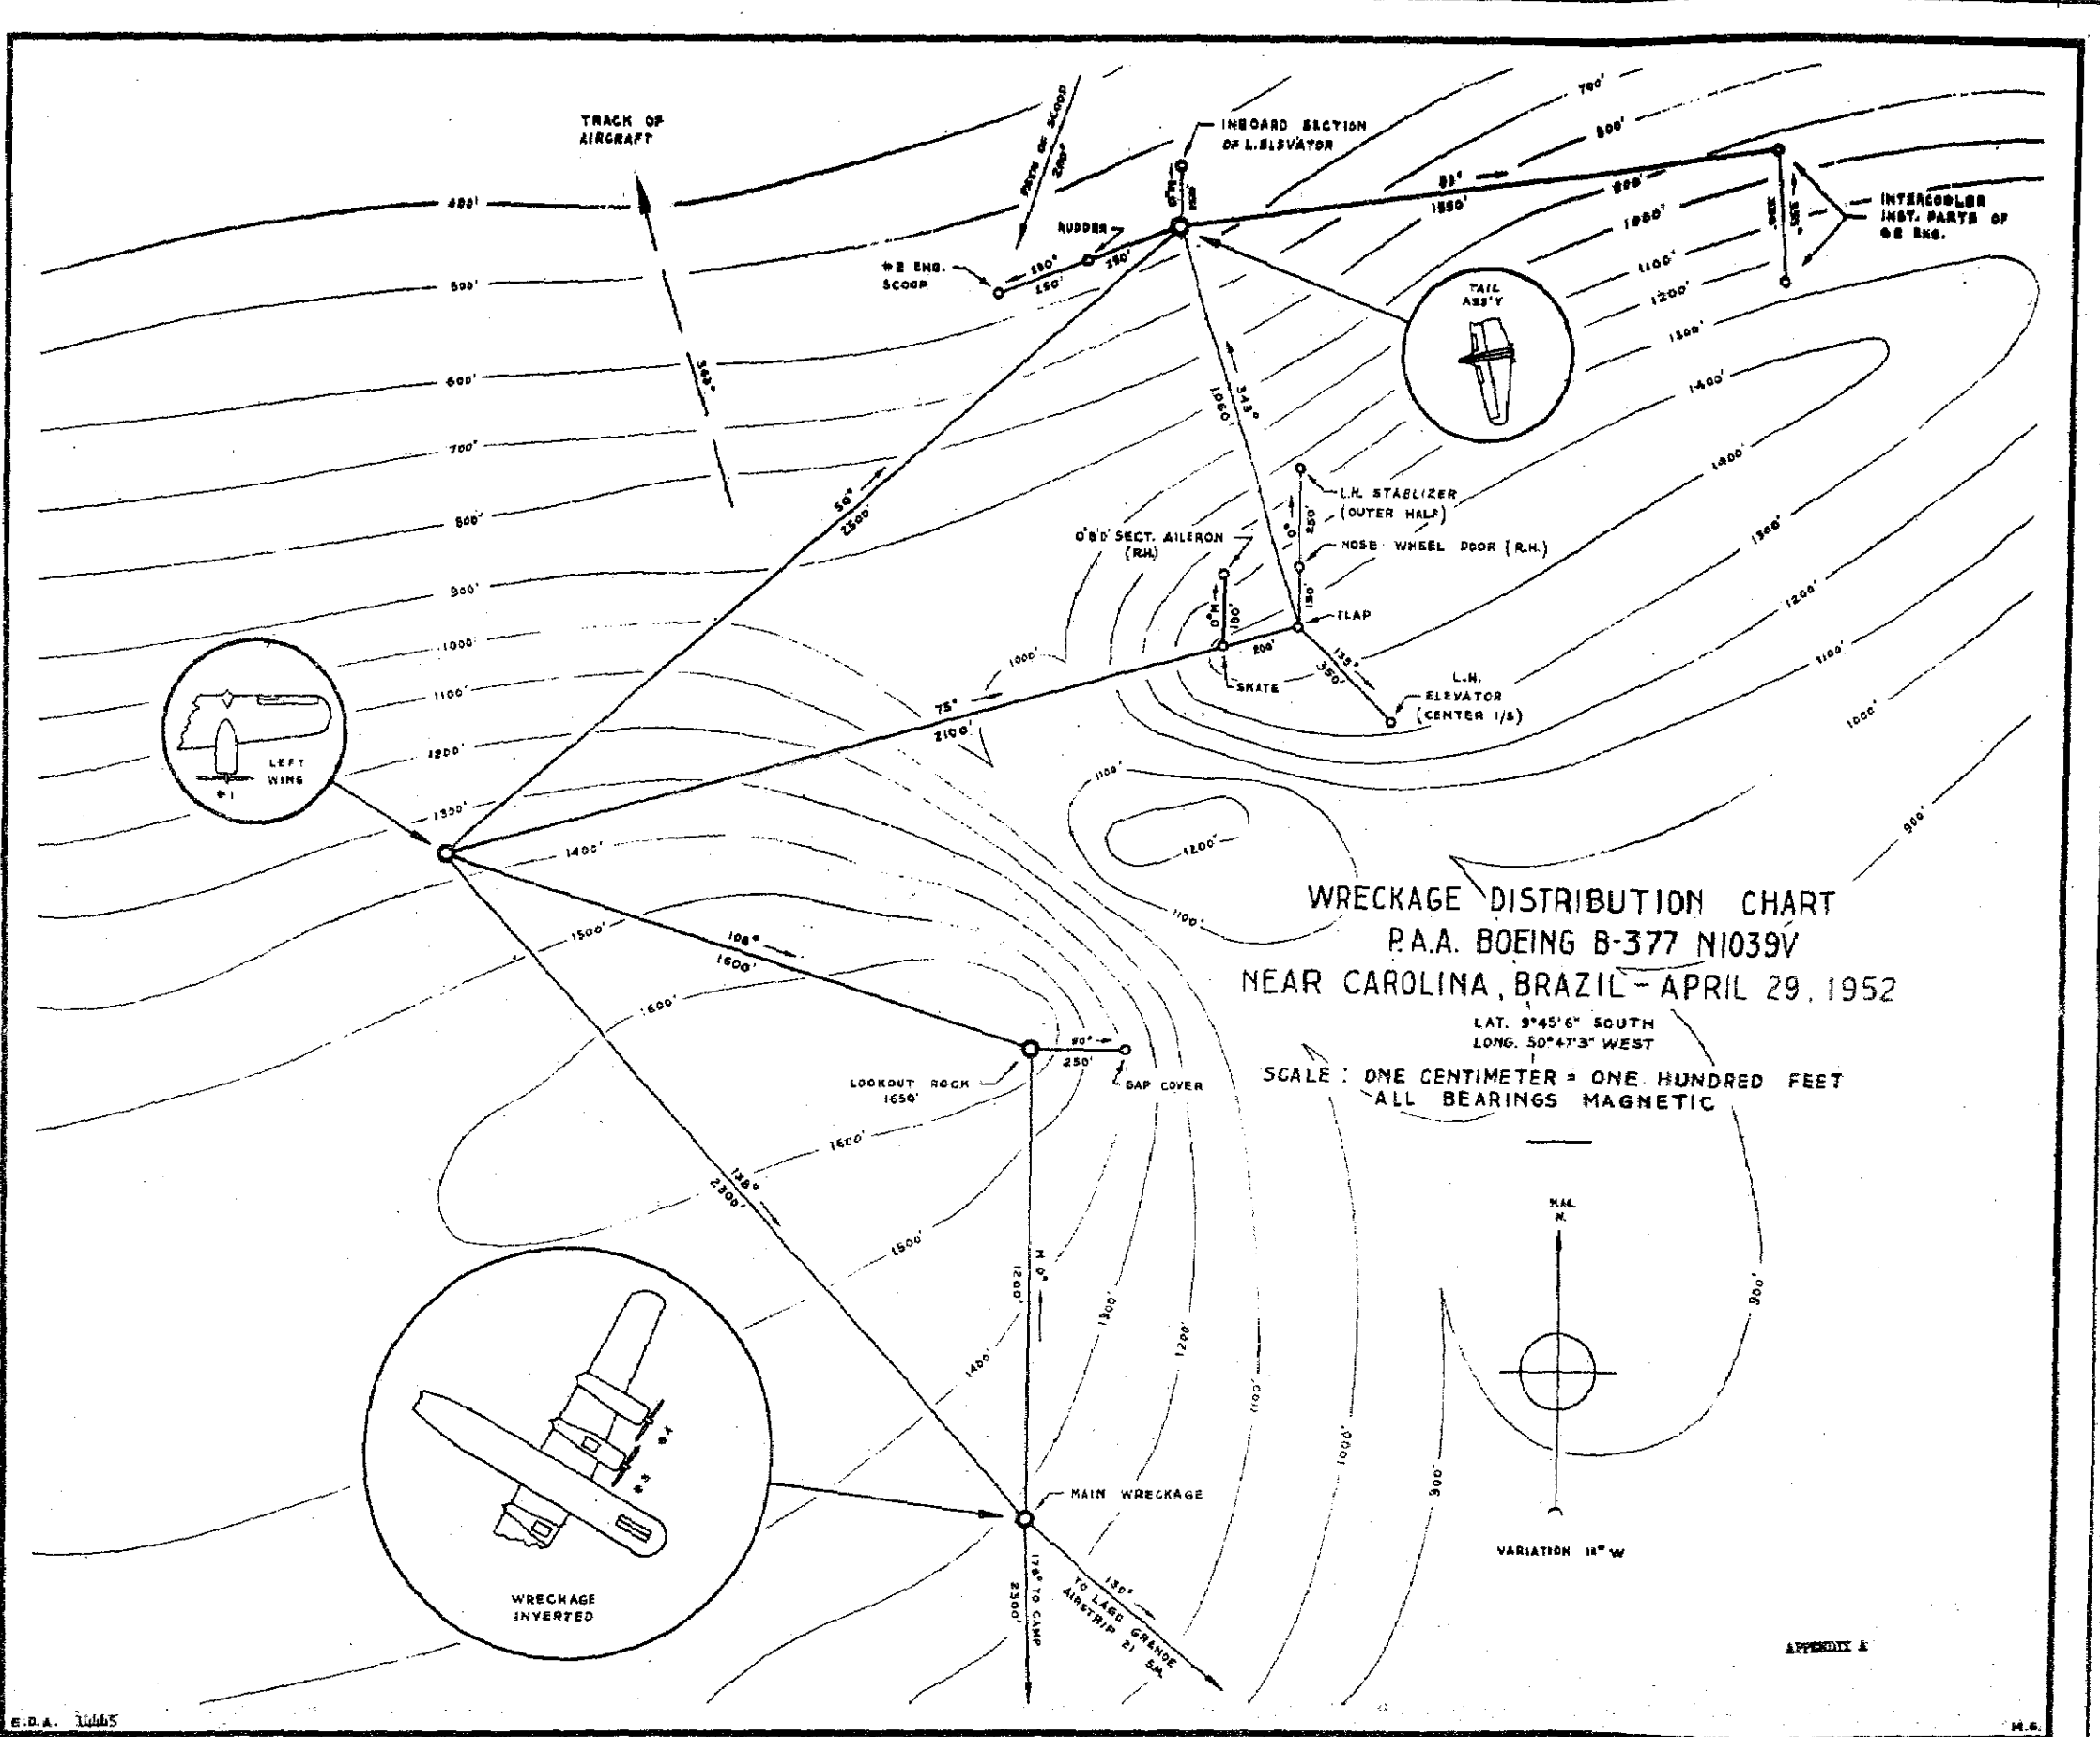
Most of the remaining structural parts of the aircraft were found within an area encompassed by a circle of approximately a 350-foot radius. From the center of this circle, the distance to the tail assembly wreckage was approximately 1,000 feet on a bearing of roughly 340 degrees. These parts included the outer portion of the left horizontal stabilizer, the middle portion of the left elevator, two inboard pieces of the left flap, the right-hand nose wheel well door, and the tip section of the right aileron. (See Chart, Appendix A.)

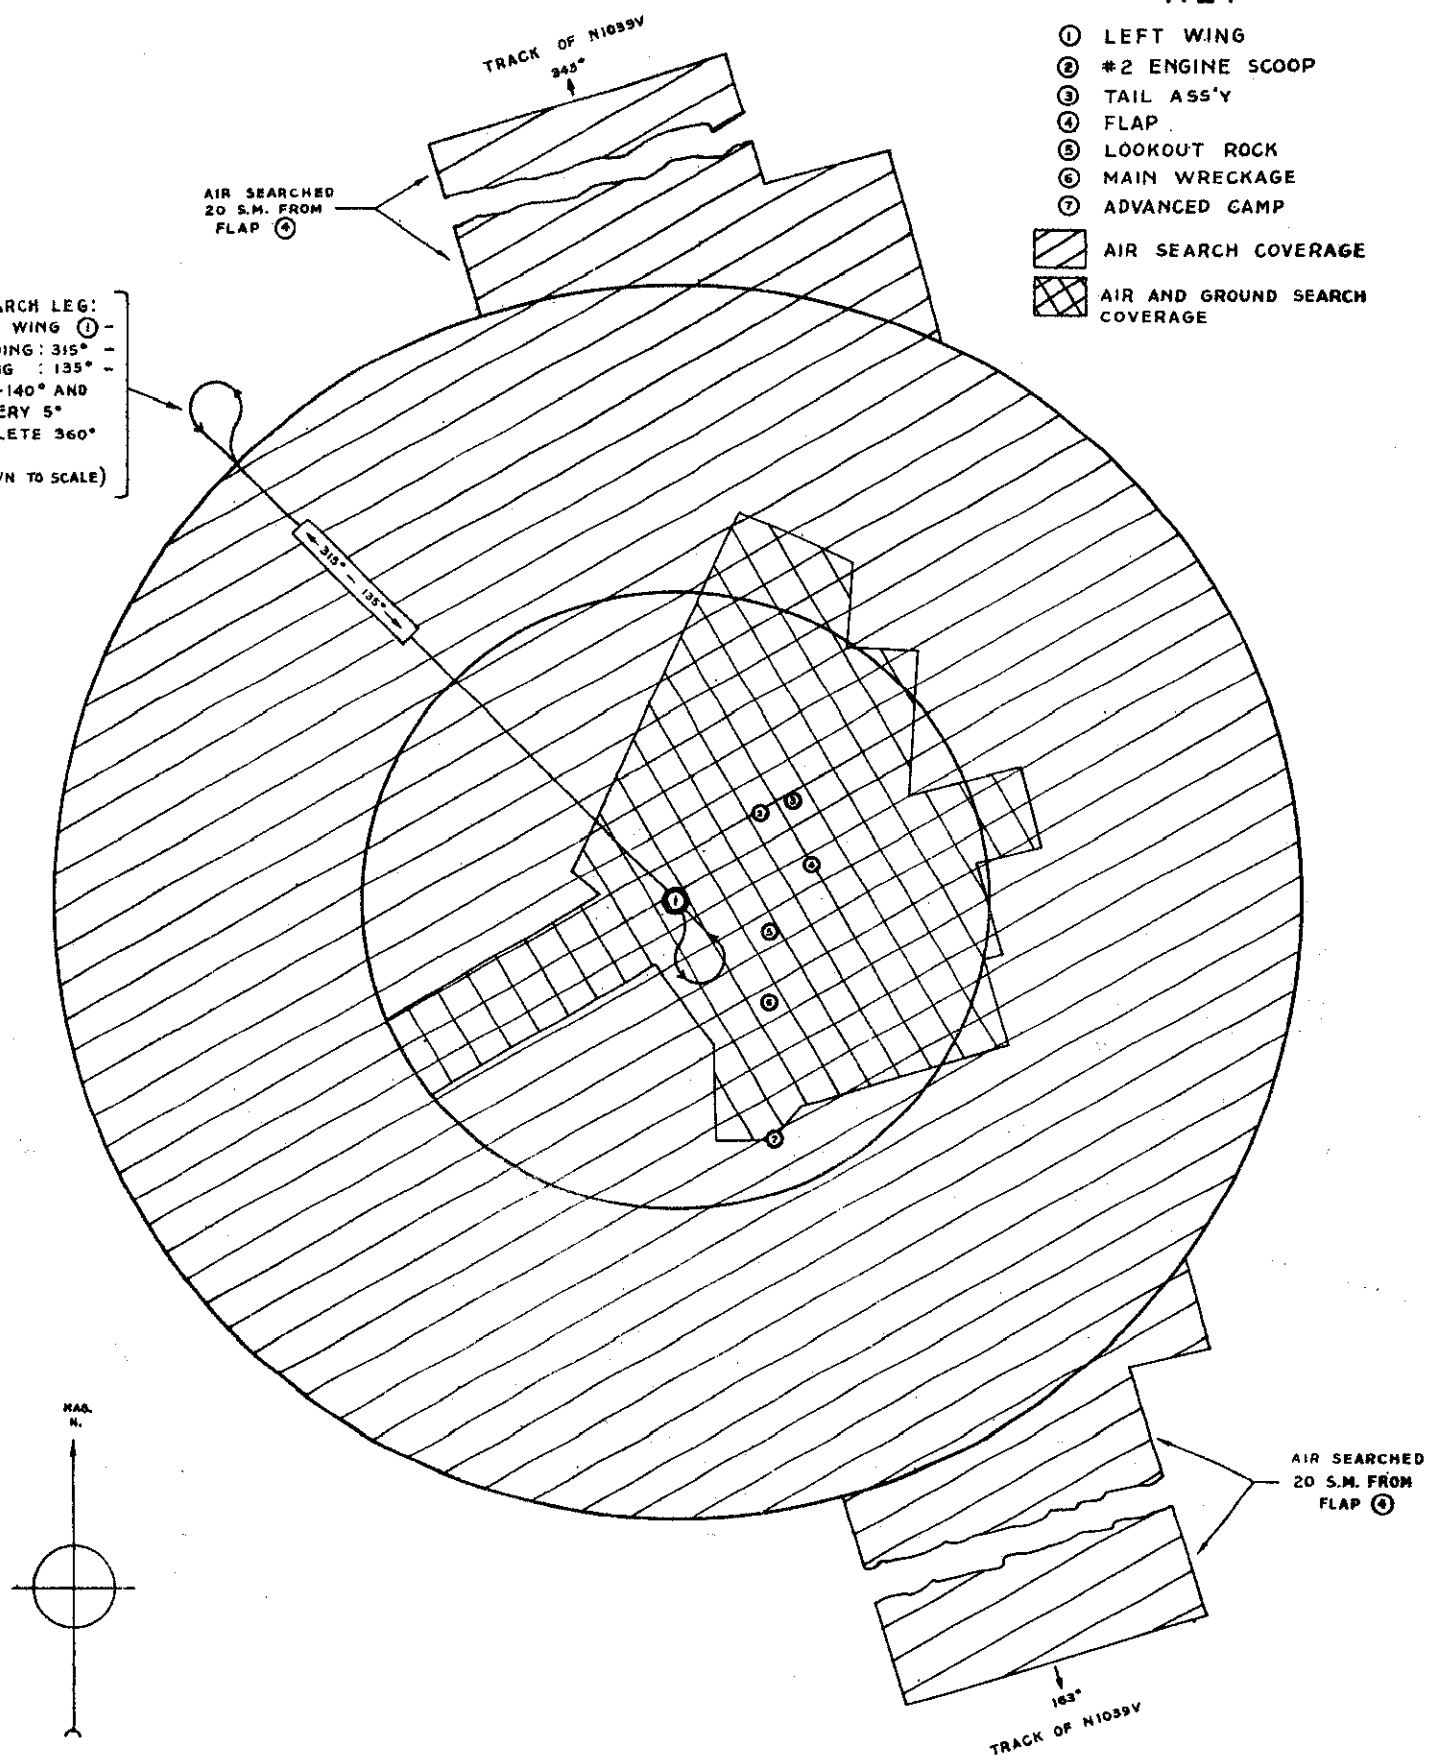
AIR-GROUND SEARCH FOR #2 ENGINE-N1039V

Extensive ground and air search^{3/} failed to locate the No 2 engine with its mounted accessories or No 2 propeller. Examination, therefore, was limited entirely to those portions of No 2 power plant which were recovered. With the exception of the left diagonal of the lower "V" strut assembly, the major portion of the engine mount structure from the ring mount aft to the point of attachment to the wing structure was recovered with the fuselage and right wing wreckage.
