No. 41BEA Viking crashed while approaching to land
at Nutt's Corner, BELFAST, 5 January 1953Circumstances

NUTT'S CORNER PLAN AND PROFILE OF EAST END OF RUNWAY 10-28

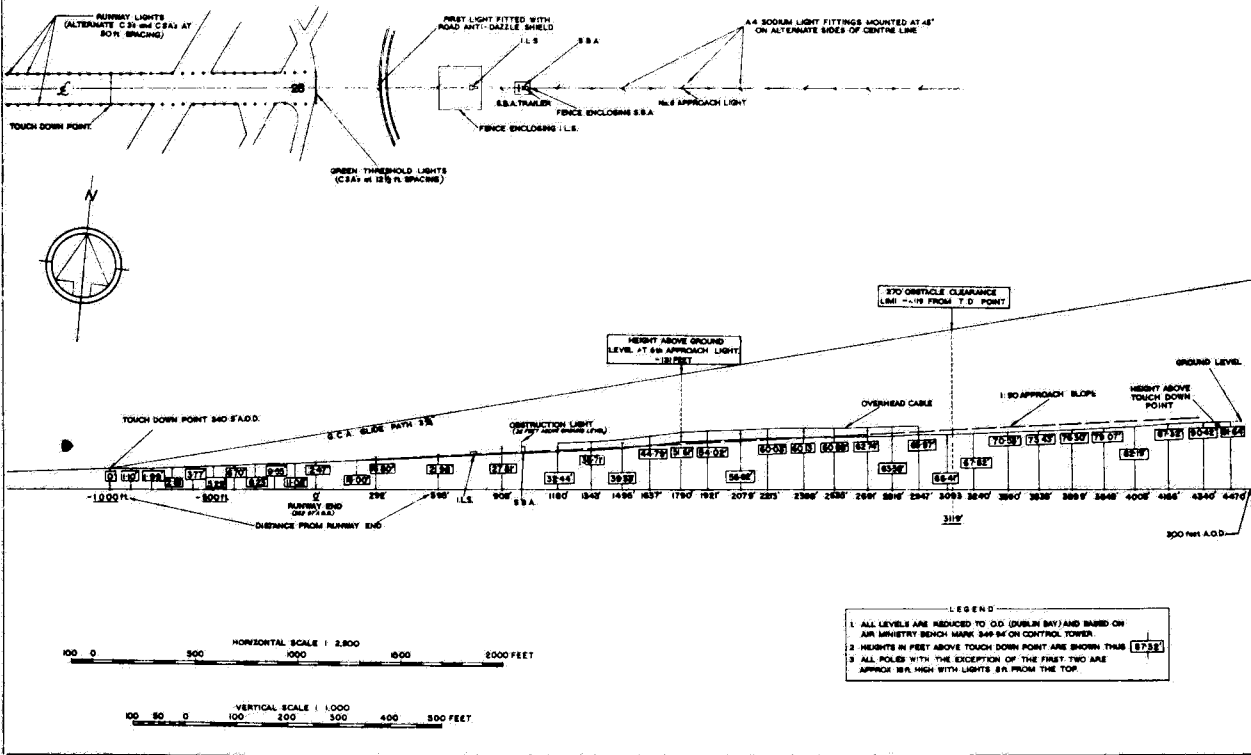
Thirty seconds after receiving this instruction the aircraft announced: "We can see the lights now". At about this time a witness in the control tower saw the lights of the aircraft as it broke cloud at height estimated at 1 000 - 1 500 feet. Its approach looked slightly steeper than normal, and when it looked dangerously close to the ground he sounded the alarm bell. The Viking maintained the same angle of descent down to the pole carrying No. 6 approach light (the top of which was 113 feet below the glide path), which it struck, and appeared to level out. Subsequent investigation showed that it touched down some 250 feet further on, ran along the ground for about 82 feet, rose again, struck the SBA van, came down again and struck the ILS building before breaking up.

There would probably have been no major disaster if the aircraft had not struck in succession five poles, the SBA van and the ILS building. In particular, it was probably the impact with the SBA van which put an end to the aircraft's chance of reaching the runway and it was

probably the impact with the ILS hut which made a major tragedy inevitable. In this sense these various obstructions contributed to the accident. But none of them would have constituted a danger except in the most exceptional circumstances; they were not, when erected, in contravention of any accepted standards and it would not have been practicable or reasonable to remove them when new ICAO Standards came into force in June 1952. The following specific conclusions and recommendations are made:

a) The lights on the poles were, for convenience of maintenance, a considerable distance (8 feet) from the top of the poles. It is highly unlikely that if they had been at the tops it would have made any difference to the aircraft, but a small increase in safety, probably sufficient to compensate for the increased difficulty of maintenance, has been obtained by moving them nearer to the tops of the poles since the accident and it is recommended that they be retained in that position.

b) The SBA van was not intended to be a permanent installation and it would not be reasonable to require exceptional measures to deal with the remote risk attached to its being in the line of approach to the runway.

c) It is undesirable that a permanent installation such as the ILS building should be in such a position as was occupied by the ILS building at the time of the accident. It is recommended that the plan for rebuilding it on a site offset from the runway be proceeded with and that the effects on its efficiency as an aid to pilots of its being off-centre be carefully studied. Meanwhile, it is desirable that investigation into the practicability of putting such installations underground should be pursued.
