No. 37BOAC Comet D.H. 106 aircraft accident during take-off  
on 26 October 1952 at Ciampino Airport, RomeCircumstances

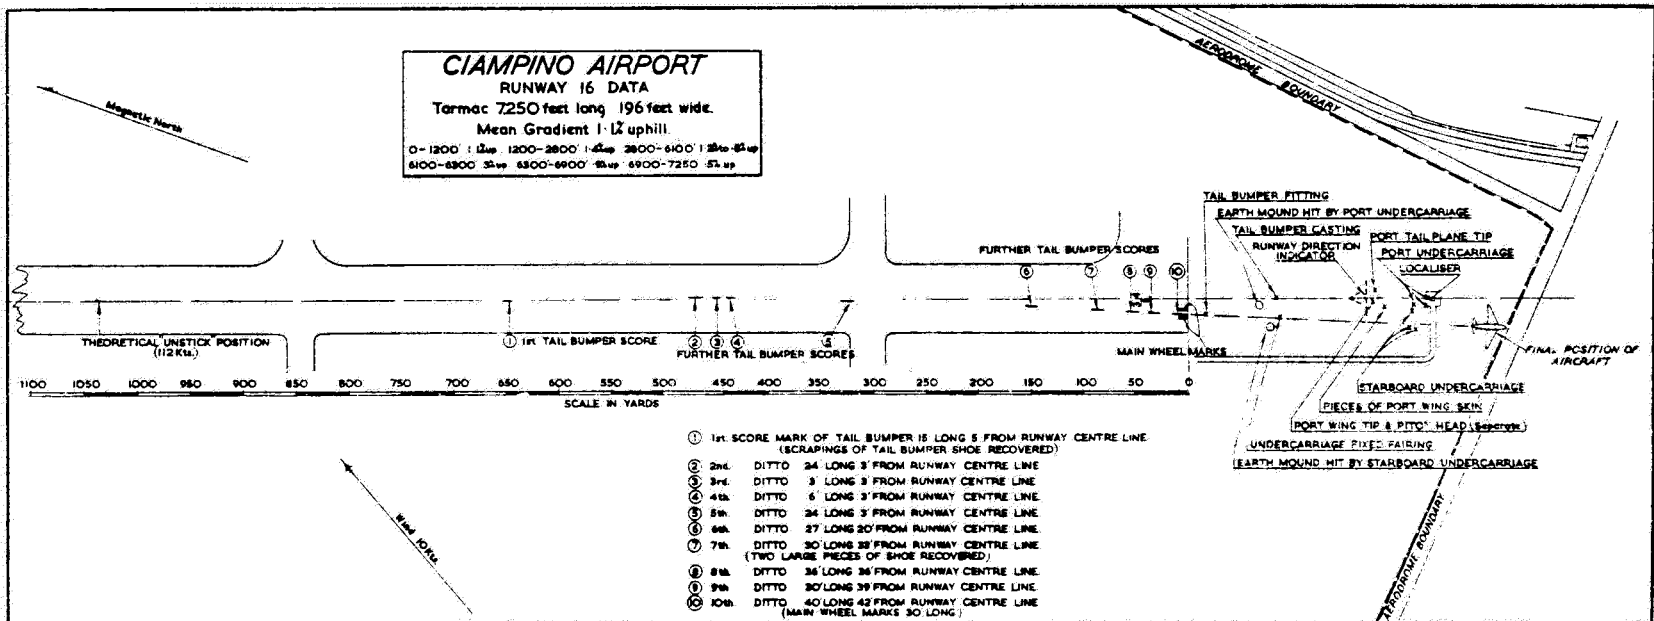
The normal fuselage incidence during the take-off ground run is about 2° to 3° after the nose wheel has been raised just clear of the runway. To do this a backward stick movement of about 4 inches is required which is then reduced to 1-1/2 inches. The attitude of "unstick" is approximately 6° to 6-1/2° and to attain this the required stick movement at the time of leaving the ground is of the order of 6 inches back from the neutral position, after which the stick must be returned towards the pre-take-off position.

Take-off by the manufacturers have shown that a constant 6° incidence of fuselage during the ground run gives good results for distance run and for climb-away behavior. They have also shown that an increase of incidence to 9° results in a partially stalled wing giving high drag which appreciably affects the aircraft's acceleration, and that the symptoms are noticeable to the pilot as low frequency buffet. The aircraft recovers from its semi-stalled position if the nose is pushed well down.

Figure shows a diagrammatic representation of the nose-up attitude of the aircraft in the correct position of unstick, i. e., 6° - 6-1/2° nose up. The Appendix also shows that for the tail bumper to touch the ground an angle of at least 11-1/2° is required.

The accident was due to an error of judgment by the Captain in not appreciating the excessive nose-up attitude of the aircraft during the take-off.
