CIVIL AERONAUTICS BOARD

ACCIDENT INVESTIGATION REPORT

BRITISH COMMONWEALTH PACIFIC AIRLINES, LTD., NEAR HALF MOON BAY,
CALIFORNIA, OCTOBER 29, 1953

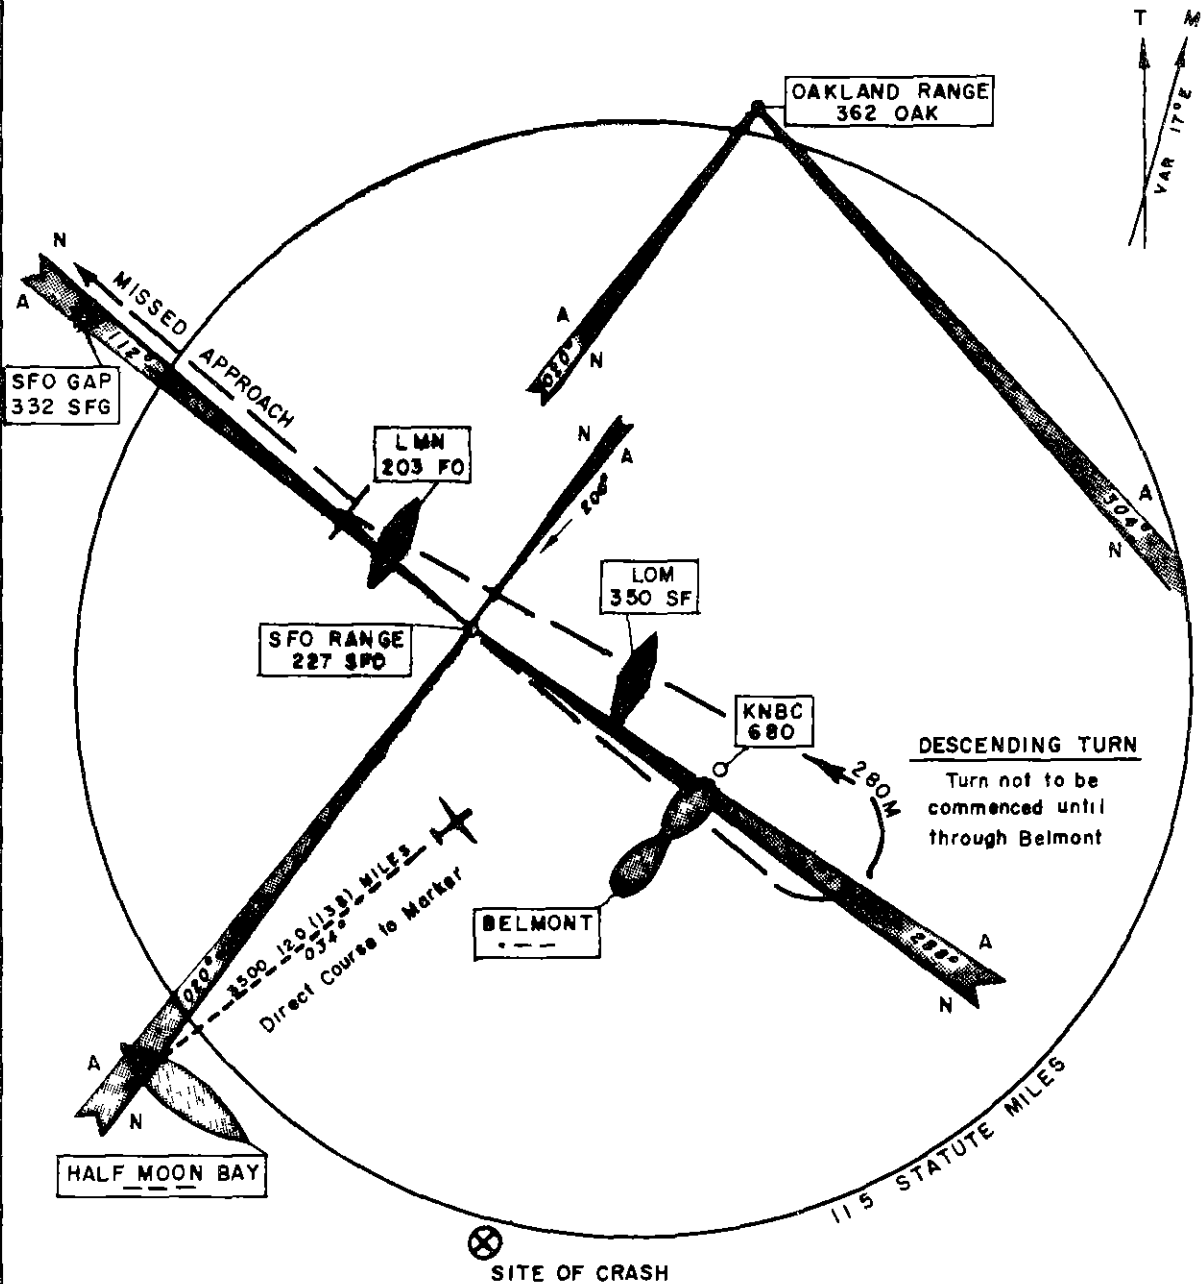
INSTRUMENT APPROACH PROCEDURE AND CRASH SITE

As the flight neared the coast, it was given its approach clearance which was acknowledged and repeated back. This clearance required the flight to maintain at least 500 feet above all clouds from the Half Moon Bay Fan Marker to the ILS outer marker. The accident site was between these two points. It is obvious the flight did not maintain at least 500 on top and descended in weather conditions which precluded visual reference to the ground.

The flight reported over the Half Moon Bay Fan Marker at 0839 and then reported, "Southeast, turning inbound," at approximately 0842. The crash took place between 0842 and 0845. It seems impossible in this time interval for the flight to have flown from the Half Moon Bay Fan Marker to the ILS outer marker, made the required turn and returned to the crash site, assuming a normal speed. This is especially true considering that a part of the distance was flown with the landing gear down and 15 degrees of flaps extended. Thus it is likely that when the pilot reported "Southeast, turning inbound," his actual position was southwest of the airport. It is therefore probable that the captain after reporting over Half Moon Bay either saw the terrain momentarily through an unreported break in the overcast or because of a radio navigational error became convinced that his position was farther northeast, and started to let down over what he believed was the proper area for this descent.
