CIVIL AERONAUTICS BOARD

ACCIDENT INVESTIGATION REPORT

ITALIAN AIRLINES (LINEE AEREE ITALIANE), AT NEW YORK
INTERNATIONAL AIRPORT, JAMAICA, NEW YORK, DECEMBER 18, 1954

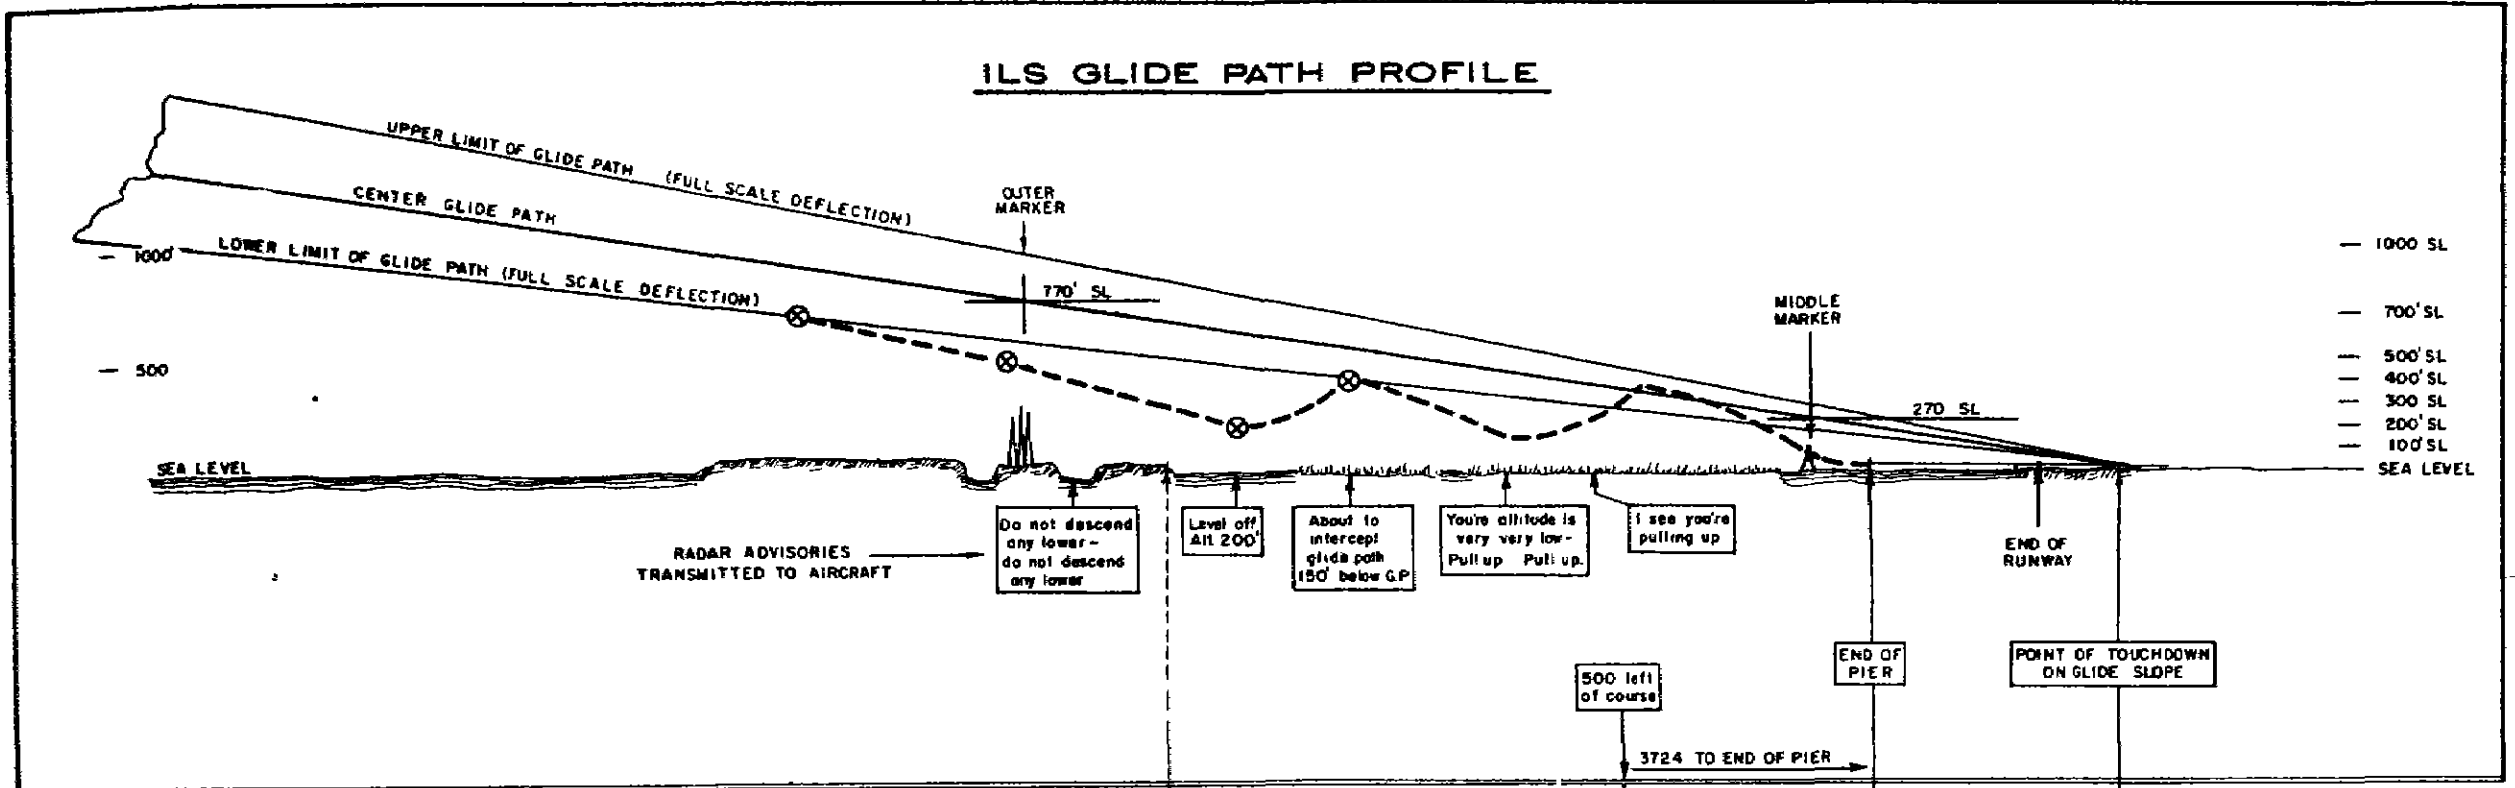
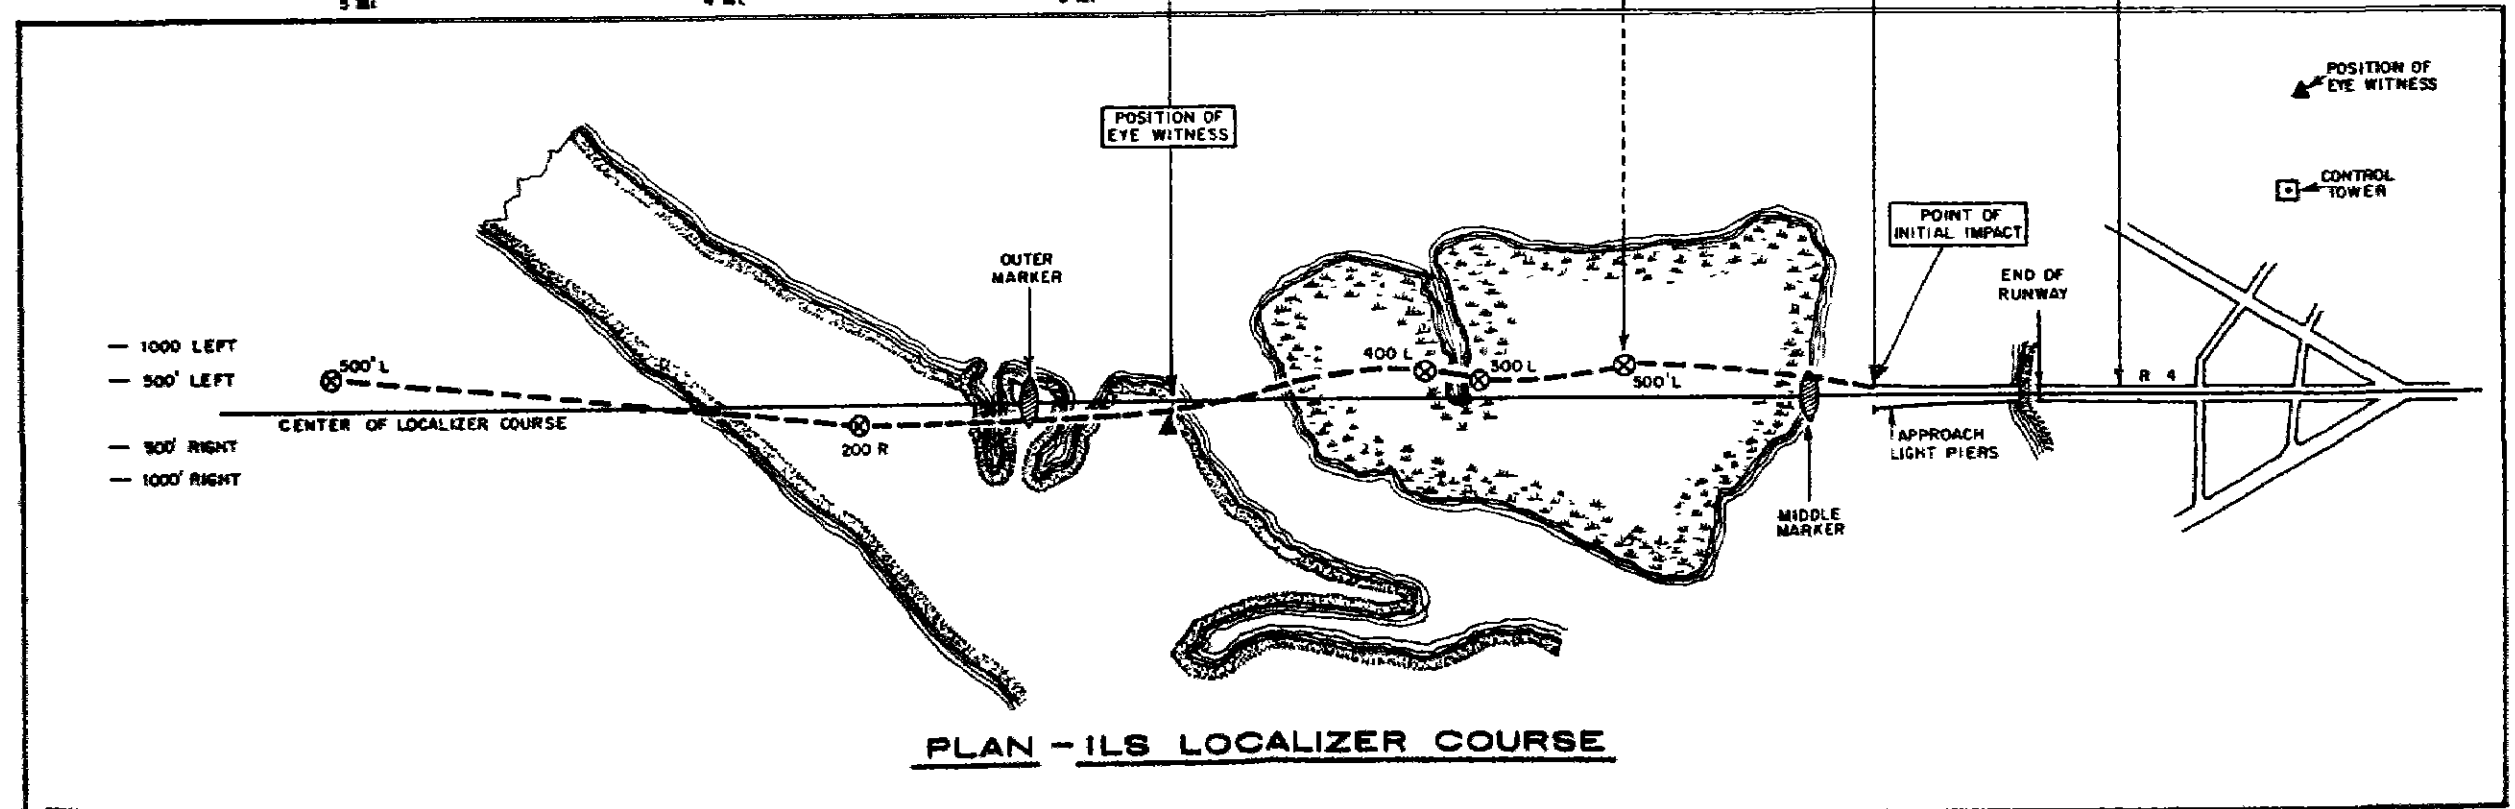
PROBABLE FLIGHT PATH AND POSITIONS OF AIRCRAFT ILINE (LAI FLIGHT 451) DURING LAST APPROACH TO R-4 NEW YORK INTERNATIONAL AIRPORT DECEMBER 18, 1964

Evidence indicates that on the last approach the pilot began a descent before intersecting the glide path and continued to descend, although repeatedly advised by the radar controller to level off. Altitudes throughout the approach indicate the ILS glide path indicator would have shown a full scale fly-up indication. This evidence strongly suggests that the pilot was not attempting to follow the glide path but decided to descend until visual reference was established. The pilot apparently descended below the overcast in the area between the outer and middle markers, probably in an attempt to proceed visually below the overcast to the runway. While attempting to do so, however, he may have encountered a drifting fog which was not recorded. Such procedure is not in accord with good operating practice and the reasons for it in this instance have not been definitely ascertained.

overcast. In order to arrest the ascent, or again descend to establish visual contact, it is believed the pilot lowered the nose of the aircraft and in so doing got very low. As a result he apparently again pulled up sharply, the aircraft drifting slightly left. The ascent seemingly continued, during which the aircraft lost airspeed and began turning right. The nose of the aircraft was then lowered and power was applied. The landing gear was probably retracted at some time during this series of events. These movements of the aircraft are strongly supported by the testimony of the surviving passengers, the second eyewitness, and the path of the aircraft as observed by the radar controller.

The final descent obviously continued until the aircraft was a short distance from the pier but too close to avoid it.

Approximate Positions and Flight Path are Based on Data Obtained from Transcription of Radar Advisories
