No. 3

KLM Royal Dutch Airlines, Lockheed Super Constellation, crashed in
the estuary of the River Shannon, Ireland, on 5 September 1954.
Department of Industry and Commerce, Ireland,
Accident Investigation Report, released
31 January 1955.

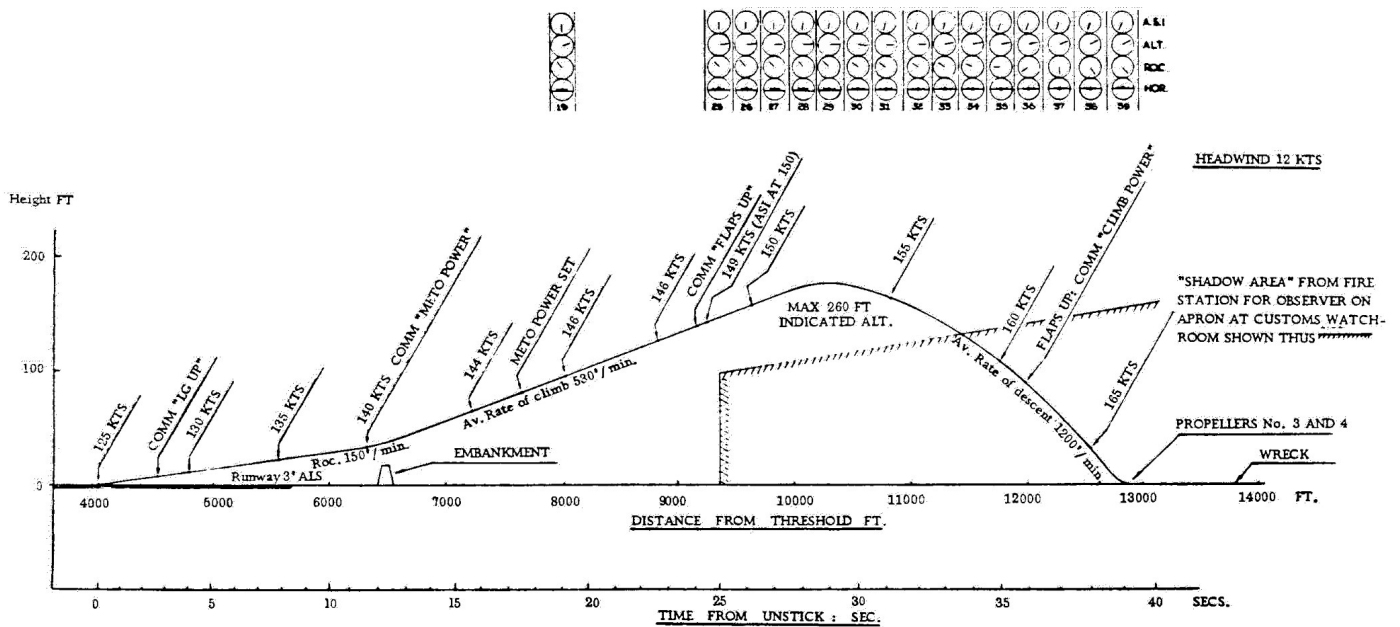
FIGURE 1
FLIGHT PATH AND
RELATED INSTRUMENT
INDICATIONS

The Court considered that the aircraft followed a flight path somewhat as reconstructed in Fig. 1. This is based on the calculations (these are set out in the original Report as Appendix V) taken from the appropriate evidence accepted by the Court and taking into account the following factors.

A surface headwind of 12 knots reported at time of take-off was allowed for. The usual variation of wind with height, as well as momentary deviations from the reported value of the surface headwind could well account for a shortening of this flight path by some hundreds of feet. The final part of the flight path, therefore, could well have been somewhat more flattened out, thus allowing for a point of first contact some hundreds of feet before the point actually shown in Fig. 1.

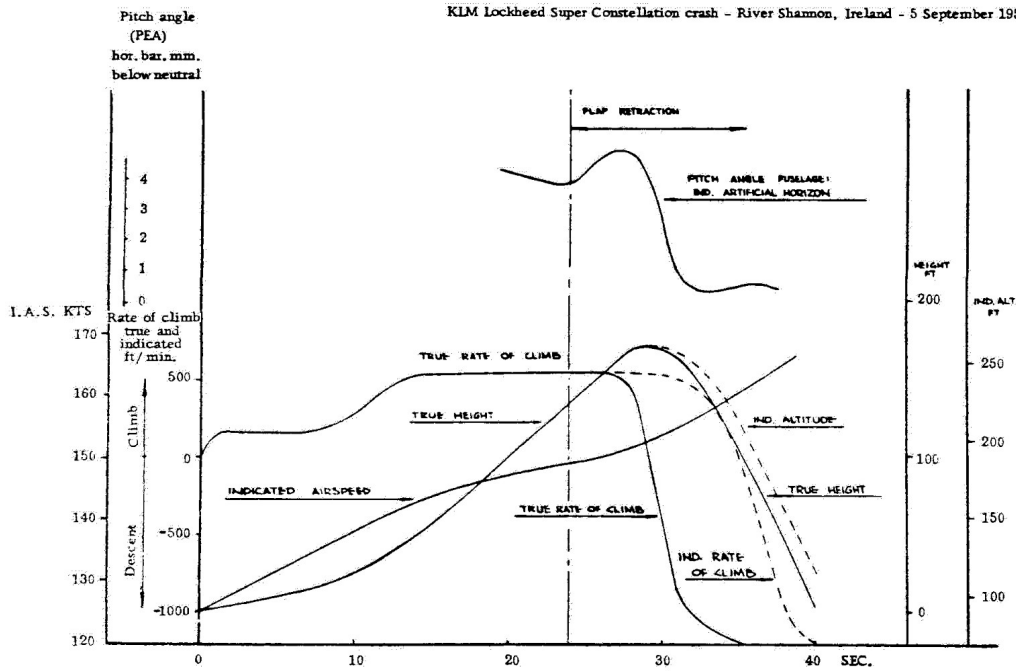
FIGURE 2
TIME HISTORY
AND
INSTRUMENT INDICATIONS

From the data of this flight path, the approximate instrument indications, available to the captain, from flap retraction onwards, were computed.
