Trans-Australia Airlines, Viscount 720 aircraft, crashed after take-off at Mangalore Aerodrome, Victoria, Australia, on 31 October 1954. Accident Investigation Summary. Aviation Safety Digest No. 4, April 1955  
(Commonwealth of Australia, Department of Civil Aviation)

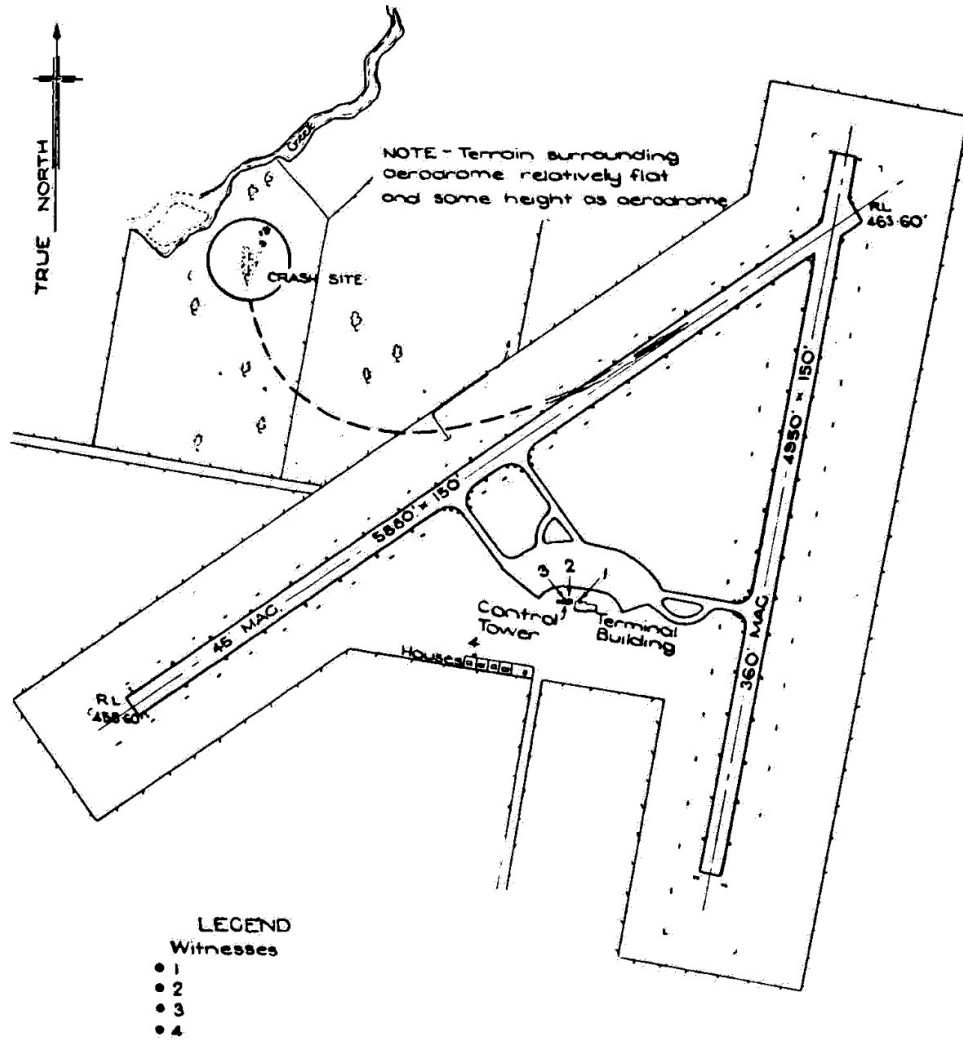
FIGURE 31

Tyre marks left on the runway during the take-off reveal that a swing to starboard occurred approximately 1 100 feet from the start of the take-off run and, as indicated by the marks on the runway, nosewheel steering was used to correct it. Marks of a second swing were in evidence 1 800 feet along the runway and it was during this swing that the aircraft left the runway at a point some 2 000 feet from the commencement of the take-off, and became airborne, 240 feet further on. There were no nosewheel steering marks during this swing. The path of the aircraft is shown in the attached plans. (Figures 31 and 32).

ACCIDENT TO VISCOUNT AIRCRAFT VH-TVA.  
 AT MANGALORE VICTORIA ON 31 OCT. 1954.  
LOCALITY PLAN OF CRASH SITE SHOWING  
ESTIMATED FLIGHT PATH

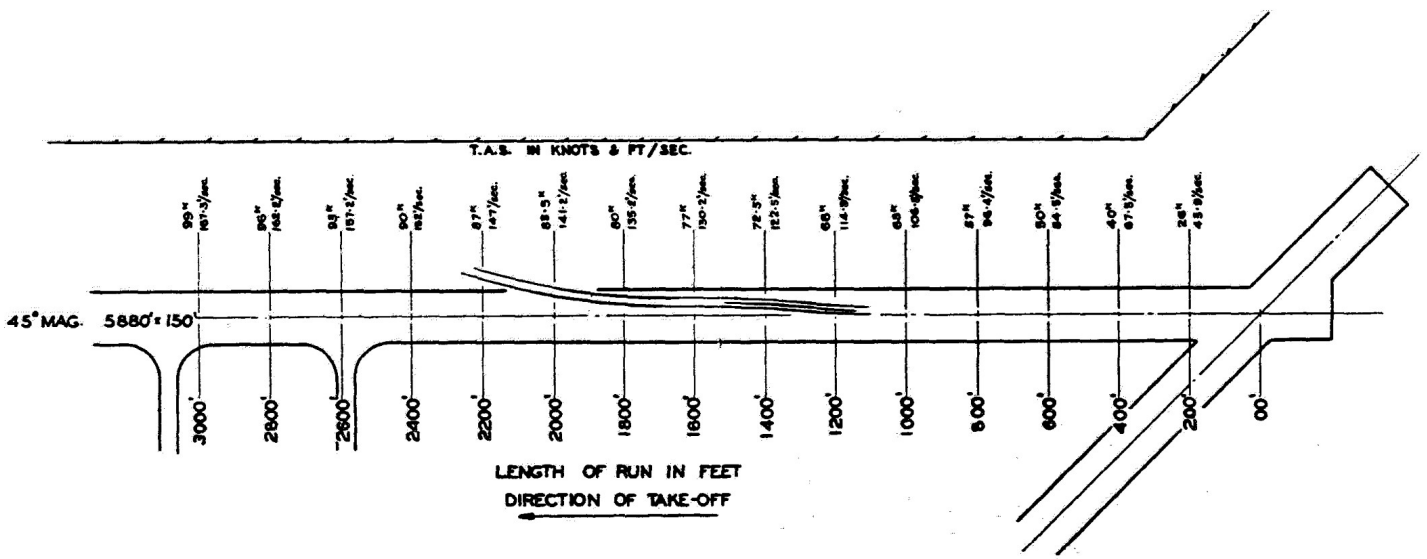
FIGURE 32

The tyre marks show that the aircraft was running 15 feet to the right of the runway centre line, when the first swing to starboard commenced at a point some 100 feet from the start of the take-off. It is estimated that the speed of the aircraft at this point would be of the order of 65 knots. Marks on the runway indicate that this swing was corrected by nosewheel steering and as the swing was controlled these marks became lighter until they disappeared when the aircraft was running straight again. Although running straight, it was still heading slightly to the right away from the runway centre line. After approximately 200 feet in this condition, which would have taken about 1-1/2 seconds, the aircraft again swung to starboard, left the runway and a short distance later became airborne. This swing was severe.

The surviving supernumerary pilot, who at this time was standing between the pilots, states that as the aircraft left the runway, the pilot-in-command pushed the throttles fully open and pulled the aircraft into the air at an airspeed between 85 and 90 knots - definitely not higher than 90 knots. It has been calculated that with normal acceleration in a three-engine take-off the speed of the aircraft where it left the runway would have been 85 to 90 knots. From what is known of the characteristics of the aircraft near the minimum control speed, it is clear that it could not be controlled directionally after it left the ground, and its fate was inevitable so long as full power was drawn at speeds below 96 knots. In deciding to lift VH-TVA into the air at this time, rather than abandon the take-off, an error of judgment was committed by the captain and the accident resulted.

RELATION OF TRUE AIR SPEED TO TAKE-OFF RUN.
