No. 4

Trans-Canada Air Lines, DC-4-M2, CF-TFD, crashed below the third peak of Mount Slesse, British Columbia, on 9 December 1956. Report by the Department of Transport, Canada. Serial No. 56-16.

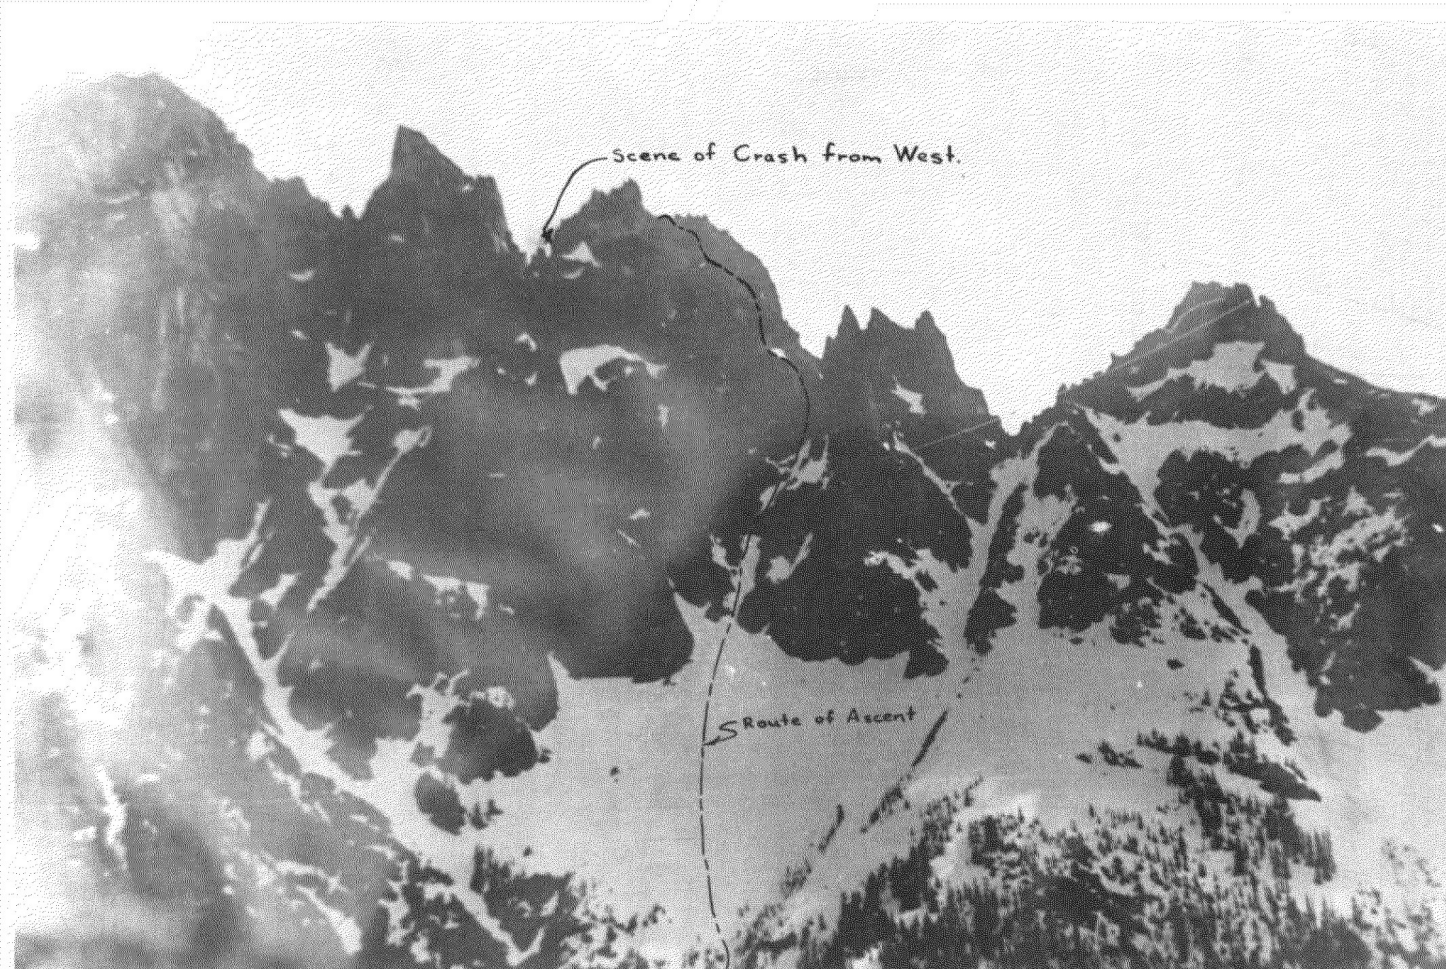
FIGURE 3

MOUNT SLESSE FROM THE WEST - Part of the route which CF-TED took prior to the crash of 9 December 1956. This does not show the knoll from which ascents were made.

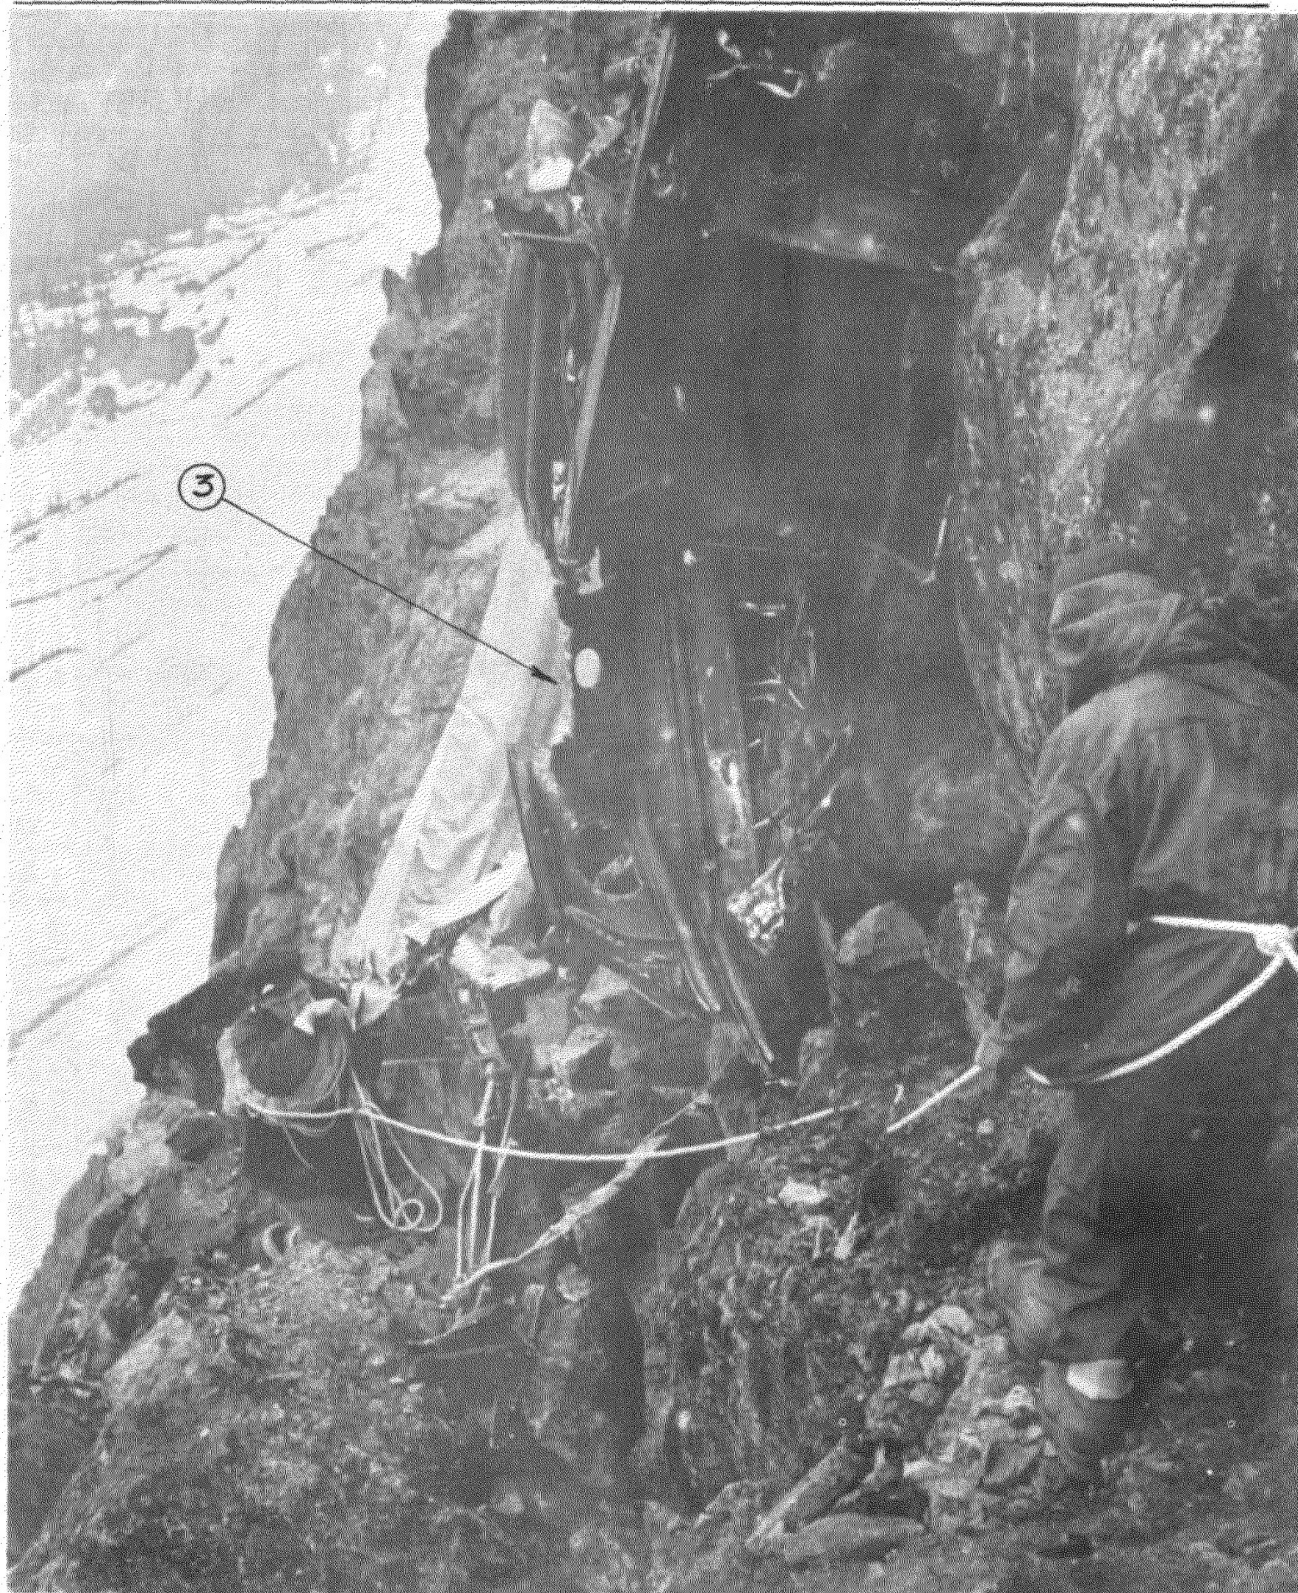
FIGURE 4

The lower wreckage hanging on the face of the cliff was identified as a piece of main spar material but its position prevented a detailed examination to determine its exact location in the aircraft. Oil covered the face of the rocks in this area and part of a propeller piston and cylinder assembly and the oil regulator of No. 1 engine were found. Many nuts, bolts,

washers and small pieces of engine material were noted in crevices in loose rocks and on rocks in this area. The upper wreckage hanging on the cable was a small tangled mass of broken metal conduit, electric wiring and cables.

BOTTOM OF LOWER WRECKAGE OF TCA, DC-4, CF-TFD - part of centre section behind two engines. The rocks here were covered in oil and many nuts, bolts, washers and metal fragments were found stuck on rock faces and in loose rocks.

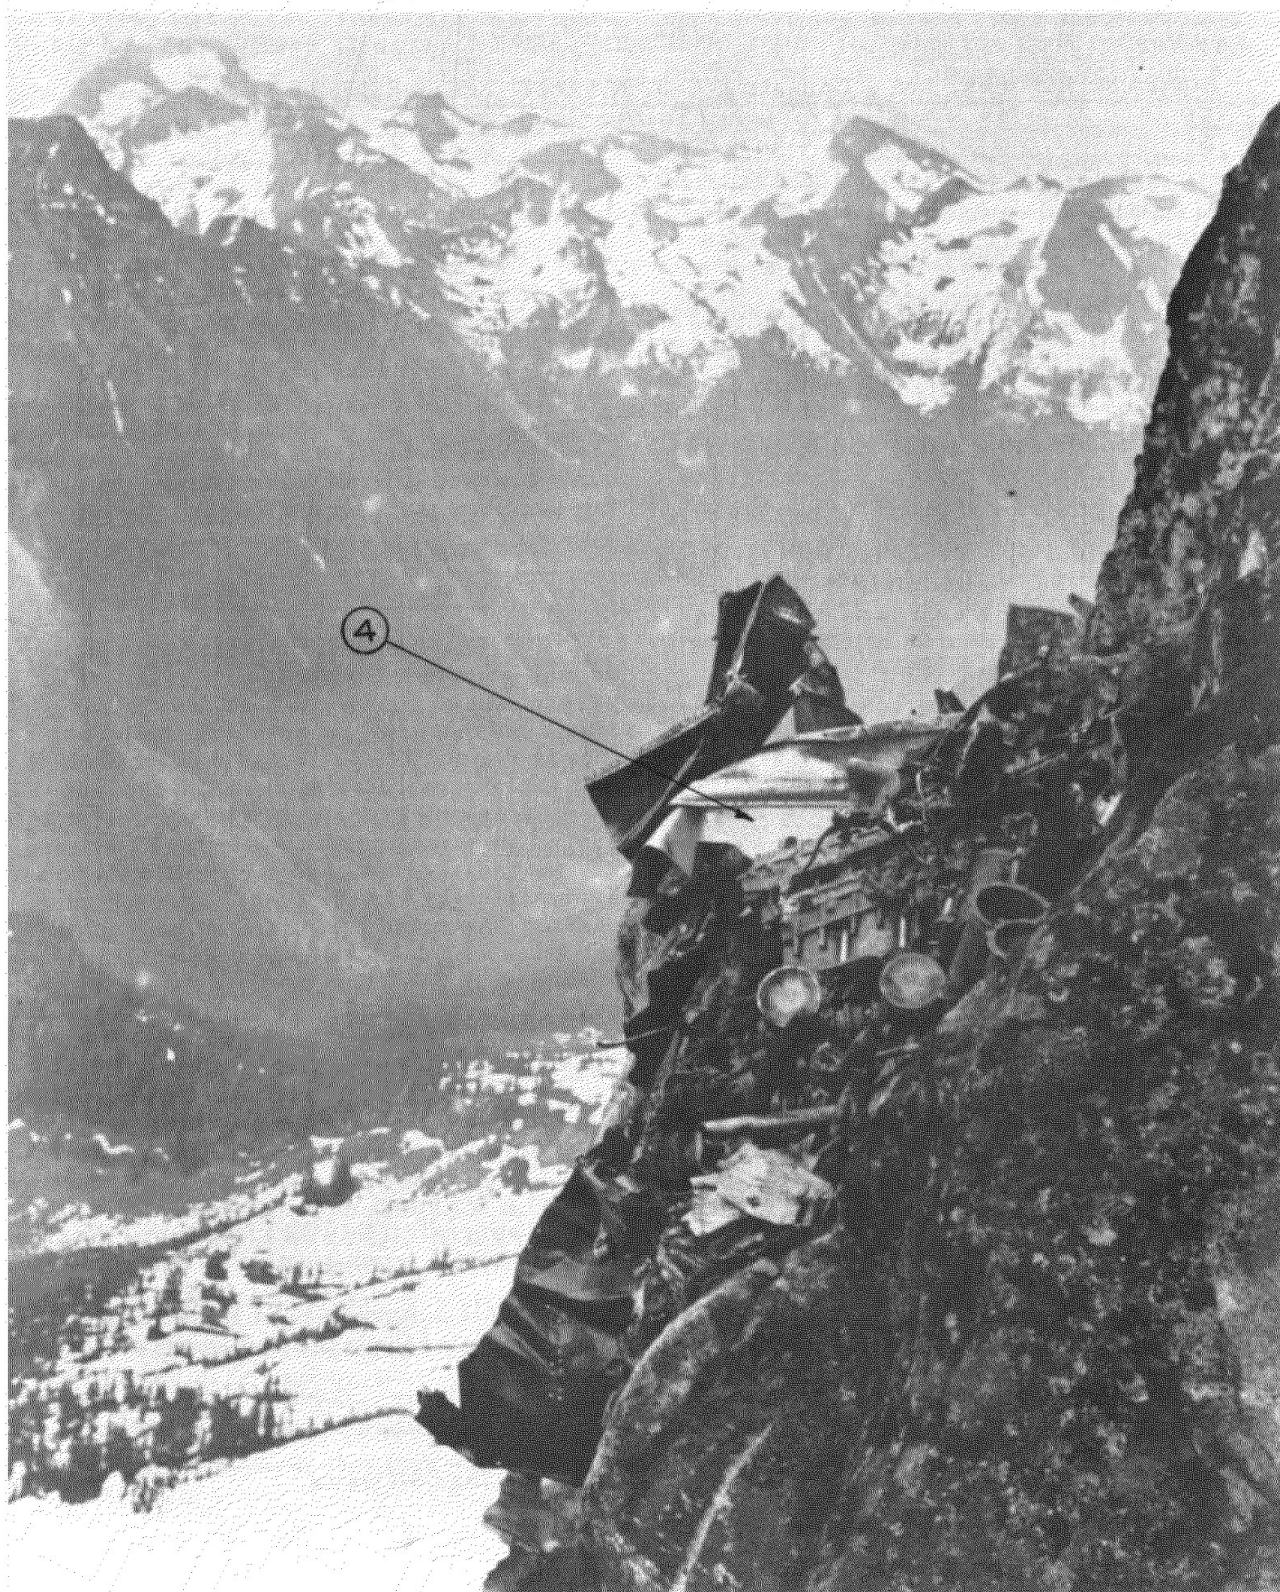
FIGURE 5

On the shelf the remains of two engines were found. One to the south of the mass of wreckage on the shelf rested in an unreachable cleft in the rock face and though badly smashed was, compared with the other engines, far more intact. The other engine, which included one of the bearers, was smashed to small pieces and lay to the north of the mass of wreckage.

CF-TFD CRASH IN BRITISH COLUMBIA, CANADA - View of engine south of wreckage on cliff.
