No. 24

Aerotaxi S. A. Bogota, de Havilland DHC-2, HK-181, crashed 8 kilometres from the Municipality of Santo Domingo, (Antioquia), on 4 June 1957.
Report released by Department of Civil Aeronautics, Colombia.

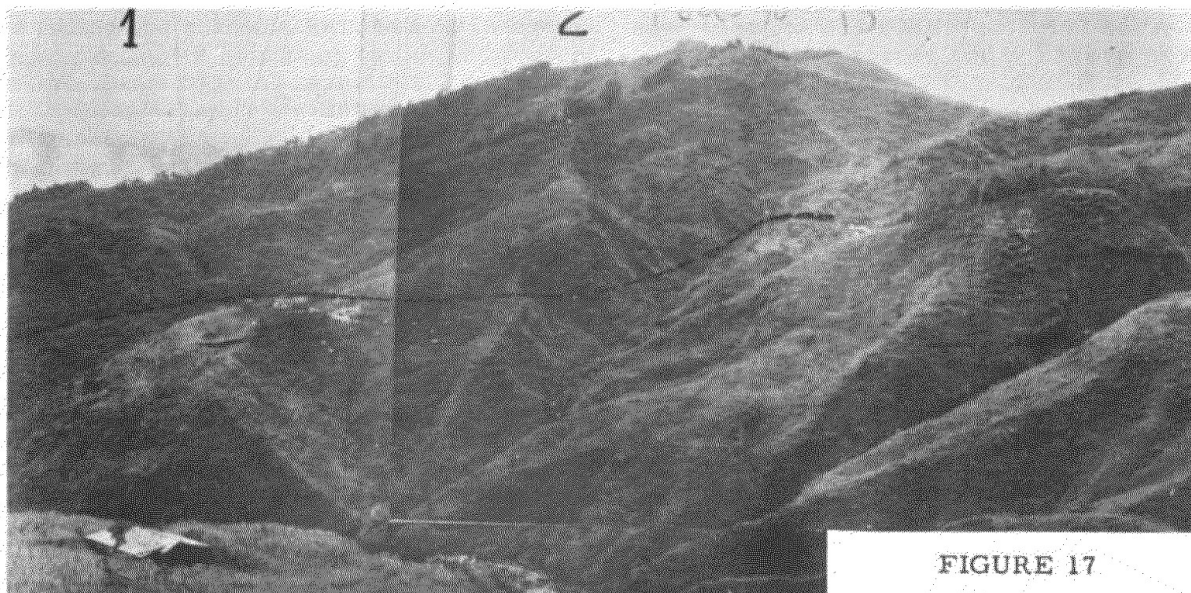
FIGURE 17

Low flying through a dead end canyon. Contributing cause: low strata preventing visibility.

These photos show the route which HK-181, a Colombian aircraft, took prior to crashing into a hill 8 km from the municipality of Santo Domingo - the result of low flying in a dead end canyon in poor visibility conditions.

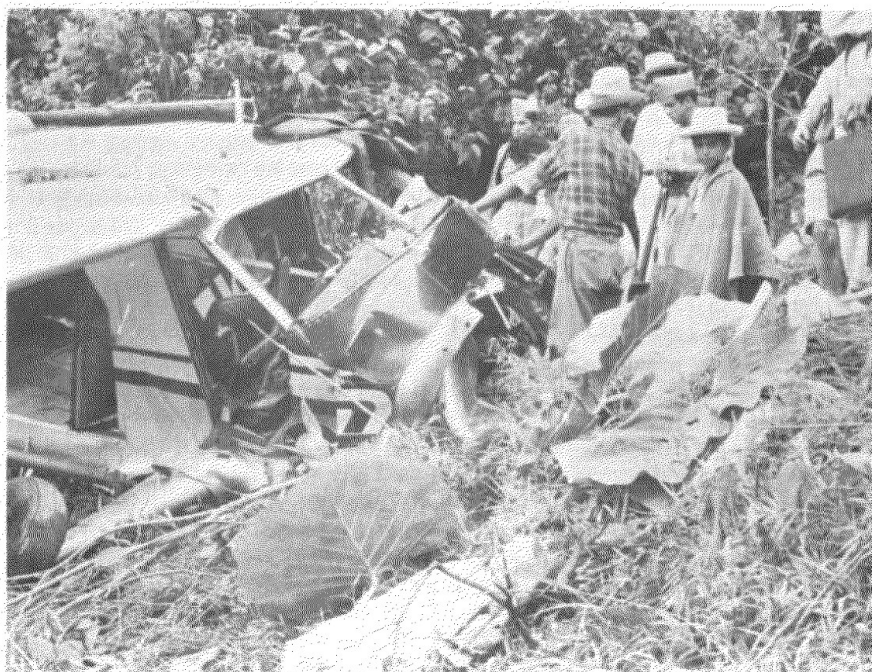
FIGURE 18

of 130 degrees, the propeller in low pitch and slightly bent, the fuel selector valve on the front tank, the shut-off valve off, both flaps indicating a landing attitude, the left wing and the left elevator torn free, the left landing gear and the tail skid torn free, the engine at a 45 degree angle towards the left of the fuselage, and the fuel tank in good condition. When examining the engine, no metal particles were found in the filter and there was no indication of fire. As the carburettor was in an inverted position there were no traces of petrol or water in it, nor was any water found in the fuel tanks. There was no definite sign of engine failure in any of its systems. It should be noted that petrol was found in the tanks and that 39 gallons had been pumped into them on the afternoon of 3 June in order to fill them to the brim. On the afternoon of 4 June, 30 more gallons were pumped into the aircraft's tanks in order to refill them completely. Having regard to the route covered on that day, especially on that afternoon, the aircraft had enough petrol to enable it to fly for at least 3-1/2 more hours. This point is made since the investigators heard it stated that the accident was due to lack of petrol.

Close-up view of the wreckage of HK-181.
