No. 37

Linee Aeree Italiane, DC-3, crashed into Pale Perse
(Monte Giner - Presanella Group) on 22 December 1956.
Report released by Ministero della Difesa - Aeronautica, Italy.

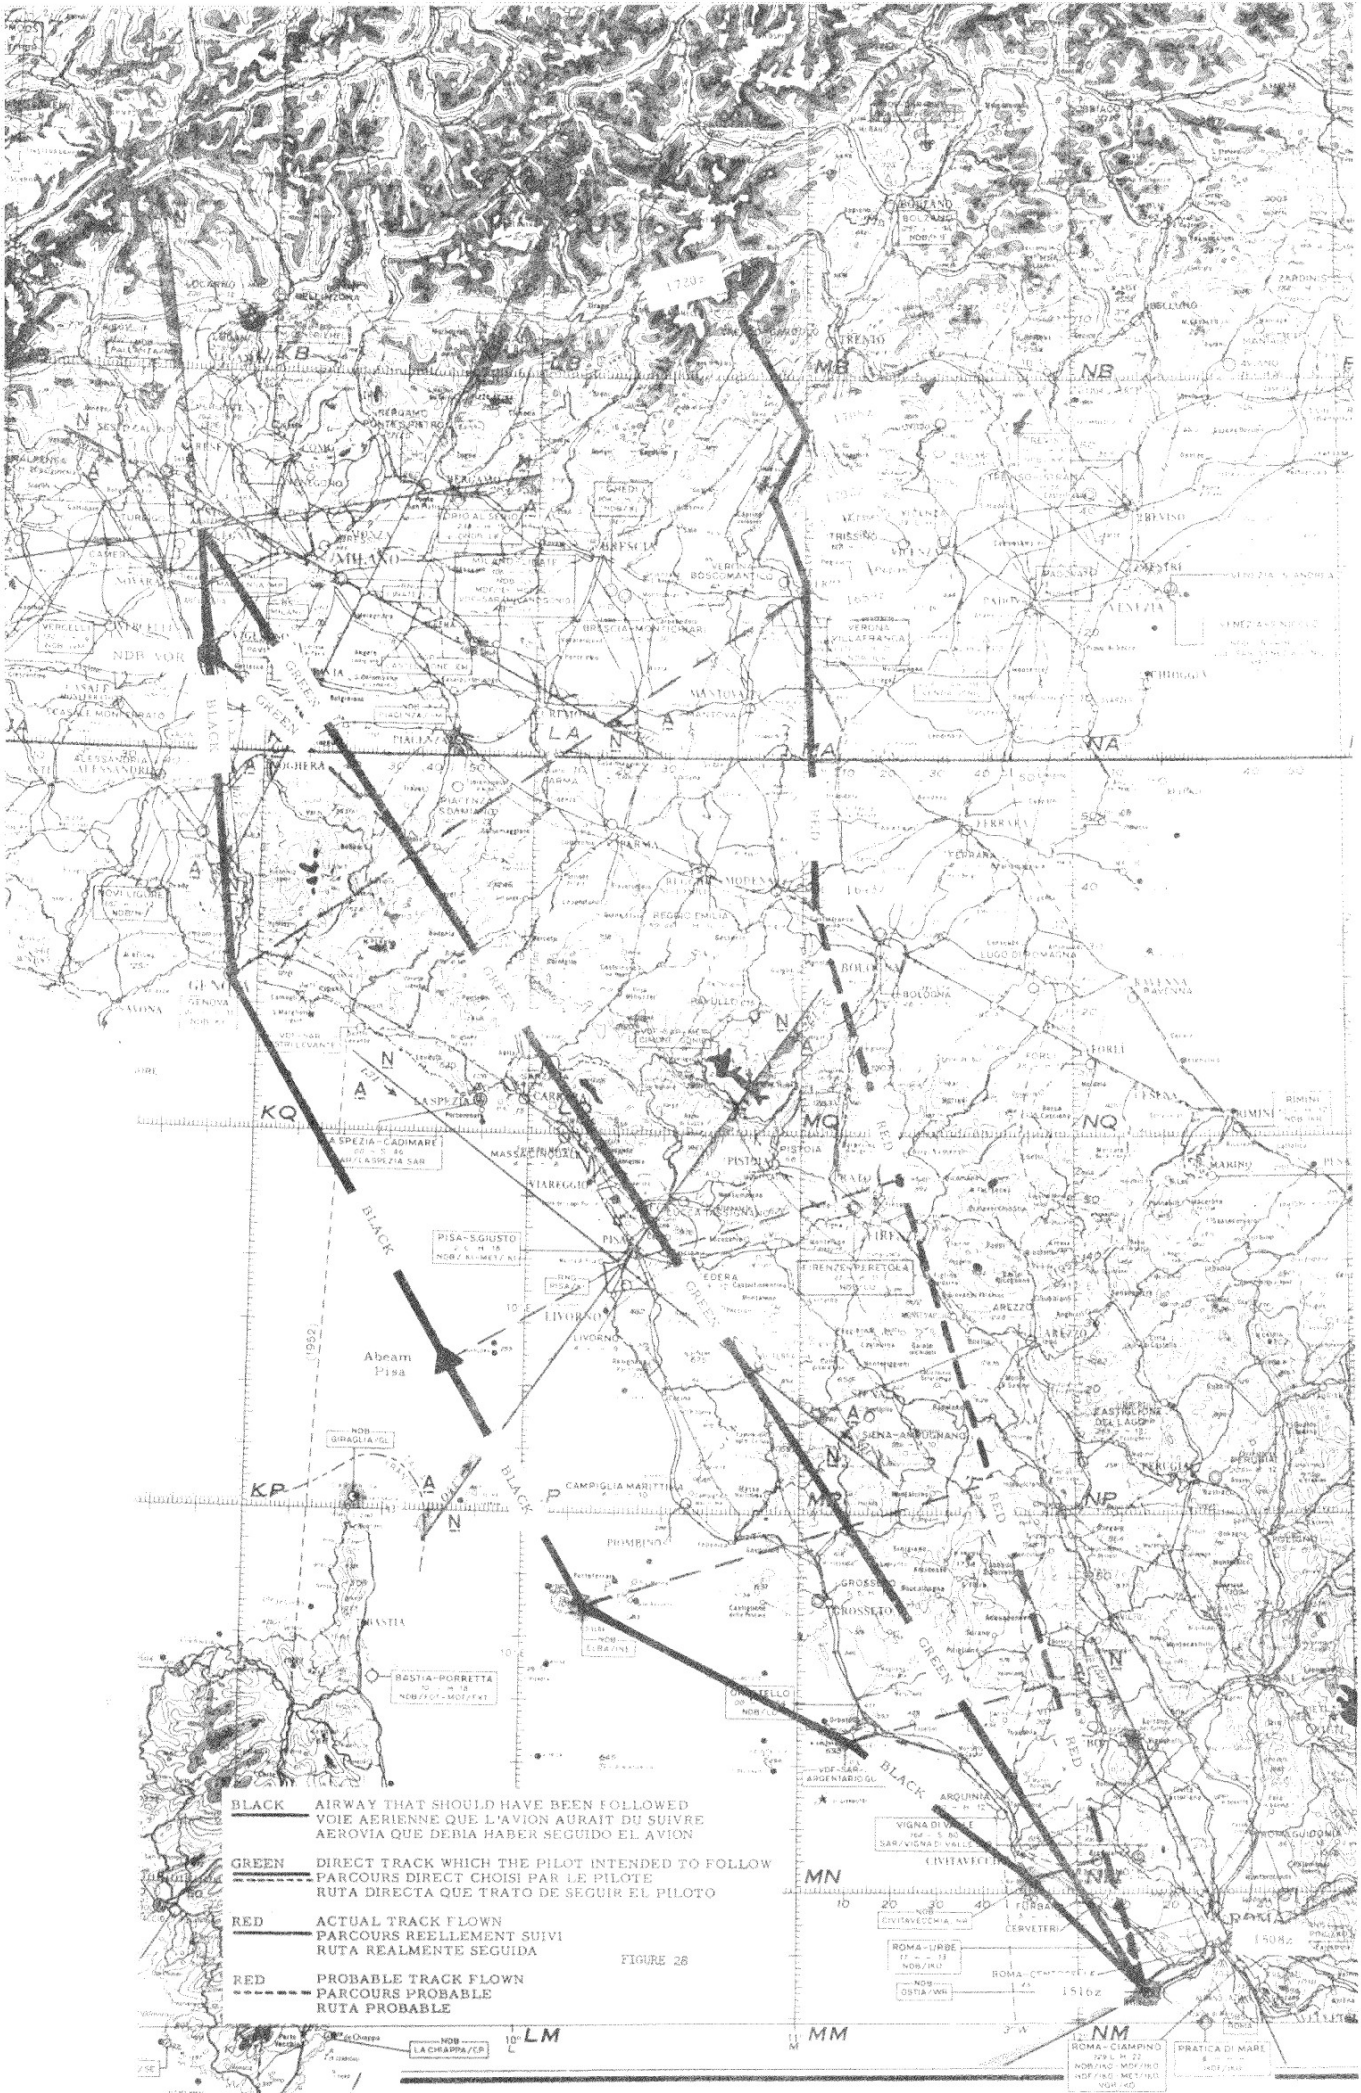
FIGURE 28

1508Z	take-off Rome
1516Z	Ostia
1640Z	20 kilometres west of Bologna
1643Z	Castelfranco Emilia
1659Z	Verona
1705Z	Mori
1720Z	crash.

It appears that the sector Ostia (1516Z) to Castelfranco Emilia (1643Z) was covered in 1 hour and 27 minutes. This time on the basis of an average speed of 230 kilometres per hour represents a distance of 330 kilometres. Since this corresponds to the distance between Ostia and Castelfranco Emilia, it may be concluded that the track followed by the aircraft coincides approximately with the line joining these two

points. It appears, therefore, that the track followed by the aircraft departed considerably from the route requested and authorized in the flight plan.
