No. 2

Braathens SAFE, DH 114, Heron, MK II, LN-SUR, crashed at Hommelfjell, Tolga, Norway, on 7 November 1956, while attempting to reach a suitable place for an emergency landing. Report of the Directorate of Civil Aviation, Norway, released 2 May 1957.

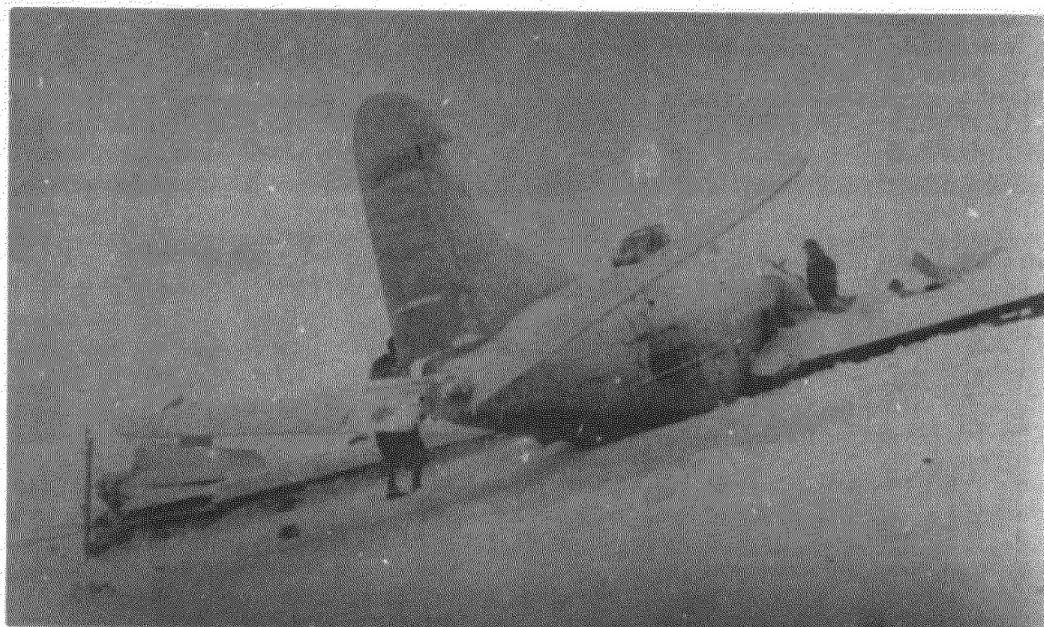
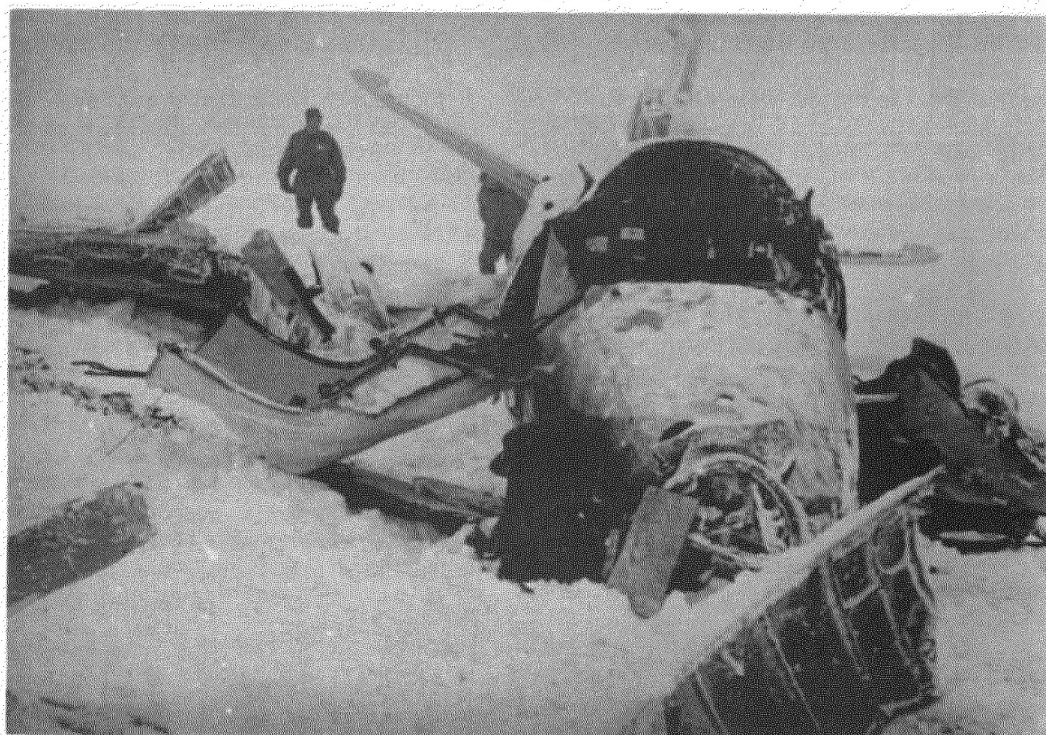
FIGURE 1

The wreckage showed signs of severe damage. The nose section had been pushed under the fuselage. The wings had been forced approximately 30 degrees out of position, with the left wing pointing forward and the right wing rearward, with resultant damage to the passenger cabin over the centre section. The fuselage showed large dents at the root of the forward beam on the right side, and behind the trailing edge of the wing on the left side. The tip of the left wing was broken off. All engines except the inside right were scattered throughout the terrain. The tail section aft of the passenger cabin was practically intact, apart from the fuselage having been broken up underneath.

General views of the wreckage of Braathens SAFE Heron which crashed at Hommelfjell, Tolga, Norway on 7 November 1956 while trying to reach a suitable place for an emergency landing.
