Skyways Ltd., Hermes 4, G-ALDV, accident at Manor Farm,  
Meesden Green, Herts., on 1 April 1958. Civil Accident Report No. C. 677  
released by the Ministry of Transport and Civil Aviation (U.K.)

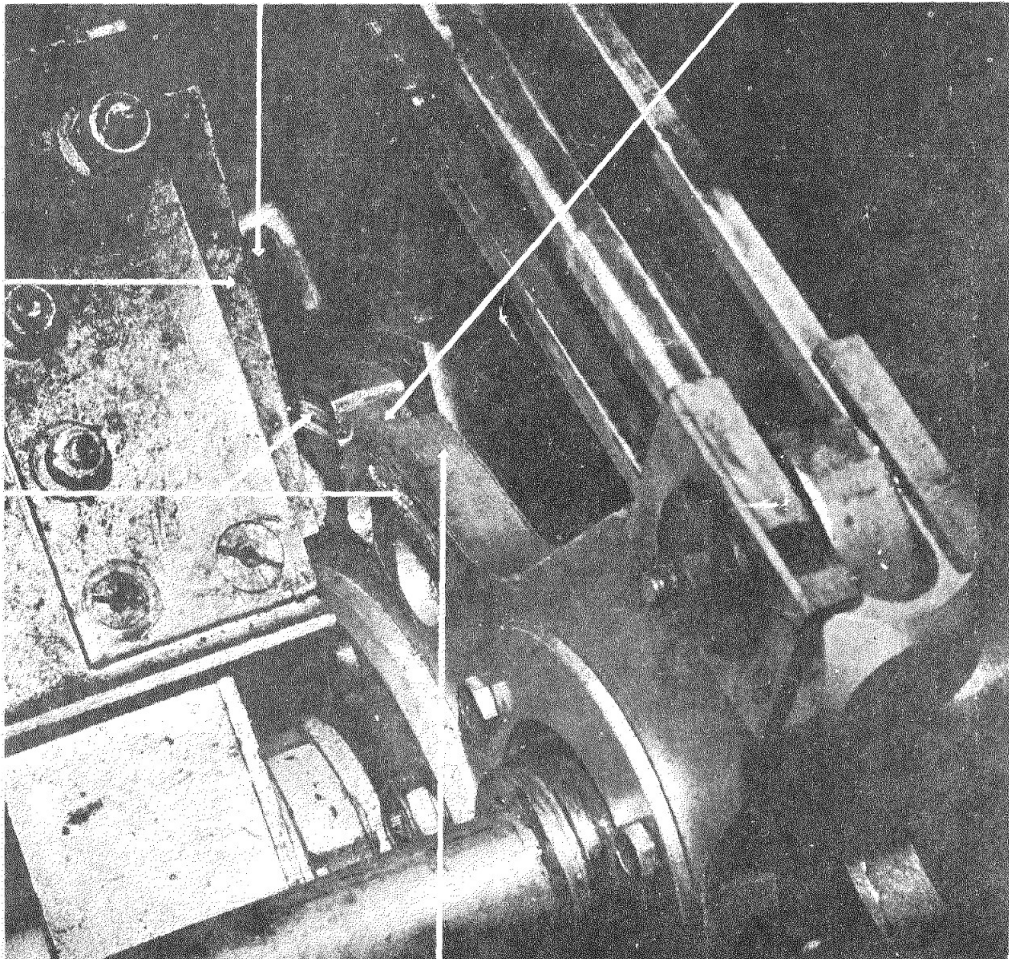
FIGURE 18

The wreckage was removed to a site with workshop facilities where the control mechanism in the stern frame bay was dismantled. Deep bright score marks were found on the face of the port side elevator datum lever (Figures 18 and 19) adjacent

to the locking latch housing which are movable and fixed parts of the elevator control system. The appearance of these marks under microscopic examination indicated that a hard object such as a small split pin had fouled and jammed the mechanism. Judging by the depth and width of the score marks it was clear that considerable force had been applied to operate the elevator controls. The object referred to above, in spite of an exhaustive search, was not found and it is presumed that it was displaced when the aircraft struck the ground. Several small extraneous objects were, however, recovered from the stern frame bay (Figure 20). Thereupon an inspection of the stern frame bay of another Skyways Hermes aircraft was carried out and a similar assortment of extraneous objects was found. The attention of the Skyways' Inspection Department and the Air Registration Board Resident Surveyor was drawn to the matter at once. Experiments were carried out on a Hermes aircraft in which a piece of 14 swg\* brass wire was introduced into the appropriate part of the control mechanism and an attempt was made to operate the elevator controls from the cockpit. It was found that they could be moved only with the greatest difficulty.

The accident was caused by the elevator mechanism becoming jammed - loss of control resulted. The jamming was due to the presence of a small extraneous object which entered the control mechanism.

SHOWING SECTION OF ELEVATOR CONTROL  
ASSEMBLY WHERE JAMMING OCCURRED

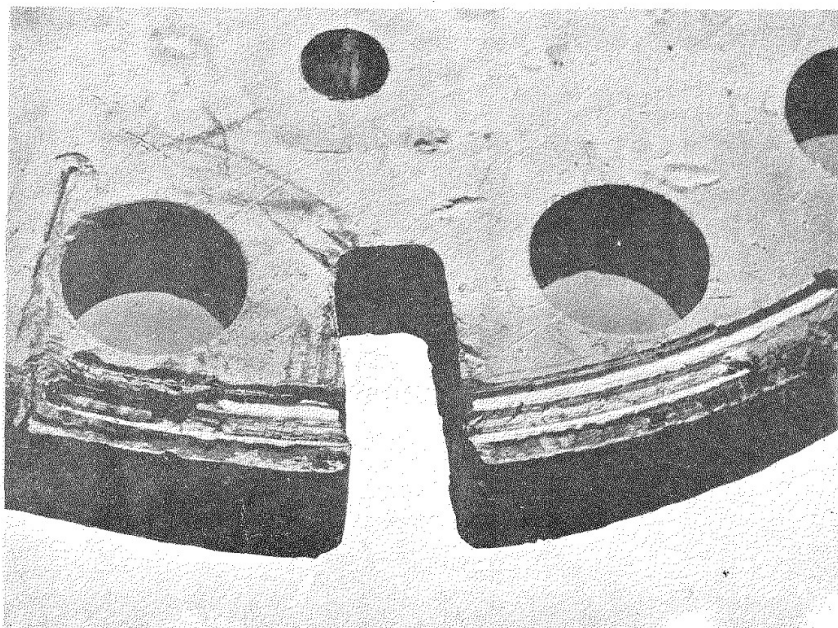
Laboratory examination of the elevator datum lever taken from the crashed aircraft showed differences in the colour of the oxide film among the score marks on one side of the locking slot indicating that some of these marks were of a greater age. The marks of more recent origin were superimposed on the others. The appearance of the superimposed score marks indicated that they were made on the same

occasion as those on the other side of the locking slot where there is no evidence of previous scoring. There is, however, no record of any previous stiffness or jamming of controls.

FIGURE 19  
SHOWING SCORE MARKS ON BOTH SIDES OF  
LOCKING SLOT OF ELEVATOR DATUM LEVER

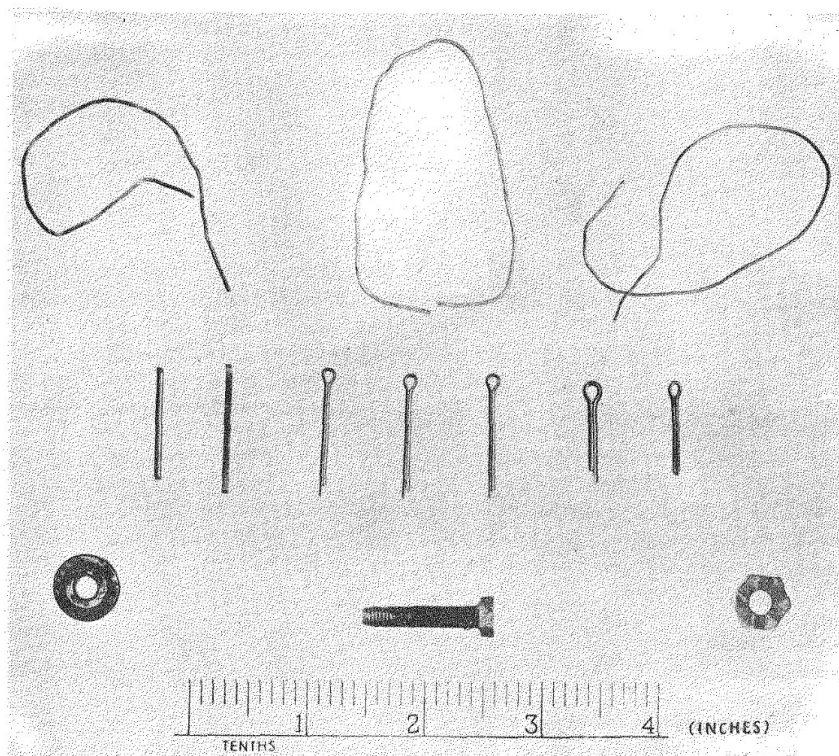
FIGURE 20  
EXTRANEOUS LOOSE ARTICLES FOUND IN THE  
STERN FRAME BAY OF THE CRASHED AIRCRAFT

2. The difficulty of keeping aircraft free from extraneous objects is something that constructors and operators have always been aware of as the structure of aircraft is such that small objects can find their way into crevices and inaccessible places. The importance of guarding against this happening and the necessity for absolute cleanliness cannot be emphasized too strongly.
