No. 16

British European Airways Corporation, AS 57 Ambassador (Elizabethan), G-ALZU, accident at Munich-Riem Airport, Germany, 6 February 1958. Report released by the Federal Republic of Germany and also published by the Ministry of Transport and Civil Aviation, United Kingdom, as CAP 153.

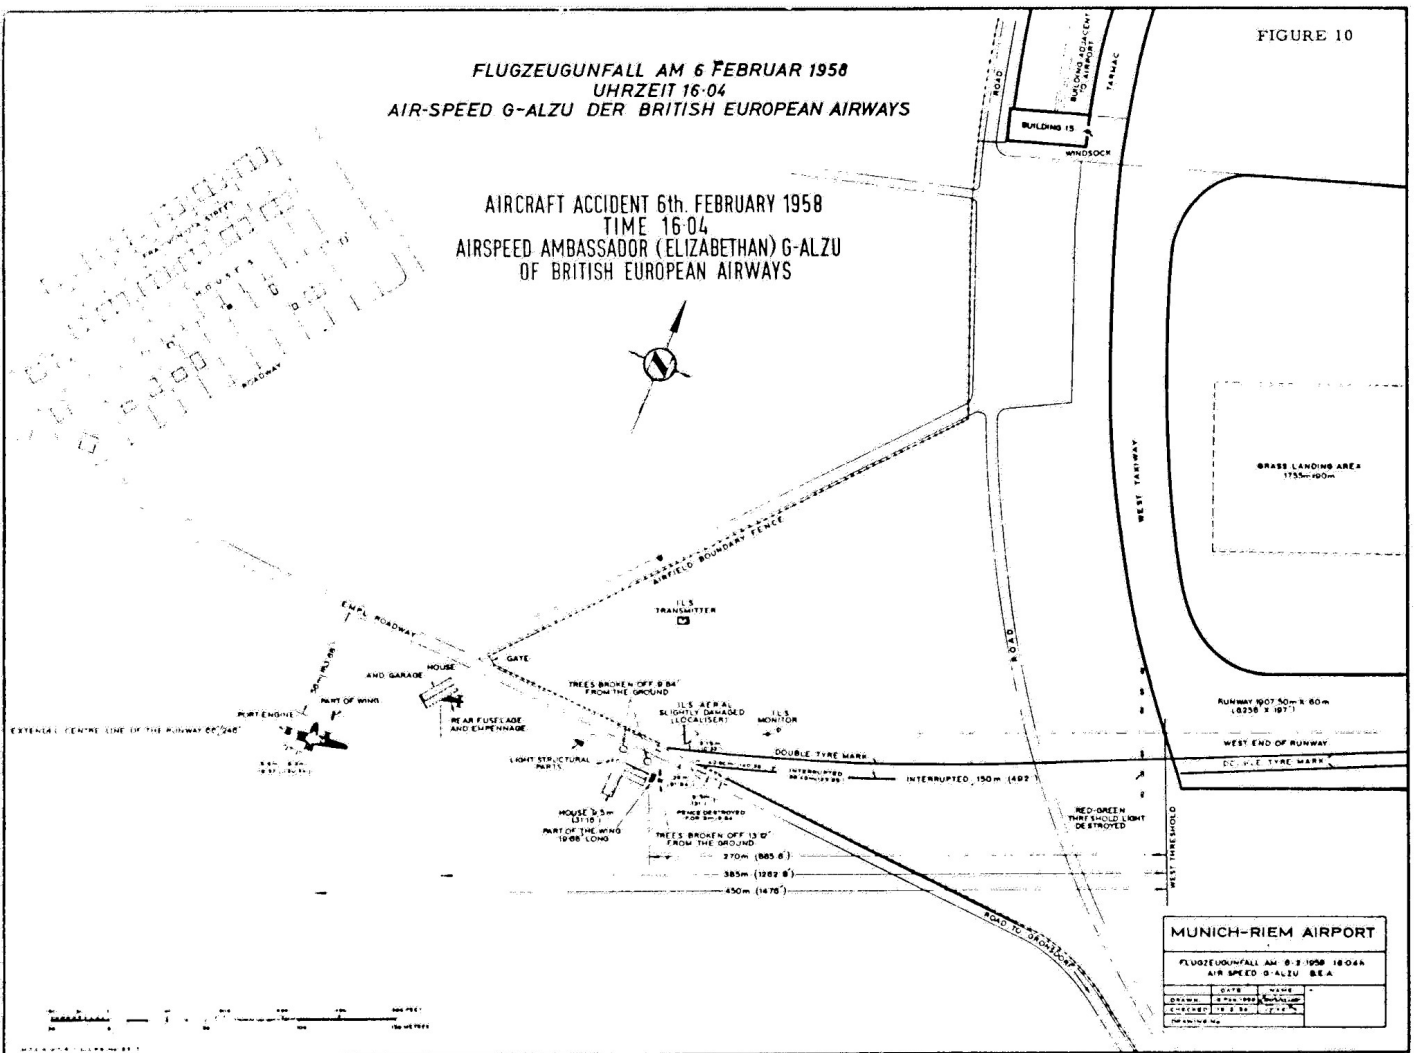
FIGURE 10

AIRCRAFT ACCIDENT 6th. FEBRUARY 1958
 TIME 16:04
 AIRSPEED AMBASSADOR (ELIZABETHAN) G-ALZU
 OF BRITISH EUROPEAN AIRWAYS

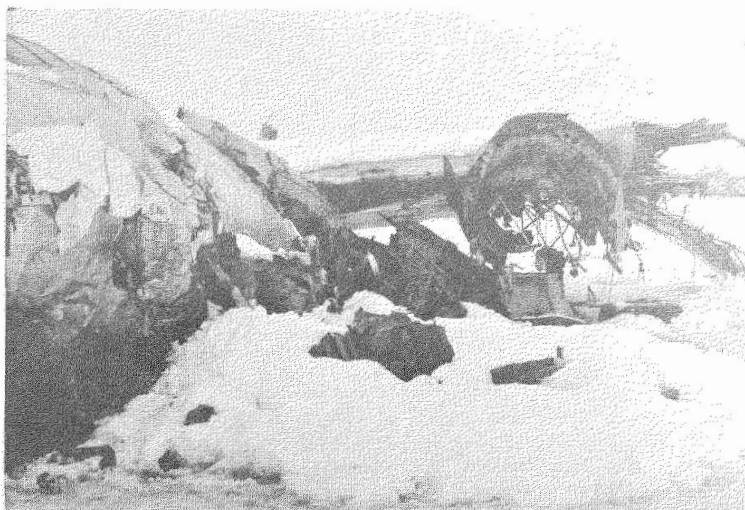
FIGURE 11

Taken on the day after
the accident, after thaw
had set in.

Left side of fuselage and
port engine mounting.

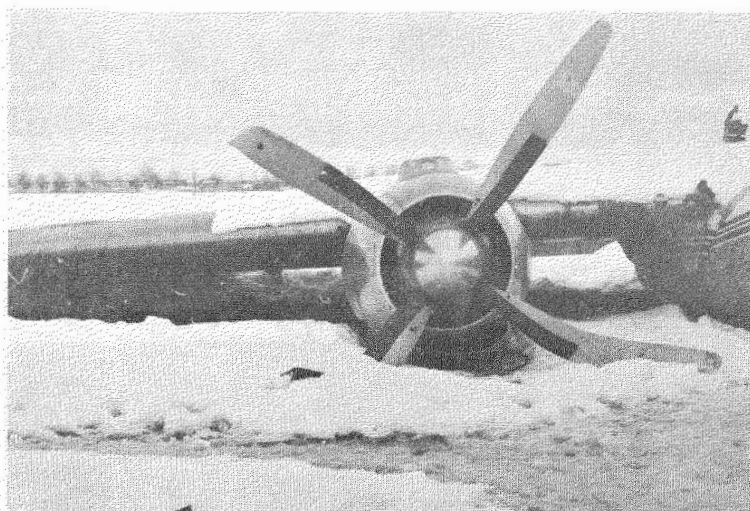
FIGURE 12

Starboard wing, with engine

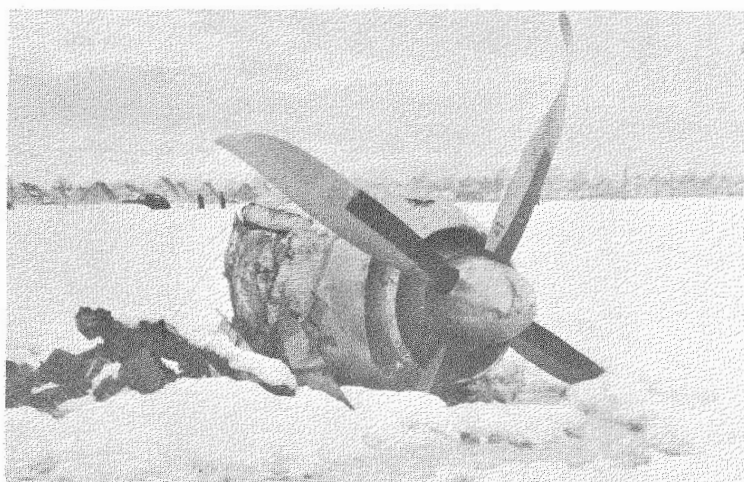
FIGURE 13

Port engine
