No. 55

Scottish Aviation Ltd., Twin Pioneer, G-AOEO, crashed 285 miles SSW of Tripoli in the Province of Fezzan, United Kingdom of Libya, on 7 December 1957.  
Report released by the Director of Civil Aviation, U.K., Libya.

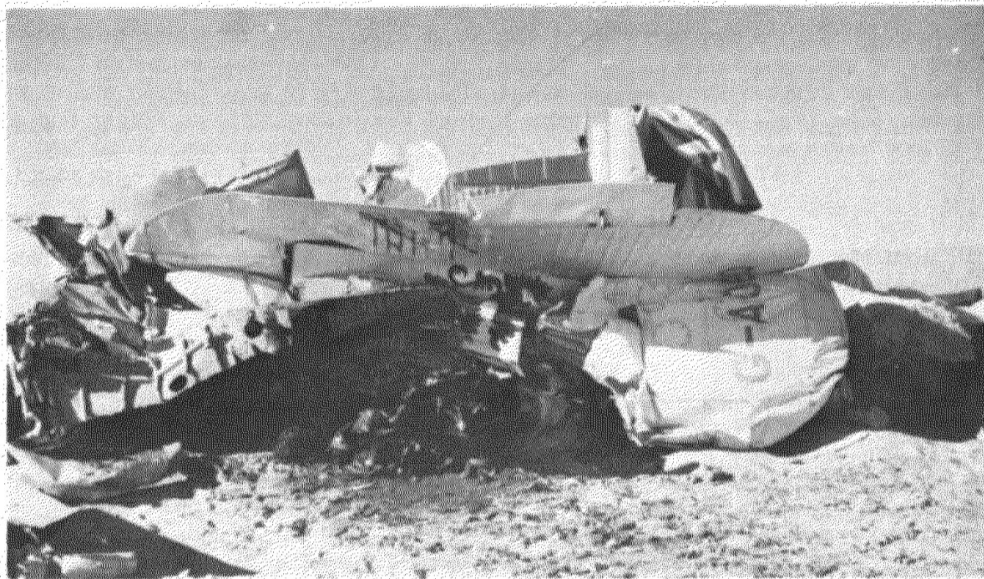
FIGURE 38

Examination of the wreckage showed that the aircraft had struck the ground at high speed in a vertical attitude and had completely disintegrated. There was no fire. The outer panel of the port wing was missing from the main wreckage, and was found approximately 1 200 yards away, back along the line of flight of the aircraft.

THE WRECKAGE OF TWIN PIONEER G-AOEO OF SCOTTISH AVIATION WHICH CRASHED IN THE PROVINCE OF FEZZAN, U.K. OF LIBYA ON 7 DECEMBER 1957

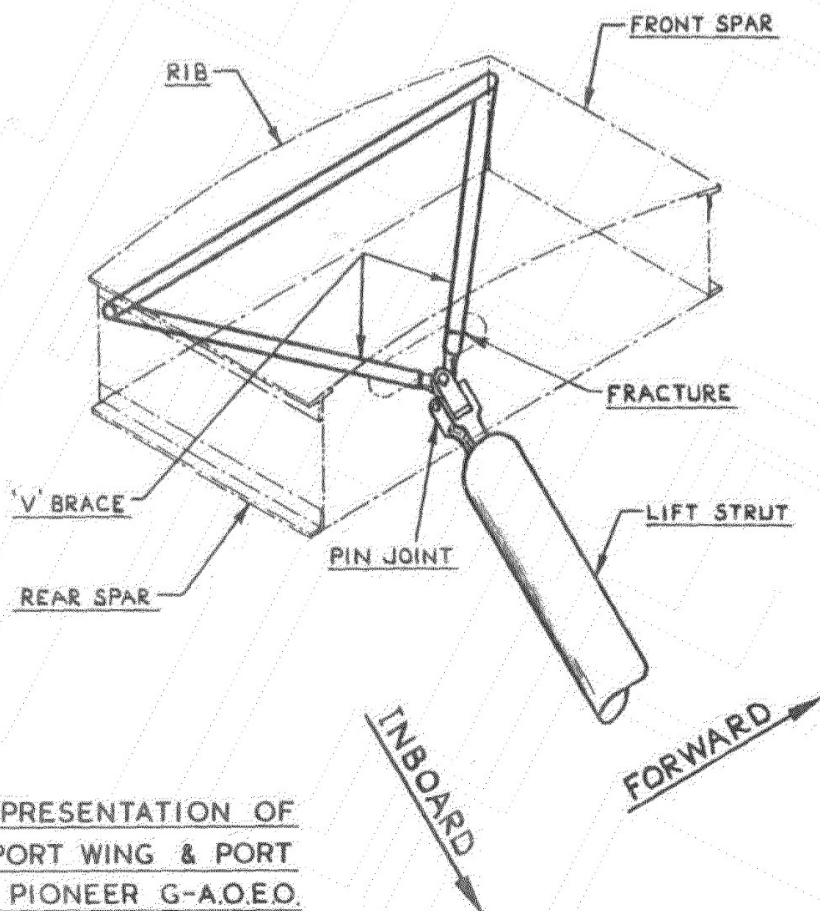
FIGURE 39

Examination of the detached outer panel of the port wing showed that the forward tube of the "V brace" had failed. This failure transferred all the upward forces of the wing to the rear "V brace" tube, which tore out of the wing, disconnecting the lift strut from the wing. The disconnection of the lift strut allowed the outer panel of the wing to fold upwards and backwards tearing away from the pin joints. There was no damage to the outer panel of the port wing which could not be ascribed to the pulling out of the "V brace" and pin joints, or to its impact with the ground. There was no evidence of any damage attributable to external causes not connected with the aircraft. The lift strut remained attached to the undercarriage leg, and was found in the main wreckage with the broken portions of the "V brace" still attached.

The broken parts of the "V brace" were removed from the wreckage and metallurgically examined by the Royal Aircraft Establishment, Farnborough, England. This examination showed that the initial failure of the forward tube of the "V brace" was due to fatigue. The "V braces" in G-AOEO were built up from 1.5 inch O.D. (outside diameter) 17 gauge steel tubes to specification 4 T 2.

In the "V brace" structure the forward and rear tubes are connected to the pin joint attachment of the lift strut by means of fork ended cadmium plated steel fittings plugged into the end of each tube and secured to the tube by shear bushes and tubular rivets. Two fatigue cracks had initiated in the forward tube at diametrically opposite points on the bore of one of the shear bushes situated about four inches up the tube from the pin joint; the cracks propagated circumferentially around the tube, and final separation had occurred in tension.

The nuclei of the fatigue cracks were associated with areas where fretting had occurred between the tube and shear bush.

DIAGRAMMATIC REPRESENTATION OF  
V' BRACE, OUTER PORT WING & PORT  
LIFT STRUT. TWIN PIONEER G-AOEO.
