No. 40

Central African Airways Corporation (Salisbury, Rhodesia),  
Viscount, VP-YNE (Mpika), crashed on the hills 5-1/2 miles to the  
southeast of Benina Aerodrome, Cyrenaica, on 9 August 1958.  
Report released by the Ministry of Communications,  
United Kingdom of Libya.

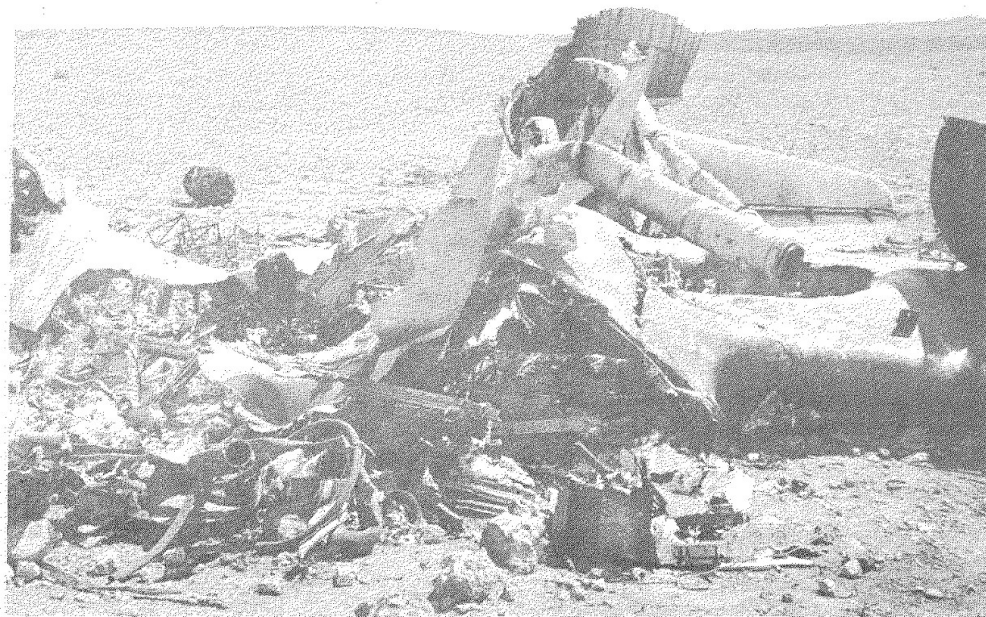
FIGURE 24

Statements made by certain of the survivors indicate that difficulty was experienced in locating the operating handles of the emergency exits after the crash. When considering these statements it must be appreciated that the crash occurred in darkness and caused the fuselage to become inverted although some of the survivors were not aware of the fuselage position until after they had evacuated the aircraft. Whilst instructions explaining the method of operation are printed on the flap covering the operating handle of each emergency exit, it is thought that passengers should, in addition, be informed either orally or by illustrated printed instruction, of the correct method of operating these exits so that in an emergency the exits can be released immediately.

CENTRAL AFRICAN AIRWAYS, VISCOUNT, VP-YNE, ACCIDENT  
SOUTHEAST OF BENINA AERODROME, CYRENAICA, 9 AUGUST 1958.  
- General view of the main wreckage - fuselage
