Straits Air Freight Express Ltd., Bristol 170, ZK-AYH, accident at Christchurch, New Zealand, on 21 November 1957. Civil Aircraft Accident Report No. 25/3/884, released by Accidents Investigation Branch, Air Department, New Zealand.

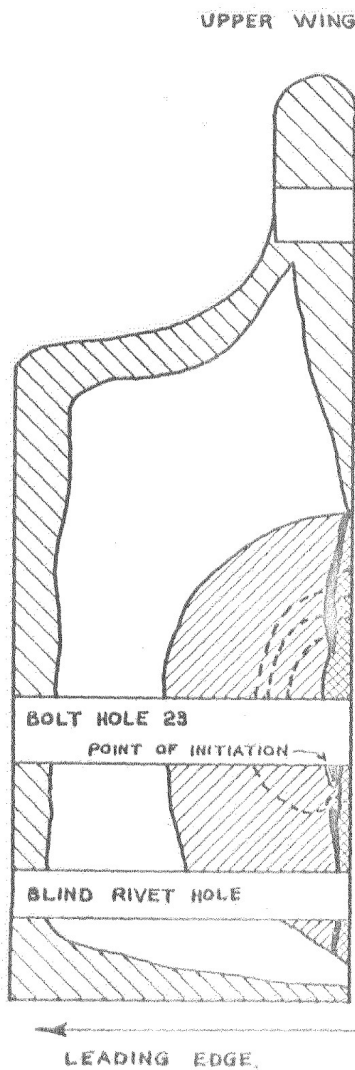
FIGURE 5  
**ZK-AYH**  
 STARBOARD FRONT  
 LOWER BOOM.

It was evident from inspection of the wreckage that the starboard outer wing broke away from the aircraft in flight. It was also clear that the cause of the structural failure was metal fatigue in the lower boom of the starboard outer wing front spar. This fatigue originated in the outermost 1/4" bolt hole drilled in the boom by the Operator during the incorporation of Bristol Modification 1169, which called for the installation of an extended joint fitting outer wing to centre section. This modification moved the point of stress concentration in the boom to a new location and, as a result, prolonged the life of the aircraft to 10 400 hours. The modification was incorporated on 21 January 1954, after the aircraft had flown 3 018 hours and the failure occurred at 7 898 hours. Although the complete boom had expended 3 018 hours of its fatigue life, it can logically be assumed that the boom was incorrupt at the point where the 1/4" hole was drilled. Thus, the initiation and propagation to failure of the fatigue crack took place at some time during the accumulation of 4 880 flying hours, over a period of 3 years and 10 months.

Fracture, as a result of encountering a severe gust, occurred in the starboard front lower boom under axial tensile loading at the section weakened by fatigue cracking.

EFFECTIVE CROSS-SECTIONAL AREA  
 OF BOOM AT THIS POINT — 2.8 sq.INS.  
 EFFECTIVE CROSS-SECTIONAL AREA  
 PRIOR TO FINAL FRACTURE — 2.1 sq.INS.

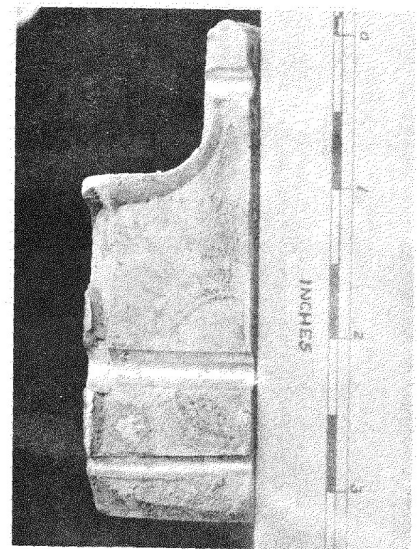
FIGURE 6

The sequence of events was set in train some considerable time before the accident, when a fatigue crack originated in the last bolt hole of the starboard lower boom joint and gradually propagated over 25% of the effective section of the boom. Additionally, a vertical crack occurred in the shear strap. Simultaneously, fretting with associated cracking, was taking place near the outer end of the joint, in the spar web, doubler, skin angle, and shims. Fretting and elongation in the bolt holes also took place during this development stage.

VIEW OF FRACTURE SURFACE  
 SHOWING FATIGUE CRACK

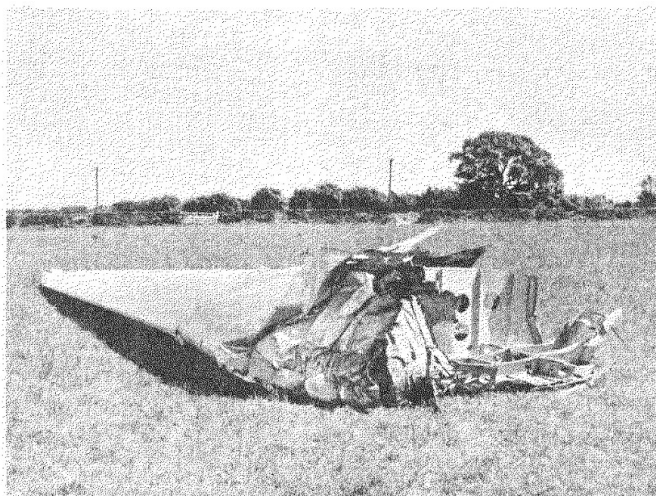
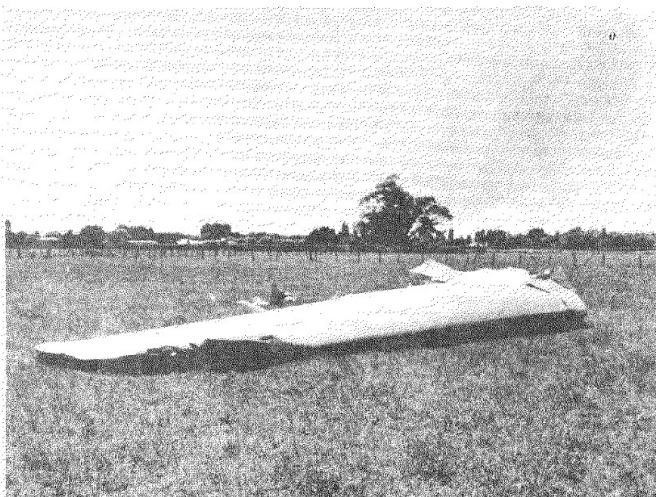
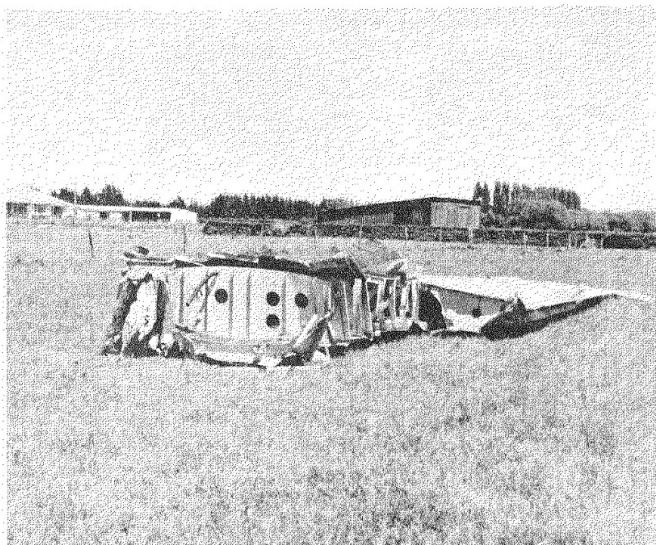
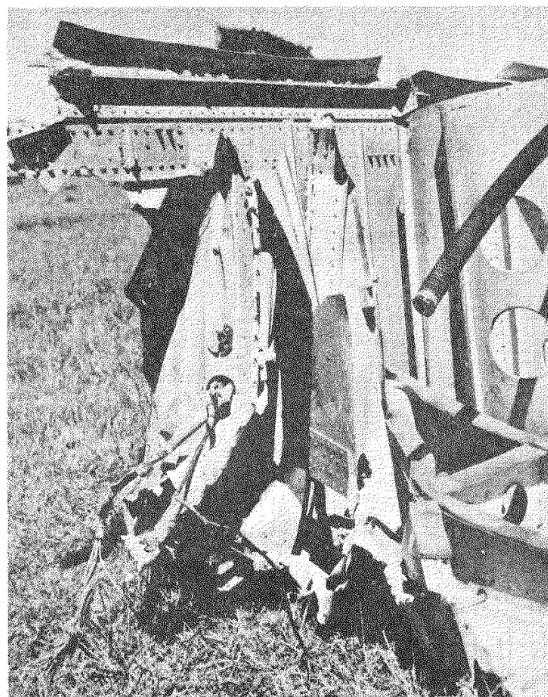
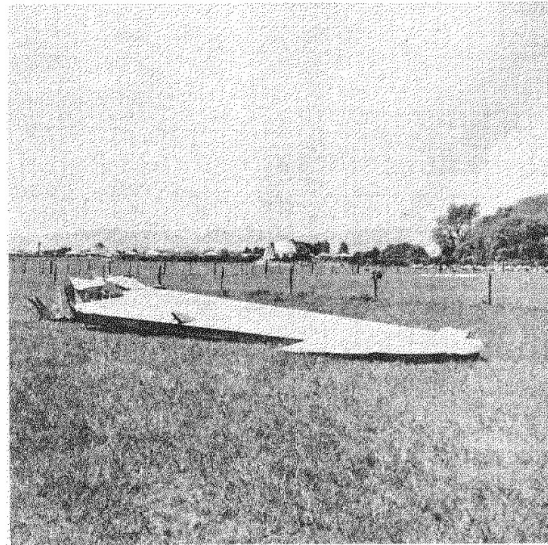
FIGURE 7  
STARBOARD OUTER WING

The starboard outer wing then folded upward and backward, resulting in failure of the starboard front upper boom at the outermost bolt hole of the wing joint fitting. Simultaneously, horizontal fractures occurred at the upper and lower ends of the spar web doubler and shear straps, with bolt hole shearing at the upper end of the strap.
