No. 47

Independent Air Travel Ltd., Viking, G-AIJE, accident 3 miles NE of London Airport, England, on 2 September 1958. Report released by the Ministry of Transport and Civil Aviation (UK). C.A.P. 155

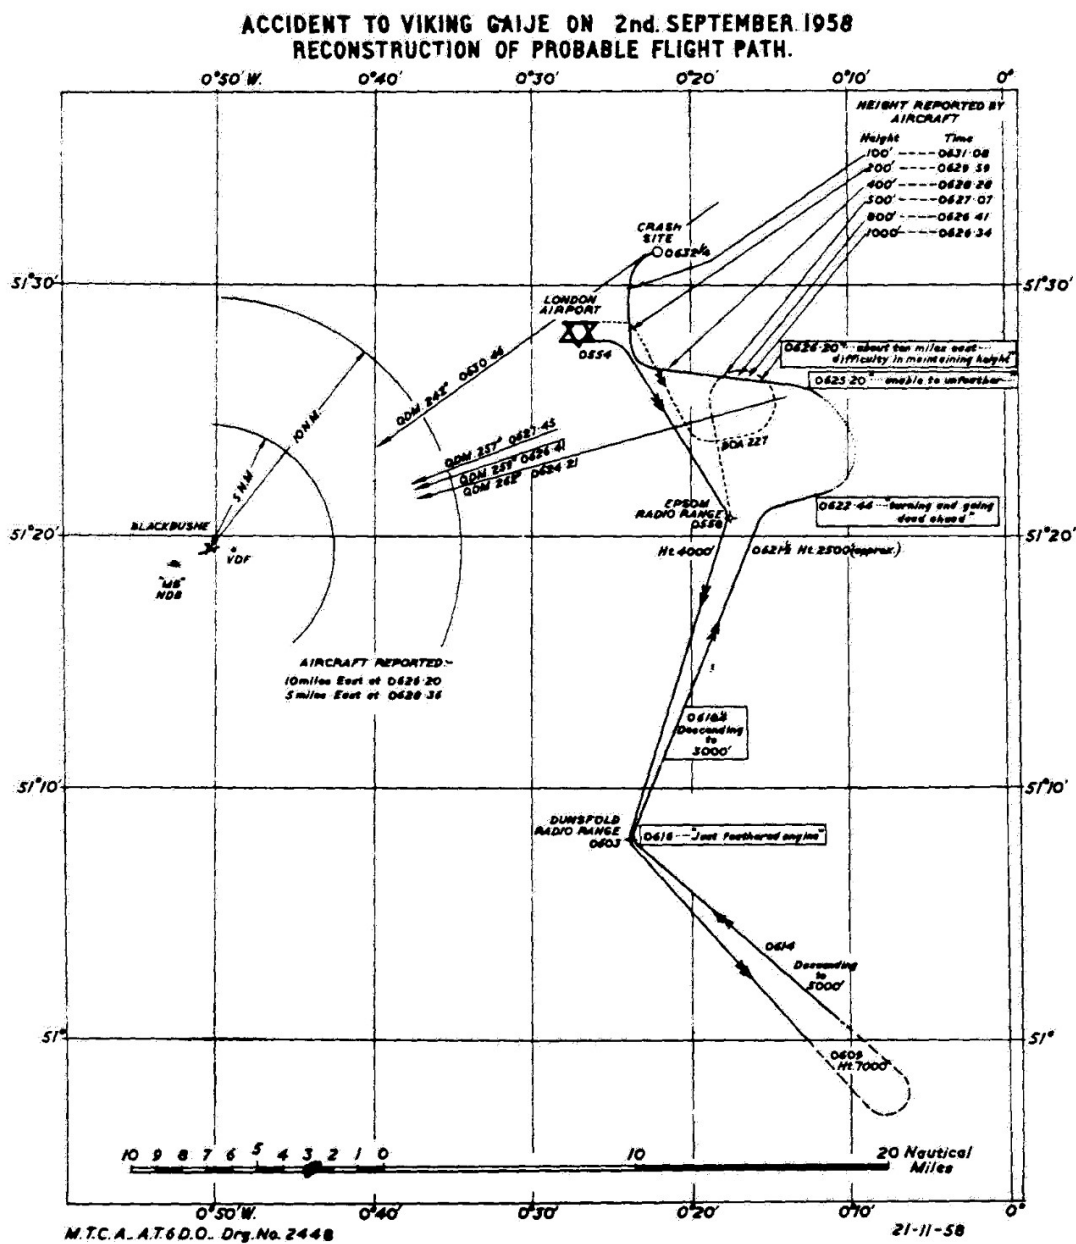
FIGURE 26

The aircraft was clearly informed that it was off course, but it is apparent from the reconstruction of the flight (Figure 26) that the crew did not know their exact position.
