No. 50

BEA, Viscount 701, G-ANHC and Italian Air Force, F-86E collided over Nettuno, Italy on 22 October 1958. Report released by the Ministry of Defence-Aviation, Republic of Italy - April 1959

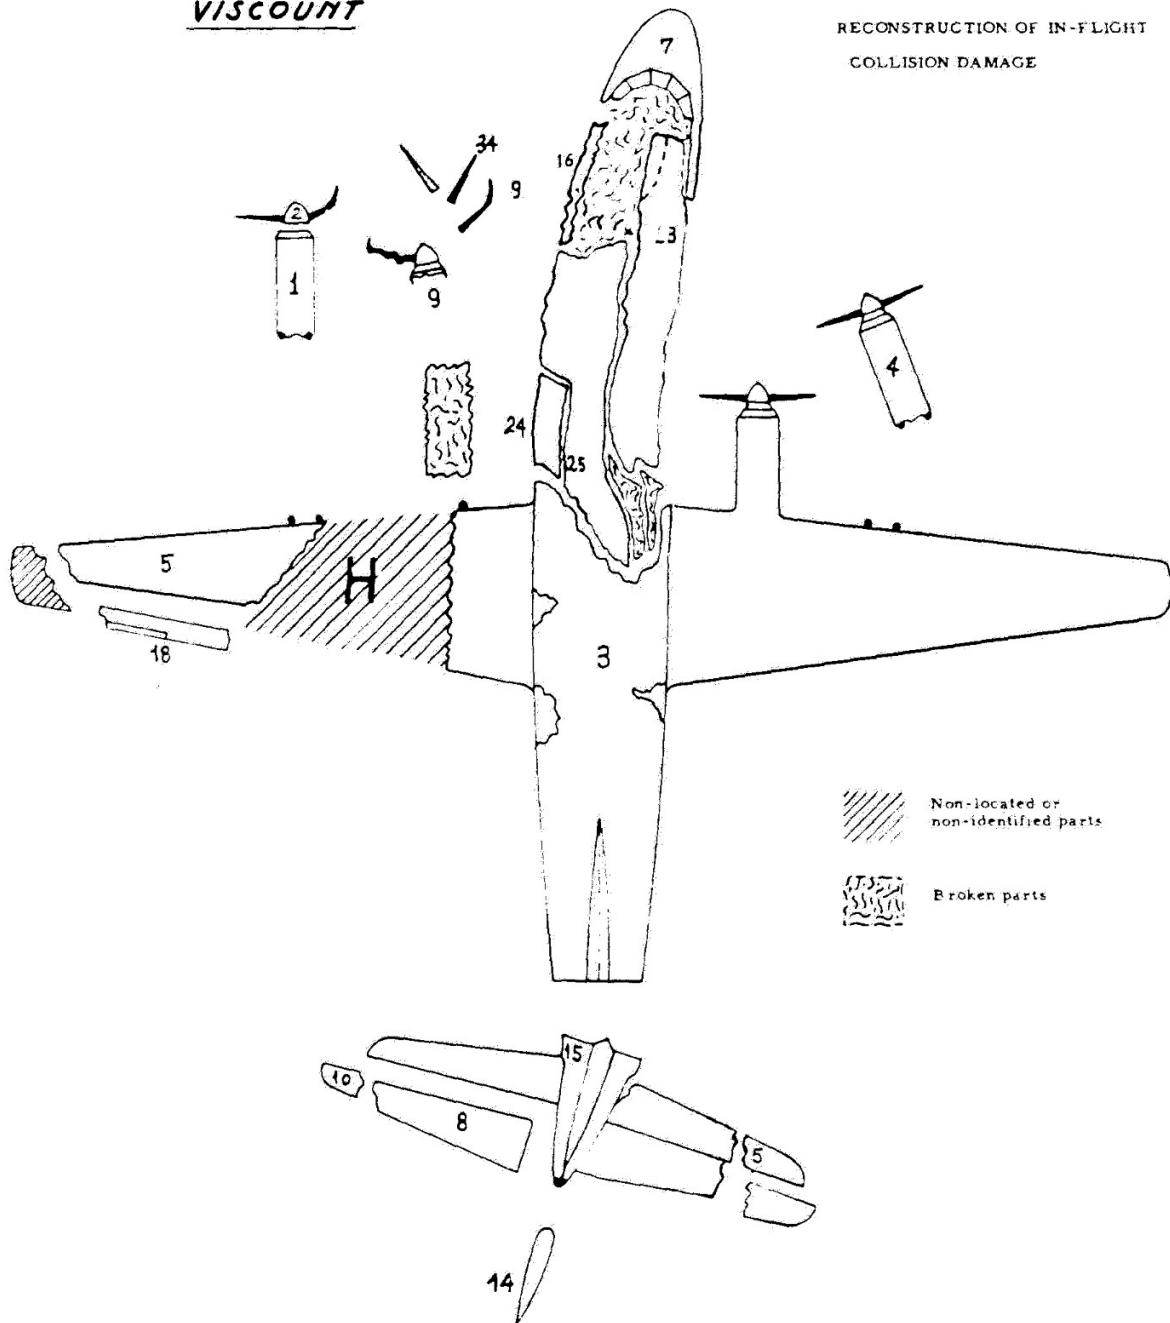
FIGURE 29

Many parts were not located, could not be identified or were broken into small fragments. The only parts of the right wing of the Sabre that could be identified were a few pieces of the wing tank, the centre hinge of the aileron and the wing tip - considerably buckled and still carrying the undamaged pitot antenna - and a few other pieces. The rest of the wing was reduced to minute and irregular fragments indicating that the wing most likely exploded.

The condition of the leading edge of the left wing of the Sabre leads to believe that the point of impact was in Area A (see Figure 29), against the leading edge of the Viscount wing between No. 1 and No. 2 engines.

- probable impact of right wing of Sabre against fuselage (nose) of the Viscount;
- impact of left wing of Sabre against Viscount No. 1 and 2 propellers with initial structural disruption of Sabre in area K (see Figure 29) and detachment of Viscount No. 1 propeller;
- impact of centre section of Sabre against No. 2 engine, with failure of centre section, and probable explosion of fuel in Sabre wing tank

- projection outwards of Sabre ejection seat with pilot;
- separation by inertia of Viscount No. 1 engine;
- impact of leading edge of Sabre left wing (area A in Figure 29) against leading edge of Viscount left wing, failure and separation of parts 21, 31 and 38 of Sabre left wing;
- breaking-up of Sabre rear fuselage and Viscount left wing in area H (Figure 28) as a result of mutual inter-penetration and consequent destruction of both aircraft;
- smashing of Sabre and powerplant and separation of tail assembly.

RECONSTRUCTION OF IN-FLIGHT  
COLLISION DAMAGE

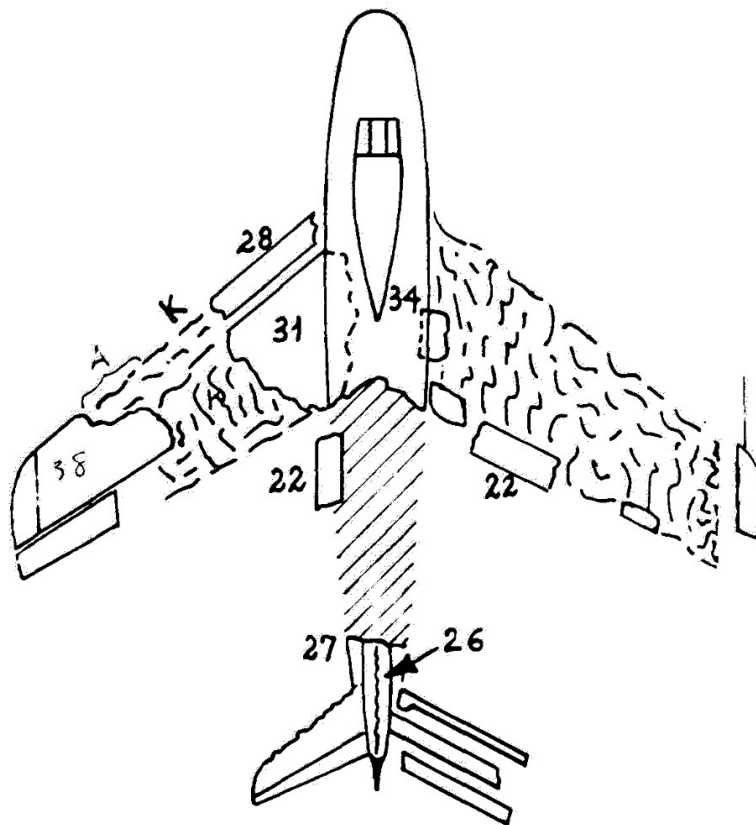
The angle, as seen from above, of the longitudinal planes of symmetry of the two aircraft was  $45/50^{\circ}$ . (See Figure 30)

The angle, as seen from above, of the longitudinal planes of symmetry of the two aircraft was 45/50°.

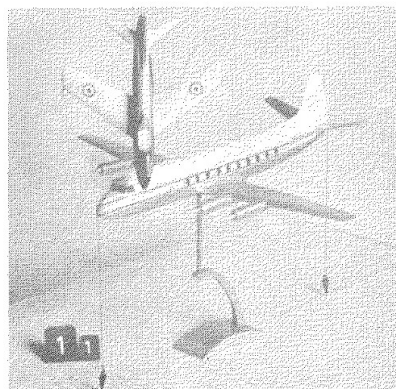
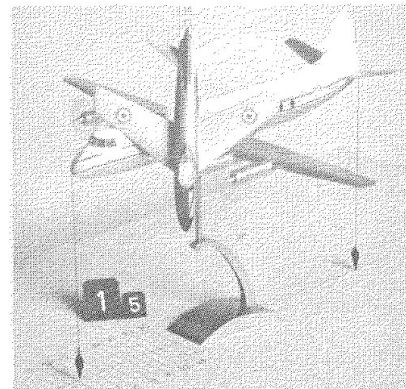
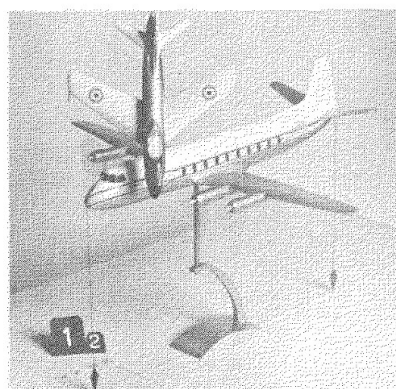
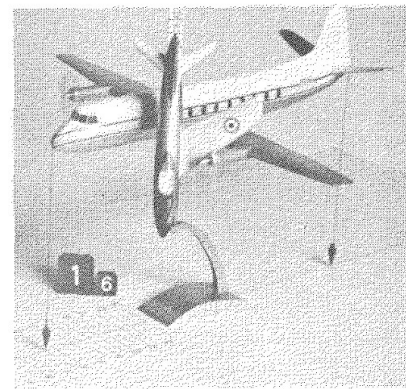
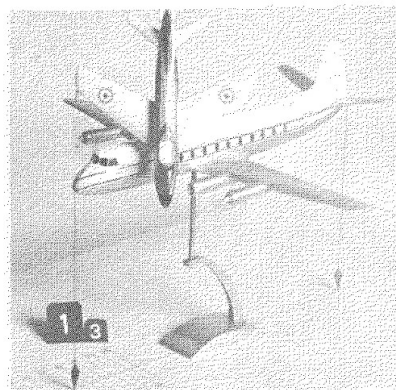
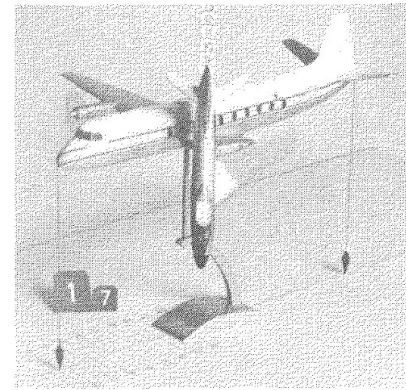
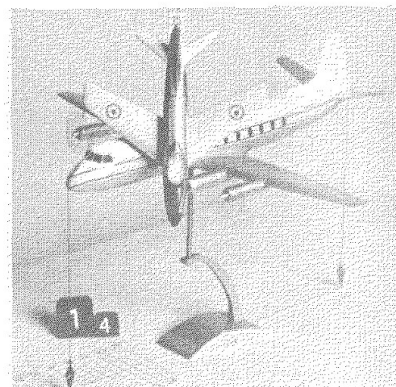
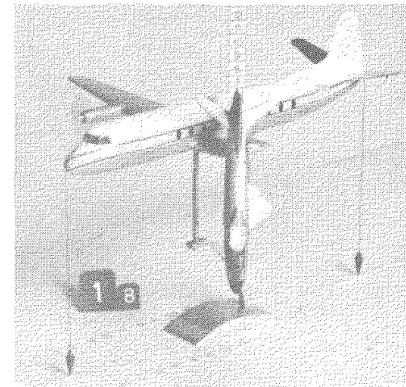
FIGURE 31

The figures in Figure 31 attempt to reconstruct the likely sequence of the collision.

Reconstruction  
of the likely  
sequence of the  
collision.
