415-110
AIRCRAFT ACCIDENT REPORT

AMERICAN AIRLINES, INC., LOCKHEED ELECTRA, N 6101A,
IN THE EAST RIVER, LA GUARDIA AIRPORT, NEW YORK,
FEBRUARY 3, 1959

~~CONFIDENTIAL~~
SYNOPSIS

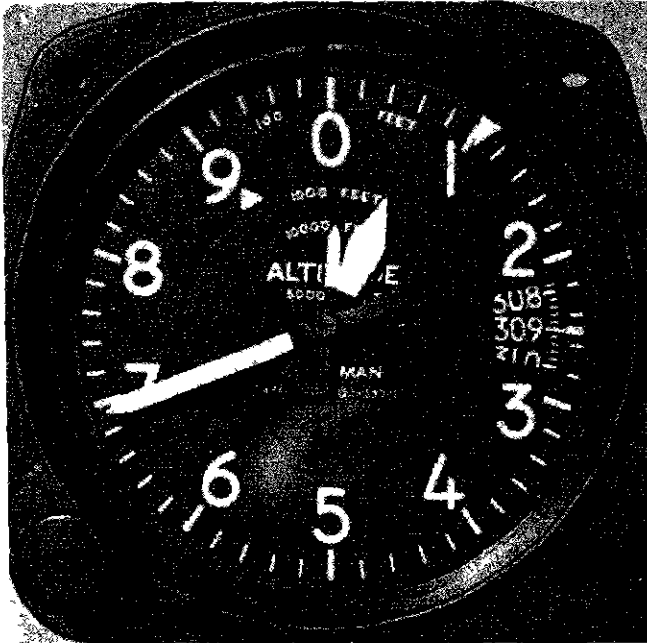
CONVENTIONAL THREE POINTER
TYPE SENSITIVE ALTIMETER

As a result of this accident, the Federal Aviation Agency, on February 8, 1959, as a precautionary measure, raised Electra landing minimums. Upon the installation of the conventional three-pointer altimeter, the restrictions were lifted.

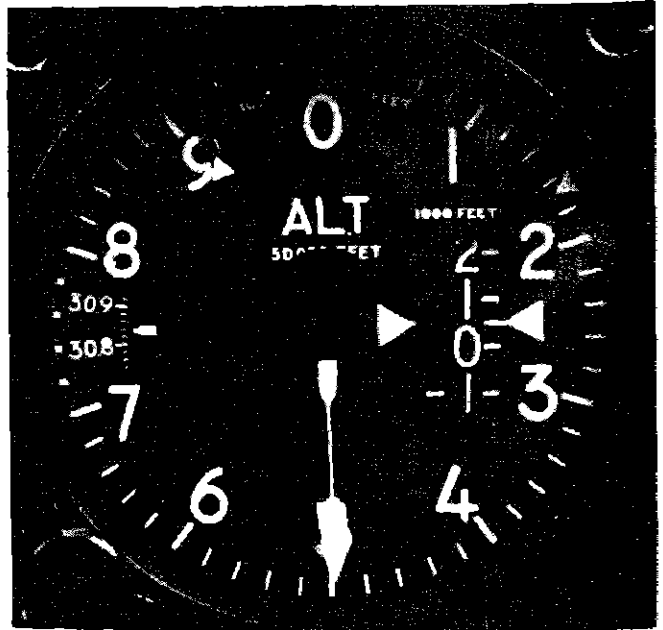
PRECISION DRUM TYPE ALTIMETER

The drum altimeters in N 6101A were calibrated prior to delivery by the manufacturer, Kollsman Instrument Corporation, according to accepted government-industry standards. Examination and testing of these altimeters subsequent to the accident did not reveal any mechanical failures other than those attributable to impact, shock, and immersion in salt water. When the wreckage was recovered, the captain's altimeter read minus one thousand five hundred feet, with a pressure altitude setting of plus 85 feet (barometric setting 29.83). The first officer's altimeter read minus one thousand six hundred and fifty feet, with a barometric setting of 29.79.

Chemical analysis of the contents of the casings of the captain's and the first officer's altimeters disclosed the presence of hydrated aluminum oxide and sea water, with traces of iron and other metallic elements ordinarily found in sea water. No marks were found on the altimeter faces that could have been caused by impact of the pointers. The glass coverings of the faces of the two altimeters were in place and not broken.

Before opening the casings of the altimeters for examination of their internal mechanisms, it was found that the manufacturer's lead seal, which entirely covers the head of one of the screws that secures the casing on the altimeter, was missing from the captain's altimeter. The purpose of this seal is to determine, when an instrument has been returned to the manufacturer with a complaint, for overhauling, or adjustment, whether the altimeter had been opened since its delivery to the purchaser.

Internal inspection of the altimeters revealed considerable corrosion within each of the instruments. A broken link pin was found in the captain's altimeter and a rocking shaft pivot was found broken in the first officer's altimeter. The corrosion was removed to permit a detailed inspection of the moving parts. The broken components were replaced, after which both instruments were checked for mechanical freedom and were found to operate without significant restriction over a range of minus 1,000 feet to 12,000 feet.

Because of the novel presentation components of the altimeter, serious consideration has been given the possibility that the pilot misread the altitude indication and thereby permitted or caused the aircraft to deviate vertically from the desired flight path. While some incidents have been reported in which a pilot had misread the 1,000-foot scale on the small drum, no such error could conceivably be involved here. The altitude presentation below 1,000 feet is accomplished by a pointer the indications and appearance of which are, for all practical purposes, identical to those used by the crew in other aircraft types and the interpretation of which calls for no new or different evaluations on the part of the pilot.

The reversed sensing of the altimeter setting numerals has already been mentioned. While an erroneous setting might result from this condition, the possible order of error would be very small indeed. Unlike the primary instrument flight reference which is frequently "generalized" by approximate positions of pointers or indicators, the altimeter setting scale must be read in order to permit any substantial correction to be made. Furthermore, the altimeter setting positions which were found in the altimeters installed in this airplane are very reliable indications of the settings existing at the time of the accident. The

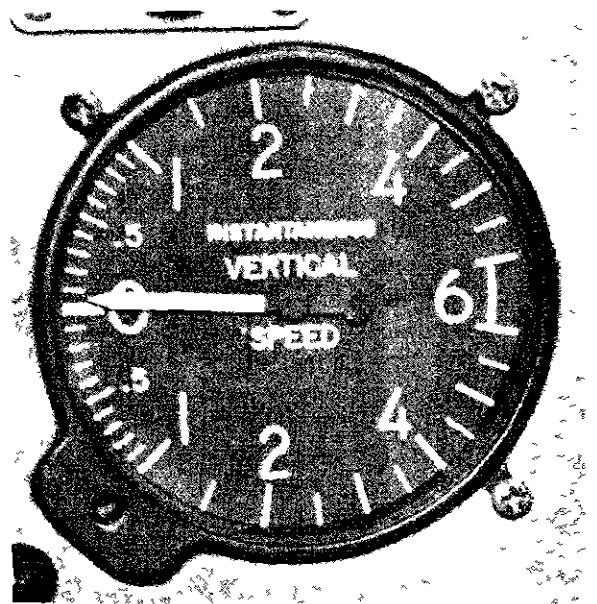
INSTANTANEOUS VERTICAL
SPEED INDICATOR

The two instantaneous vertical speed indicator instrument casings were still attached to their respective panels and relatively intact, but the instrument mechanisms were missing and were not recovered. Only one instrument face was recovered.

The Board believes that the destruction of the two instantaneous vertical speed indicator internal mechanisms was caused by impact and submersion of the instrument panels in approximately 20 feet of water.
