No. 52

Yemenite Airlines, DC-3, YE-AAB, accident near  
Roccatamburo di Poggiodomo, Perugia, Italy, on 3 November 1958.  
Report released by the Director General of Civil Aviation  
and Air Transport, Italy.

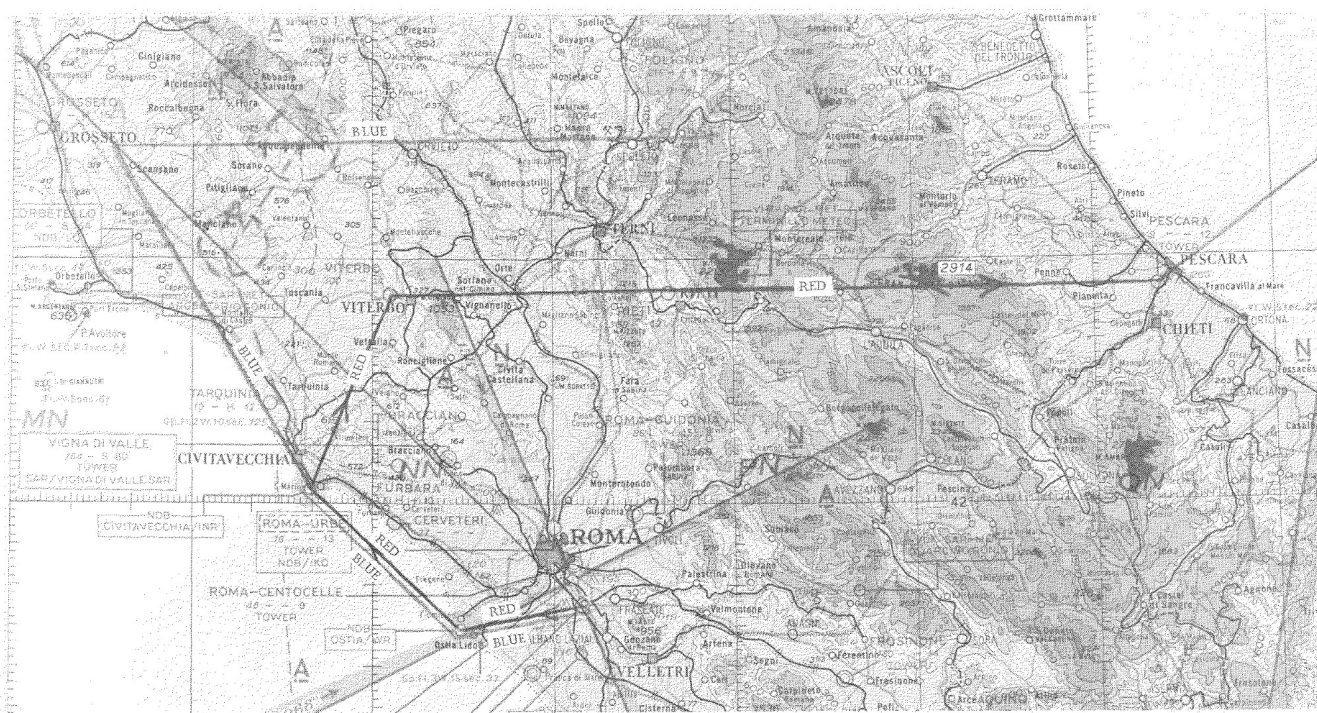
FIGURE 32

Two possible tracks of the aircraft after leaving Civitavecchia (1707) are shown in Fig. 32. During the 22 minutes up to the time of the bearing of  $315^{\circ}$  from Ciampino (at 1729) the aircraft could have covered, on a constant heading, the unbroken line to point A; or, on a zigzag course, the broken line to point A<sub>1</sub>. Then, on being given the bearing, the pilot may have turned on to an easterly heading towards the Adriatic coast. In the time remaining before the crash, namely 29 minutes (up to 1758) the aircraft could have covered, assuming a constant heading, the unbroken track A to C on Fig. 32. If, however, a zigzag course was being followed the aircraft may have flown from A<sub>1</sub> to C during this time and have been on a heading of  $020^{\circ}$  (between A<sub>1</sub> and B<sub>1</sub>) when that heading was reported by the pilot to Ciampino at 1736.
