AIRCRAFT ACCIDENT REPORT 2/90

Air Accidents Investigation Branch

Report on the accident to
Boeing 747-121, N739PA at
Lockerbie, Dumfriesshire, Scotland
on 21 December 1988

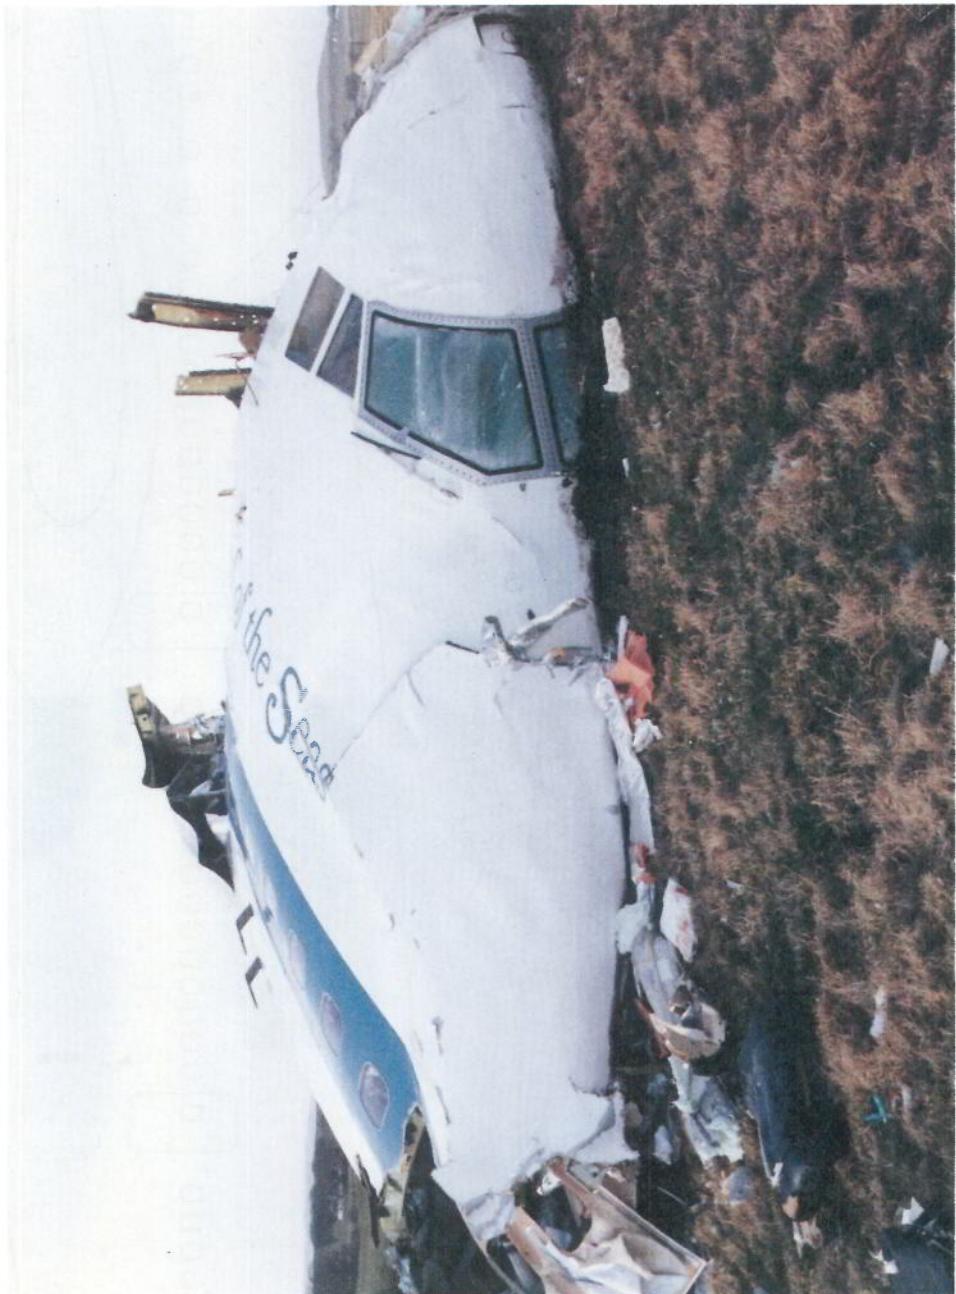
Figure B-9

The complete fuselage forward of approximately station 480 (left side) to station 380 (right side) and incorporating the flight deck and nose landing gear was found as a single piece [Appendix B, Figure B-9] in a field approximately 4 km miles east of Lockerbie at OS Grid Reference 174808. It was evident from the nature of the impact damage and the ground marks that it had fallen almost flat on its left side but with a slight nose-down attitude and with no discernible horizontal

velocity. The impact had caused almost complete crushing of the structure on the left side. The radome and right nose landing gear door had detached in the air and were recovered in the southern trail.

Examination of the torn edges of the fuselage skin did not indicate the presence of any pre-existing structural or material defects which could have accounted for the separation of this section of the fuselage. Equally so, there were no signs of explosive blast damage or sooting evident on any part of the structure or the interior fittings. It was noted however that a heavy, semi-elliptical scuff mark was present on the lower right side of the fuselage at approximately station 360. This was later matched to the intake profile of the No 3 engine.

Photograph of nose and flight deck

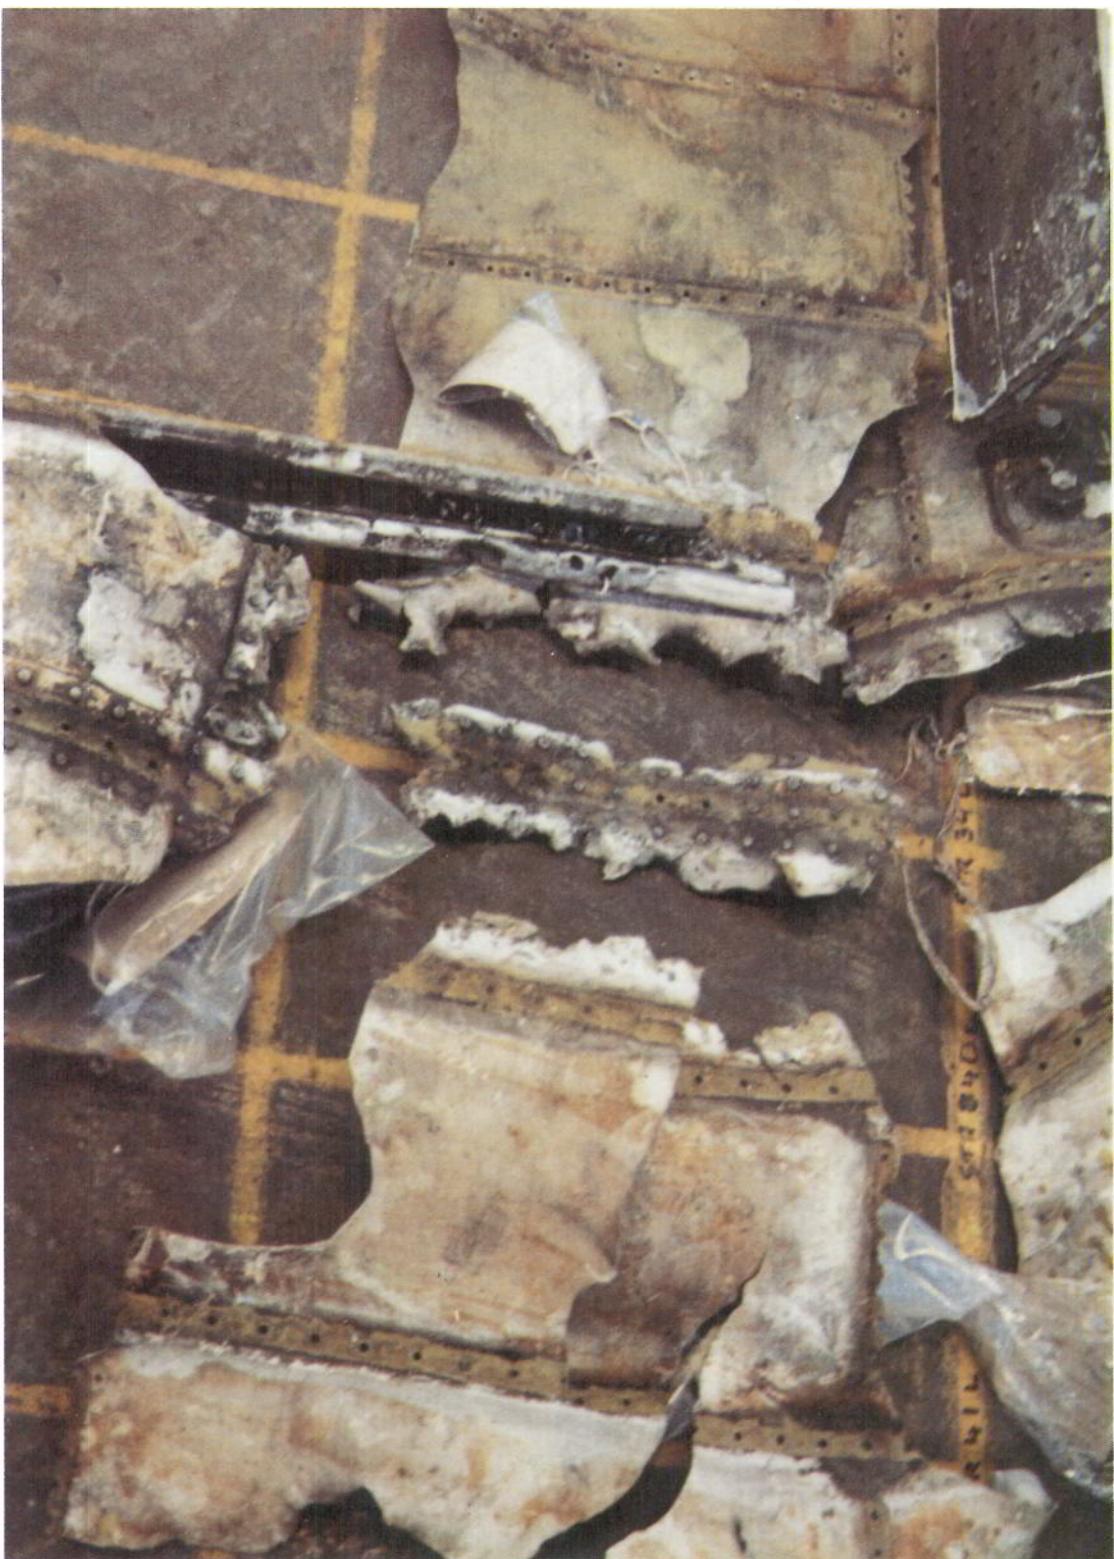
Figure B-15

The reconstruction revealed the presence of damage consistent with an explosion on the lower fuselage left side in the forward cargo bay area. A small region of structure bounded approximately by frames 700 & 720 and stringers 38L & 40L, had clearly been shattered and blasted through by material exhausting directly from an explosion centred immediately inboard of this location. The material from this area, hereafter referred to as the 'shatter zone', was mostly reduced to very small fragments, only a few of which were recovered, including a strip of two skins [Appendix B, Figure B-15] forming part of the lap joint at the stringer 39L position.

Surrounding the shatter zone were a series of much larger panels of torn fuselage skin which formed a 'star-burst' fracture pattern around the shatter zone. Where these panels formed the boundary of the shatter zone, the metal in the immediate locality was ragged, heavily distorted, and the inner surfaces were pitted and sooted - rather as if a very large shotgun had been fired at the inner surface of the

fuselage at close range. In contrast, the star-burst fractures, outside the boundary of the shatter zone, displayed evidence of more typical overload tearing, though some tears appeared to be rapid and, in the area below the missing panels, were multi-branched. These surrounding skin panels were moderately sooted in the regions adjacent to the shatter zone, but otherwise were lightly sooted or free of soot altogether. (Forensic analysis of the soot deposits on frame and skin material from this area confirmed the presence of explosive residues.) All of these skin panels had pulled away from the supporting structure and had been bent and torn in a manner which indicated that, as well as fracturing in the star burst pattern, they had also petalled outwards producing characteristic, tight curling of the sheet material.

Detail of shatter zone of fuselage

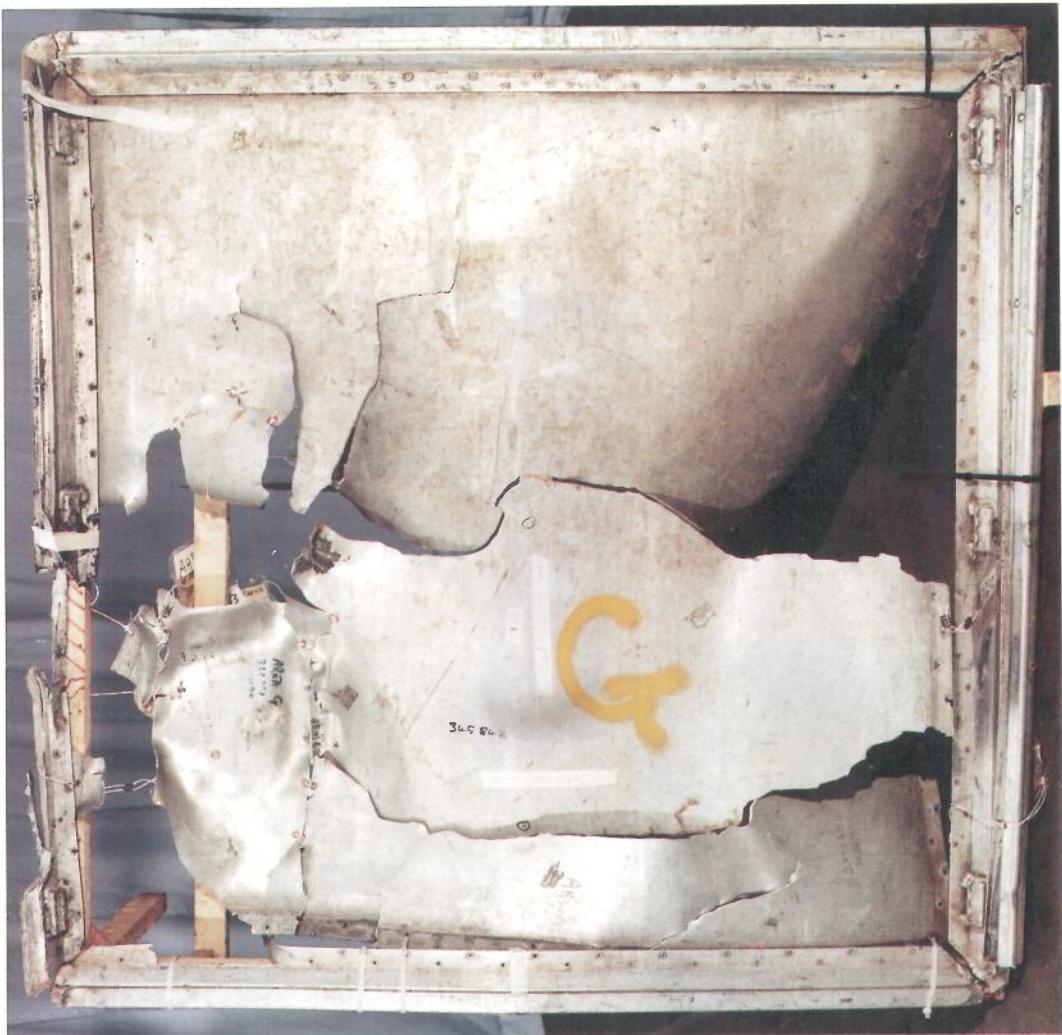
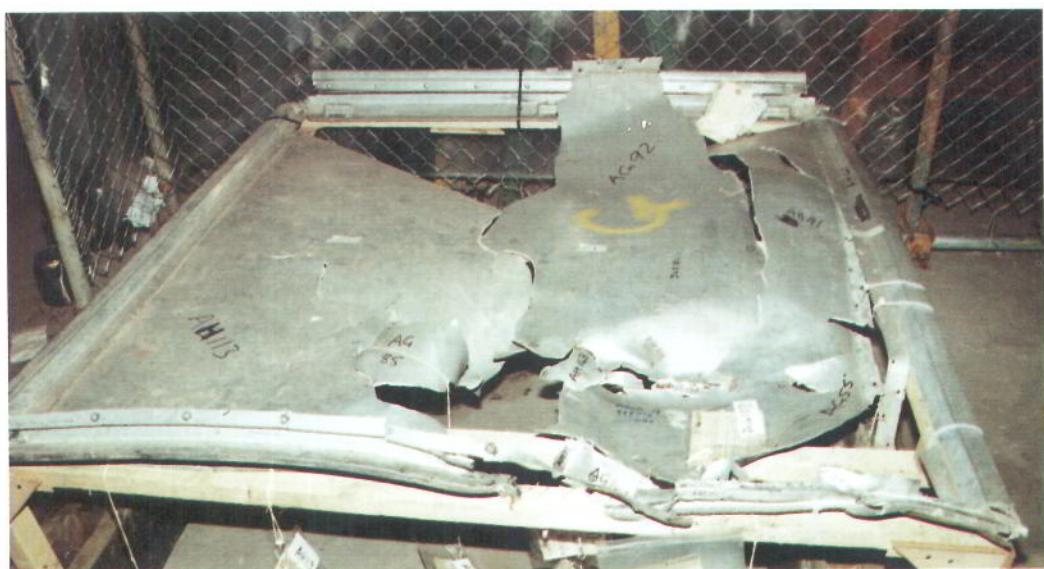
Figure F-3

Detail of Damage to Container Floor

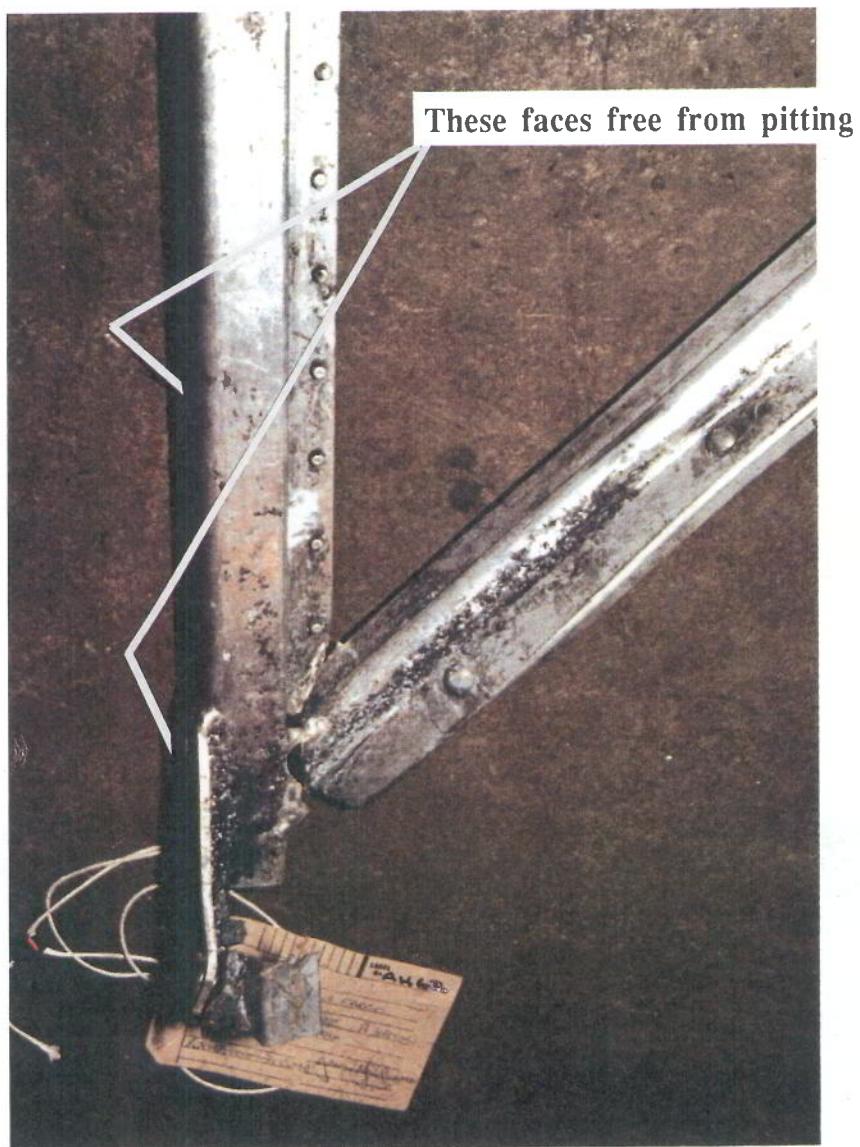
Figure F-9

**Detail of items from aft face of container
AVE 4041 PA showing evidence of blast
damage**
