No. 20

Pluna Airlines, DC-3, CX-AGE accident at Carrasco Airport, Uruguay on 9 October 1962. Report released by the Directorate General of Civil Aviation, Uruguay.

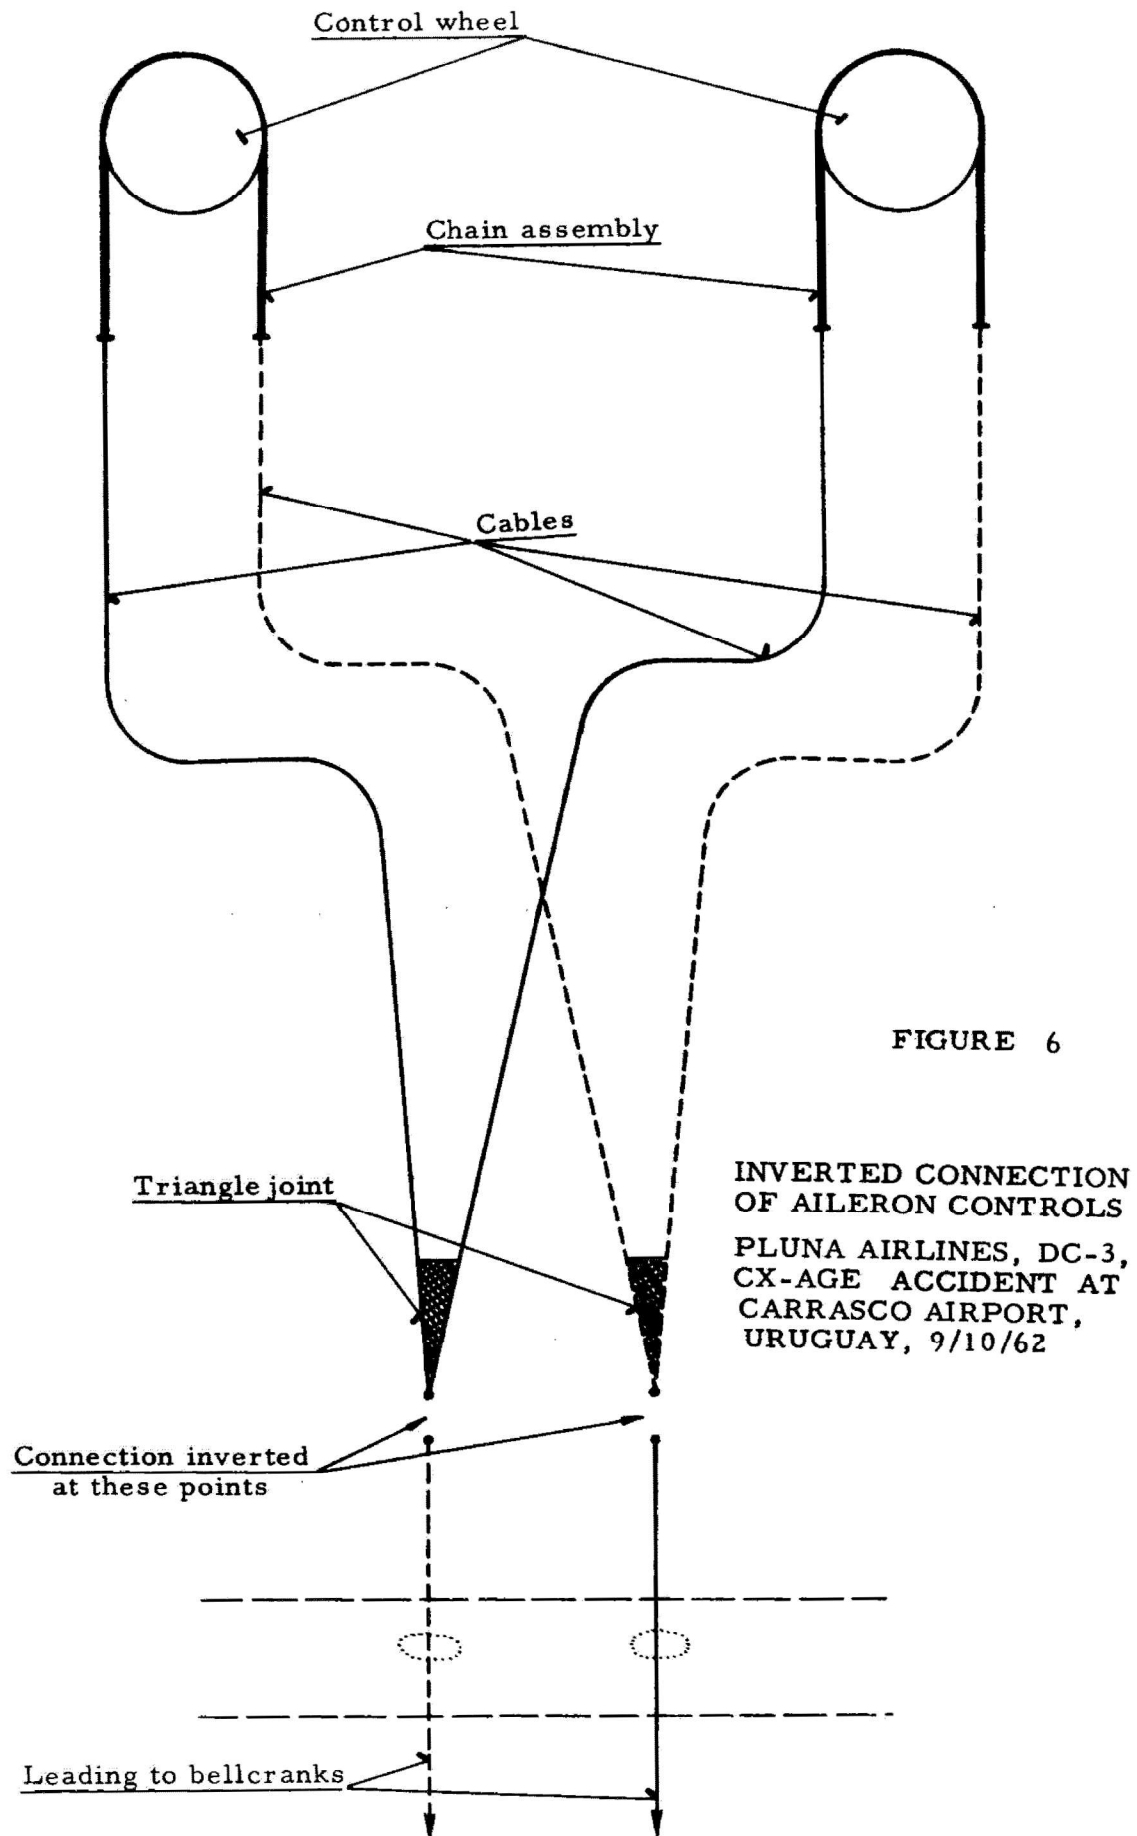
It was possible to establish that the installation, from the control columns as far as the triangle joints was correct, however, the latter had been attached to the opposite cables leading to the bellcranks, causing the inverted functioning of the whole system. (See Figure 6)

The Plana mechanics believed that an inverted connection was not possible without giving rise to friction and easily detectable noises. Tests were, therefore, made on another DC-3 aircraft which was undergoing maintenance. The results showed that the system appears to function quite normally whether the triangle joints are correctly attached or inverted. Thus, the only way of determining correct installation is by visual inspection after the connections have been made.
