No. 19

Continentale Deutsche Luftreederei, G. m. b. H., Douglas C-54 (B-DC), D-ABEB, accident 2 NM from the threshold of runway 07, Kano Airport, Nigeria on 17 June 1961. Report released by The Ministry of Transport and Aviation, Nigeria.

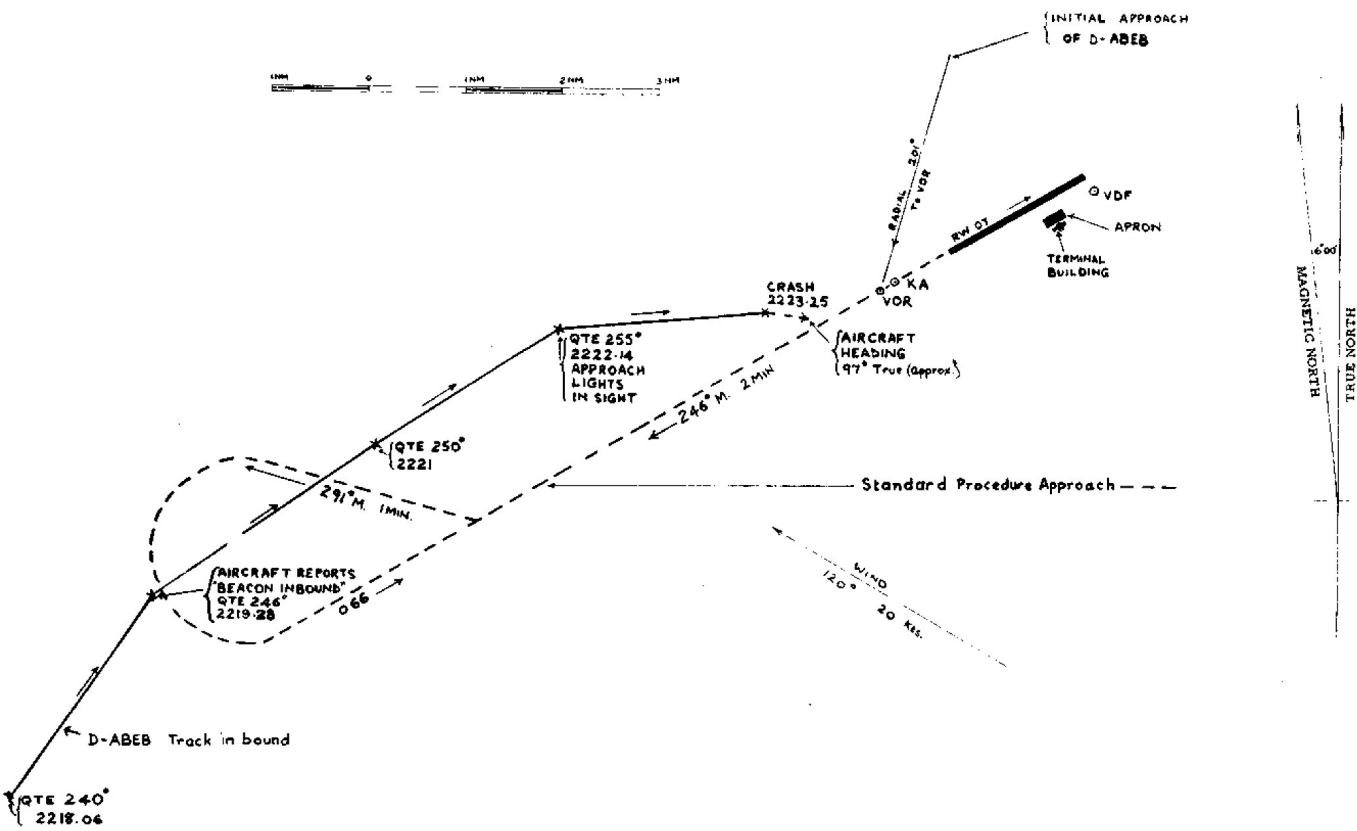
FIGURE 9

It has been found impossible to plot the outbound track of the aircraft with any reasonable accuracy. At the time it completed its procedure turn, it should have been 7-1/2 NM from the KA beacon; in actuality, at the time it reported "beacon inbound" at 2219:28 hours it was approximately 8-1/2 NM from the KA beacon and 1 mile north of the extended centreline of runway 07; but before this, at 2218:06 hours, when it obtained a bearing of 240°T it was approximately 10-1/2 NM from the KA beacon and just south of the extended centreline. (See Figure 9).

Due to the bearings that the aircraft obtained during its final approach it has been possible to plot its inbound track. (See Figure 9). It will be seen that the aircraft tracked away from the centreline until it was about 1-1/2 NM north of the centreline at a distance of 4-3/4 NM from the threshold of runway 07. It later appears that the aircraft did not turn in towards runway 07 until just after the last bearing 255°T, when it reported it had the runway lights in sight. This evidence is in accord with that of eyewitnesses of its final approach, and with the heading of the aircraft when it first impacted.
