No. 28

Cunard Eagle Airways Ltd., Vickers Viking 3B, G-AHPM, accident near Stavanger Airport, Sola, Norway, on 9 August 1961. Report of the Royal Norwegian Commission for the Investigation of Civil Aircraft Accidents, dated 28 May 1962. Also released by the Ministry of Aviation (United Kingdom) as C.A.P. 182.

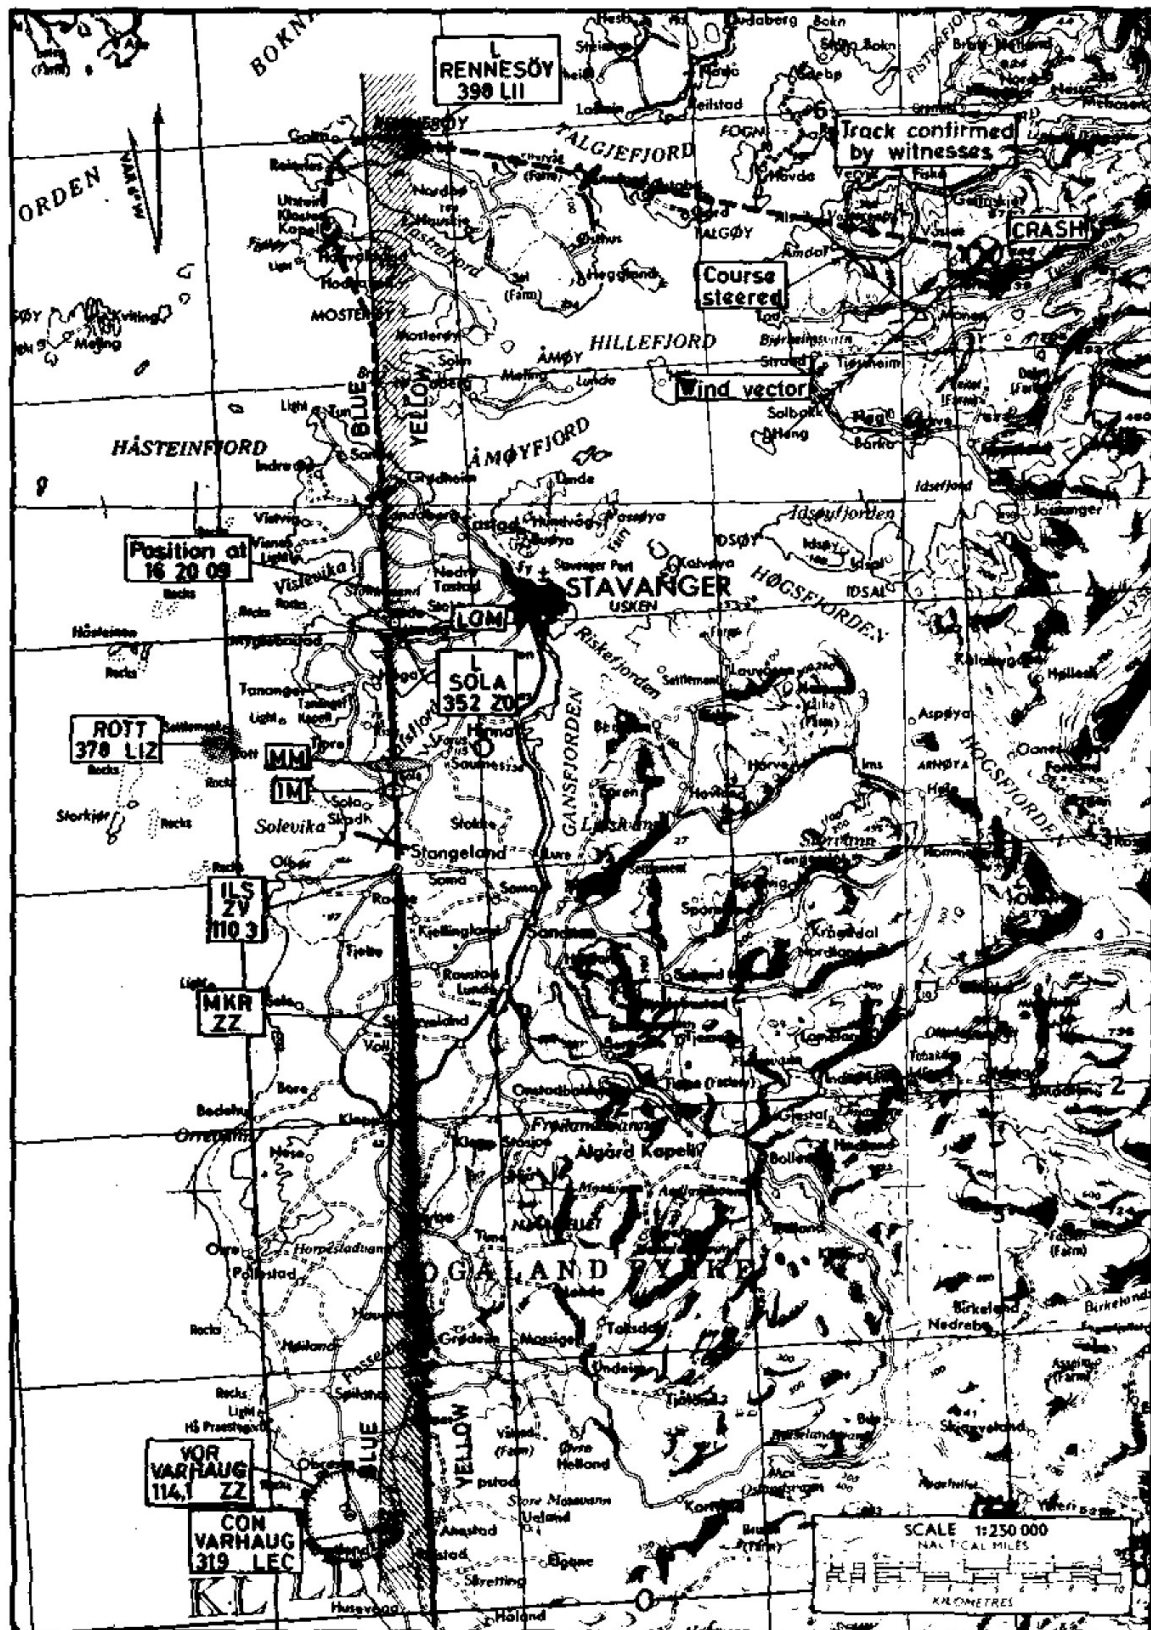
FIGURE 14

The most likely one is associated with the very strong southwesterly wind. It was established that the aircraft passed the vicinity of Sola northbound, and it is reasonable to assume that the captain was attempting to follow the prescribed ILS procedure. It is likely that the wind at 1 600 ft was about 230°/60 kt and the maximum drift the aircraft would experience on the procedure turn would have been about 26° and during part of the turn the ground speed may have been as high as 195 kt. If insufficient allowance was made for the drift, it can be shown that by the time the aircraft had completed the turn to rejoin the localizer beam the wind effect would have taken it close to or even through the centreline. After completing this turn the aircraft should still have had a short distance to run before reaching the beam and at this point the localizer needle on the instrument in the cockpit should be giving a "fly left" indication. When this needle starts to move towards the "on course" position the turn on to the final approach is made. However, if the aircraft had passed through the centreline whilst still making the turn, the crew ought to have been aware of this from the "fly right" indications even if they had missed the actual movement of the localizer needle. In addition, the radio compass indicator would have made this

apparent if it was correctly tuned to the ZO locator. With the wind speed and direction at the time, even if the captain had allowed for sufficient drift to make good the required outboard procedure turn track, it would still have been necessary for him to extend the "still air" timing of 45 seconds by approximately 1 minute 15 seconds to ensure that he was still on the western side of the localizer by the time he had completed the final part of the procedure turn.

After completing the procedure turn there is little doubt the crew expected still to be on the western side of the localizer beam and they may have missed the movement of the localizer needle that resulted from crossing the beam. If the crew misinterpreted the indications of the localizer needle this would help to explain why the heading of 135° - 140° M was maintained to the position of the crash. However, if the ILS equipment in the aircraft was working satisfactorily the crew must, for at least 4 - 5 minutes, have had a continuous indication that they were on the eastern side of the localizer beam. The Commission was unable to explain how the crew in a situation of this nature could continue on the heading indicated for the time stated unless they either did not note or were misinterpreting the ILS indicator readings.

RECONSTRUCTION OF LAST PART OF FLIGHT
