Derby Aviation Ltd., C-47B, G-AMSW, accident near Mount Canigou, Pyrenees on 7 October 1961. Report released by the Inspectorate General of Civil Aviation, Ministry of Public Works and Transport, France, in Le Journal Officiel (No. 9, 1962). This summary is based on the translation of the final report published as C. A. P. 179 by the Ministry of Aviation, United Kingdom.

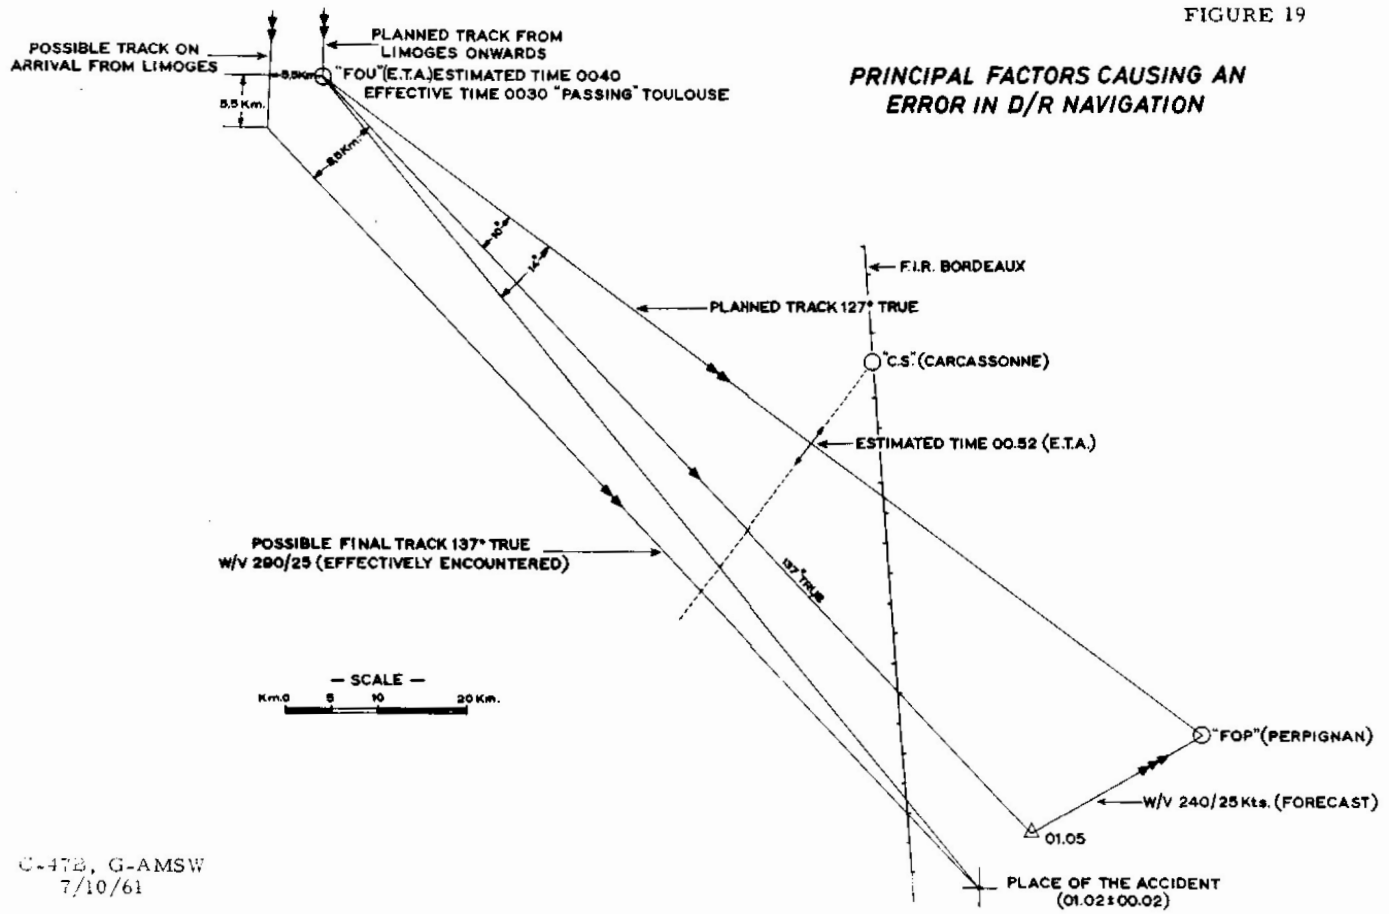
FIGURE 19

The aircraft struck the northwest side of Pic Barbet, a northeast spur of Mount Canigou at a flight level of very nearly 75. The impact point was about 40 km from Perpignan aerodrome and 150 km from Toulouse. At the accident site the mountain side slopes at about 60 to 70°. It is very rugged, with boulders, crags and even cliffs, which make access difficult, and the ground is covered with dense vegetation in the form of rhododendrons 60 cm high, and wooded, sometimes only sparsely, with pine trees. From evidence at the scene of the accident, it was ascertained that at time of impact the aircraft was flying straight and level on a heading of about 148°T. (heading from Toulouse to the place of the accident: 141°T.)
