No. 7

SABENA, Boeing 703-329, OO-SJB, accident at Berg, 2 km northeast of the threshold of runway 20 at Brussels National Airport, Belgium on 15 February 1961. Report released by the Minister of Communications, Belgium.

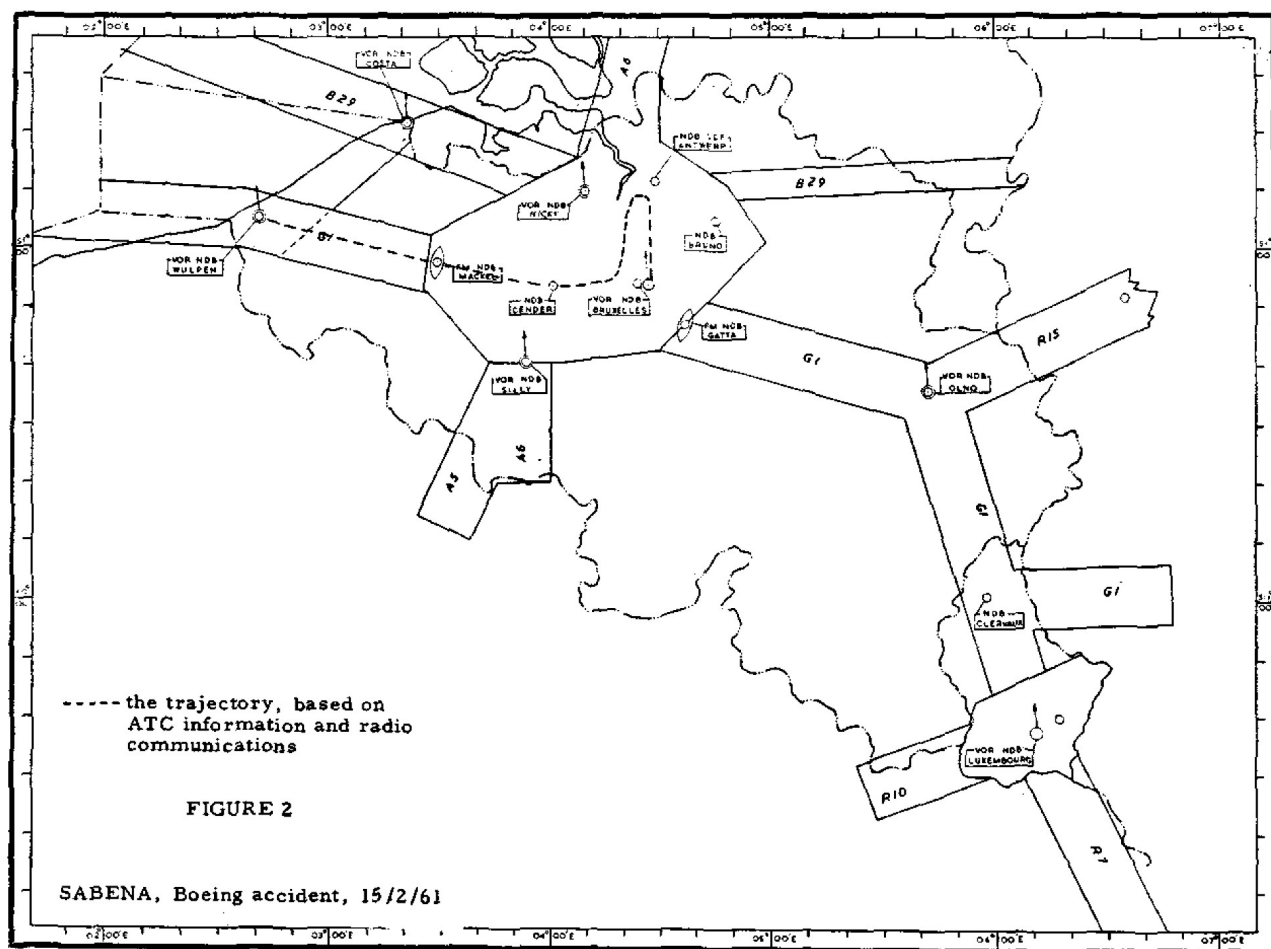
Figure 2 shows this trajectory from the point of entry into Belgian territory until the break in radio communications.

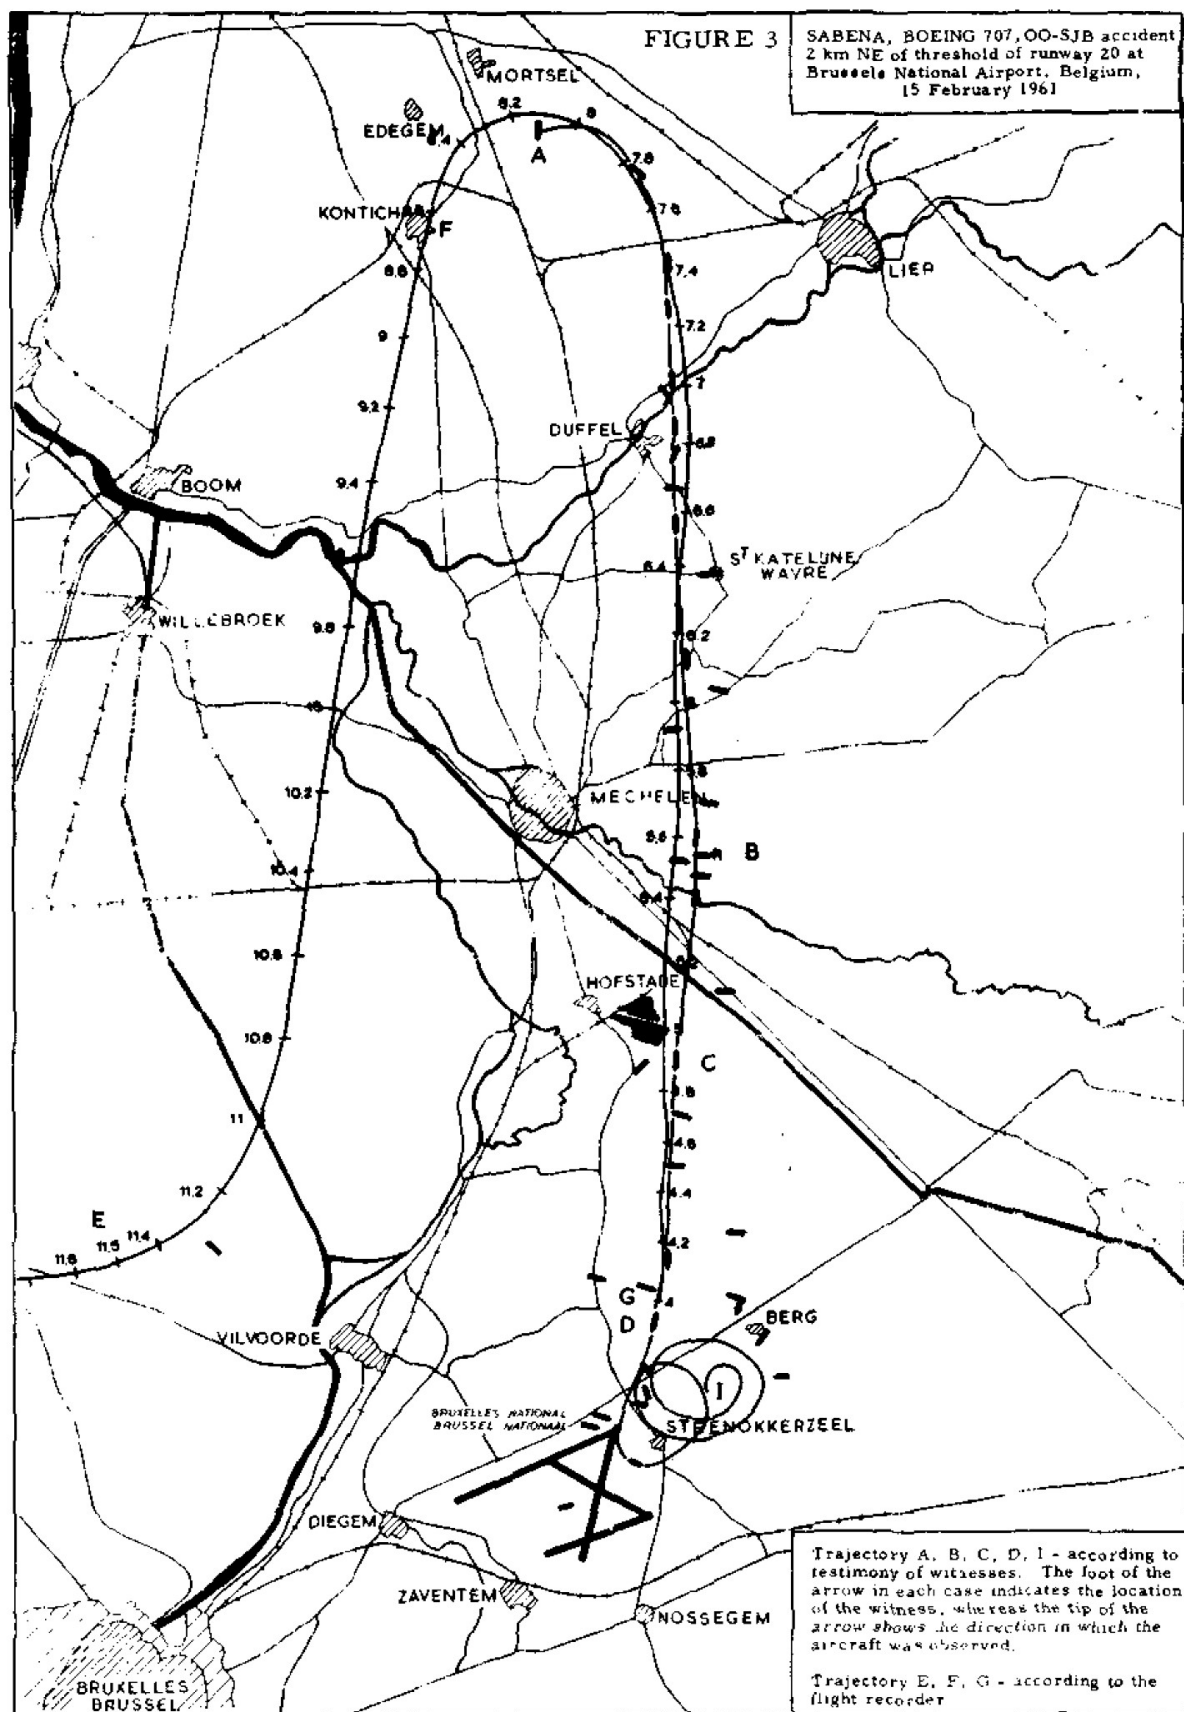
The trajectory is shown as Points E, F and G on Figure 3. It is based on information extracted every 12 or 15 seconds on the time scale of a graph. It is to be noted that the flight recorder was an experimental model and, moreover, it was found in an area where the fire was particularly intense. For this reason, the value of the information furnished by the graph during the last 4 or 5 minutes of flight is uncertain or worthless. The recorder does not give points of the trajectory directly. It provides for the airspeed and heading of the aircraft at each instant. From these observations and supposing that the speed vector has the same direction as the heading, a series of tangents can be traced for which the envelope constitutes the trajectory. There is no correlation between the times of the testimonies and the times of the recorder, however, one may attempt to place the curve established according to the witnesses' testimony over the curve established according to the elements of the flight recorder by displacing the latter and by taking into account its orientation, which is determined by the indications of successive headings.
