No. 15

KLM/VIASA, DC-8, PH-DCL, crashed into the Atlantic Ocean 3 km off the coast of Fonte da Telha, Almada District, Portugal, on 30 May 1961. Report, dated 1 March 1963, released by the Director General of Civil Aviation, Portugal.

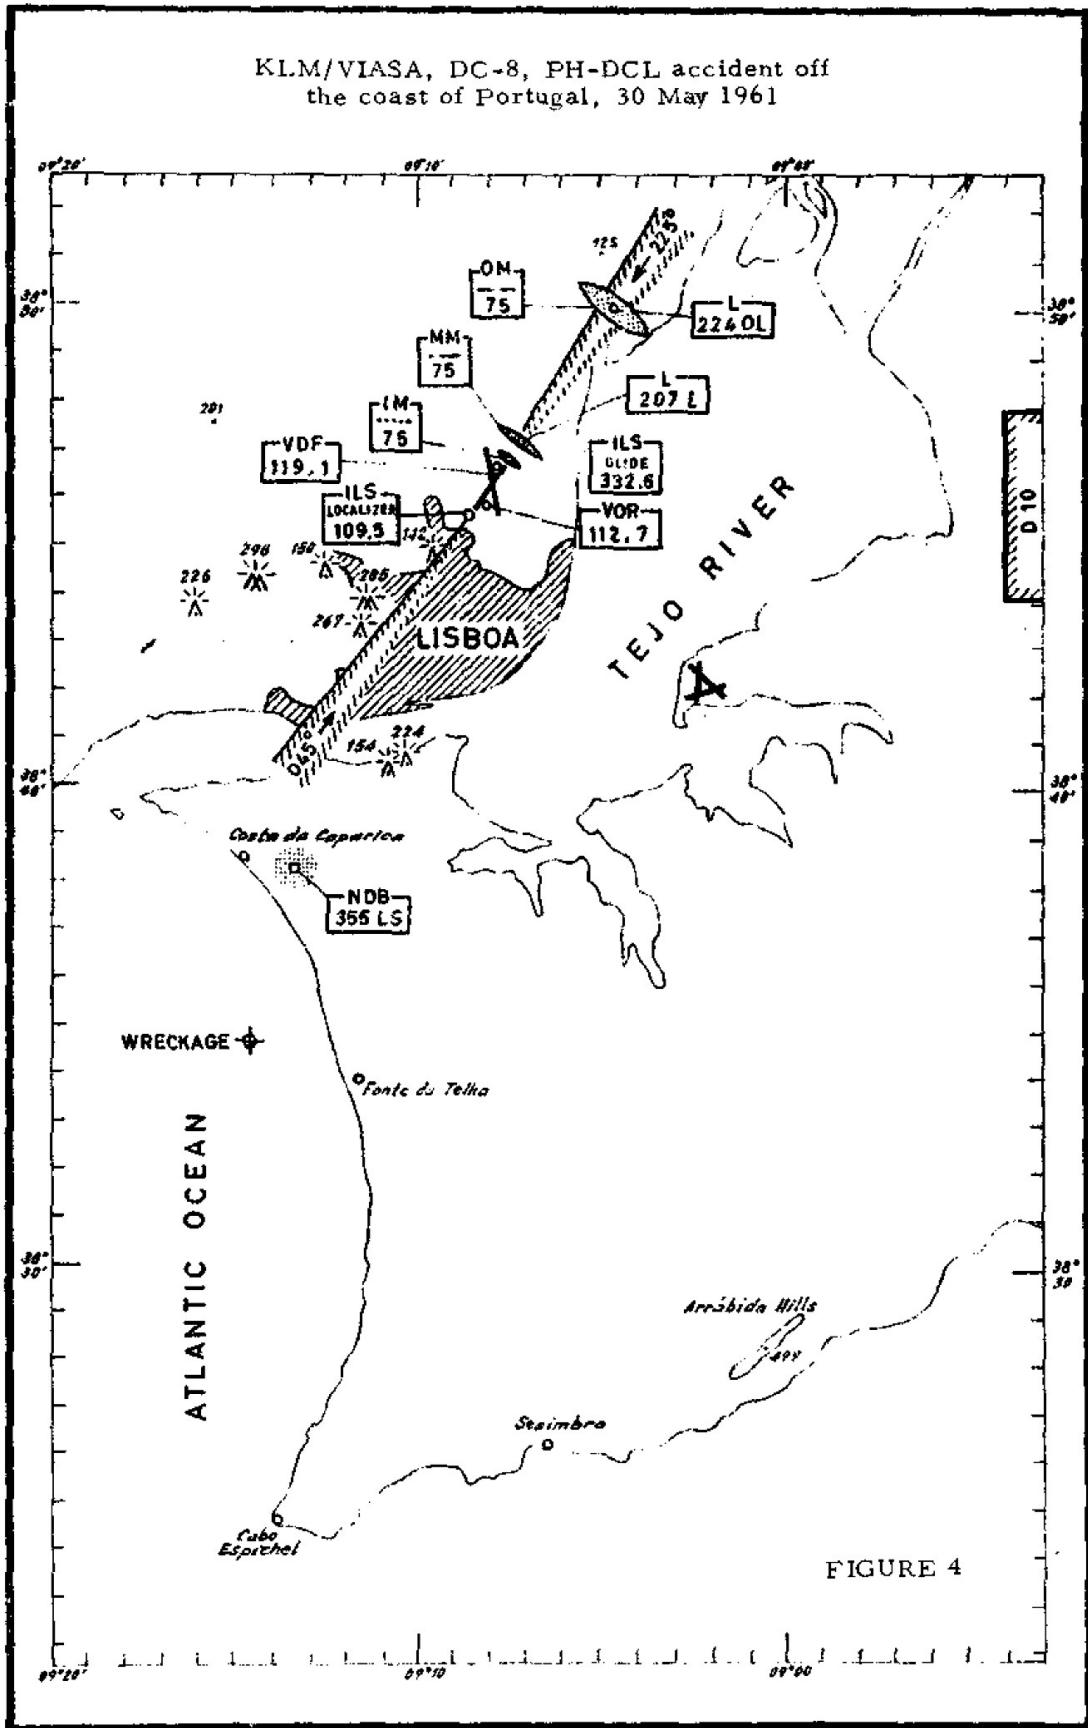
FIGURE 4

KLM/VIASA, DC-8, PH-DCL accident off
the coast of Portugal, 30 May 1961
