AVIATION INVESTIGATION REPORT

A15Q0120

Loss of control and collision with terrain

Air Saguenay (1980) inc.
de Havilland DHC-2 Mk. 1 (Beaver), C-FKRJ
Tadoussac, Quebec, 7 nm N
23 August 2015

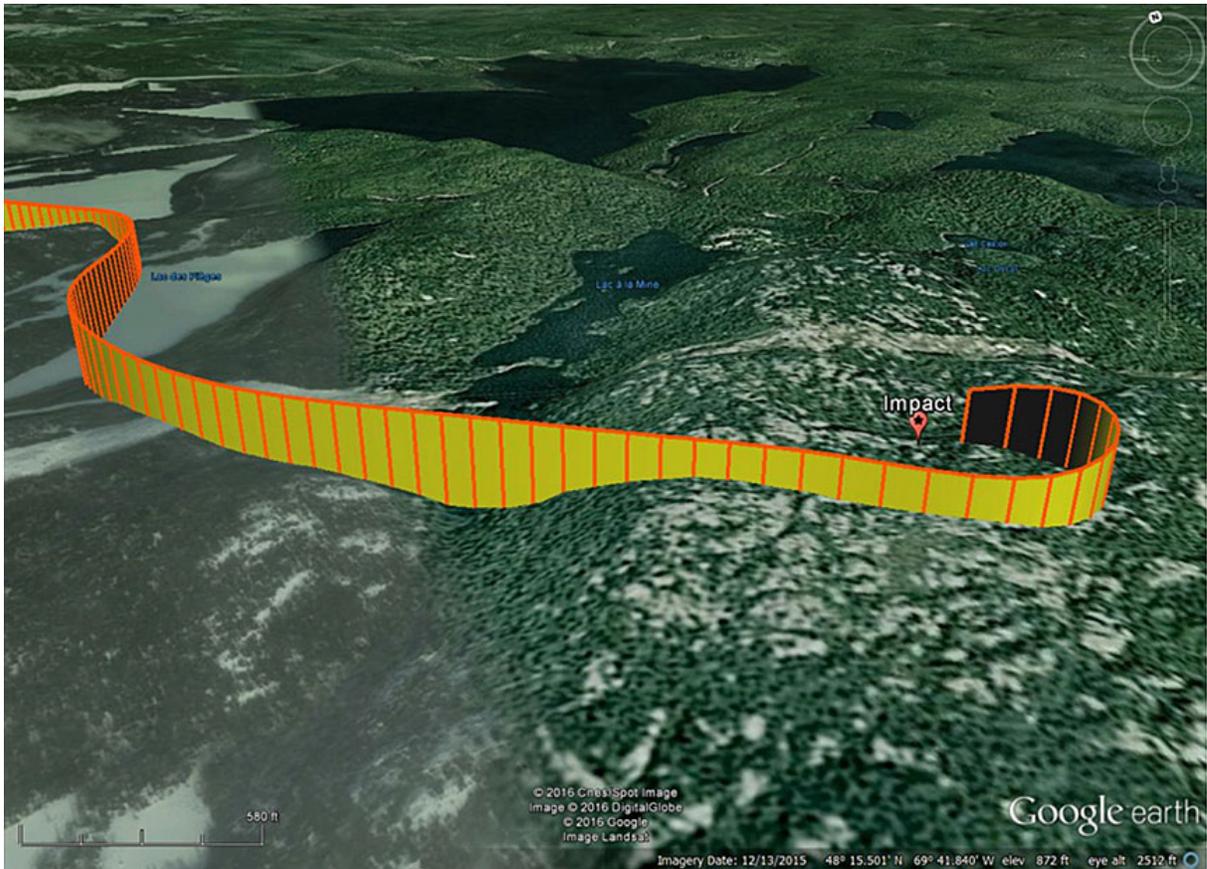
Figure 2. Final turn according to global positioning system data (Source: Google Earth, with TSB annotations)

C-FKRJ then descended to an altitude of approximately 1100 feet ASL, approaching hilltops with an elevation of about 1000 feet ASL. Just south of the town of Sacré-Cœur, Quebec, the aircraft turned toward the northeast and flew over the hills at about 100 feet above ground level (AGL) before turning back toward Lac Long. As the aircraft was flying over a hilltop at about 110 feet AGL, the pilot initiated a steep left turn. C-FKRJ stalled aerodynamically mid-turn, which caused the aircraft to enter an incipient spin. At 1127, the aircraft descended vertically and struck a rocky outcrop on top of a hill at 48°15.405' N and 069°41.597' W (Figure 2).

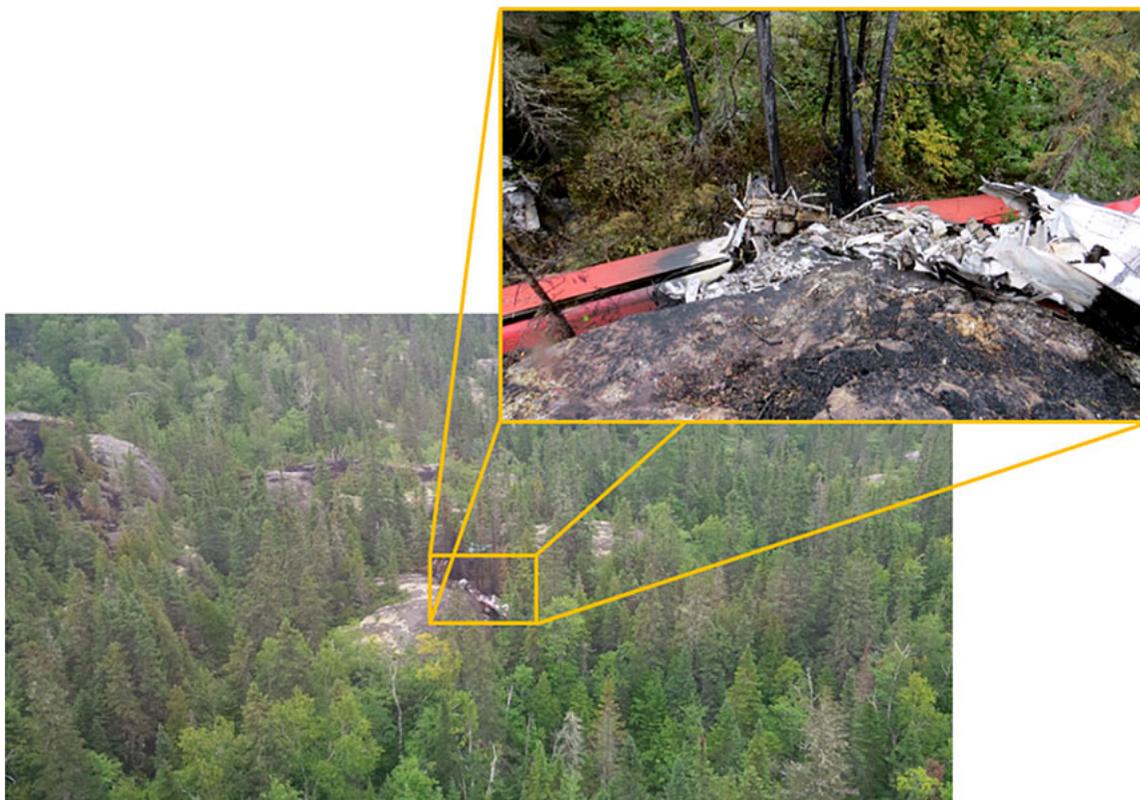
Figure 6. Accident site

After colliding with the rocky outcrop, the aircraft caught fire and the cabin was destroyed by the post-impact fire (Figure 6). Because there were no survivors or witnesses, and given the destructive nature of the fire, it was not possible to collect evidence of the source of the fire, the fuel spill, or the propagation of the fire.

The wreckage was positioned vertically, nose down. The belly of the aircraft was leaning against a rocky outcrop. The engine had separated from the aircraft under the force of the impact and was found about 8 m downhill. The propeller was still attached to the engine and was substantially damaged. Both blades were bent and twisted; one had broken off and was found under the wreckage.

During the aircraft's descent, the propeller had left 6 gashes in a tree at equal intervals of about 81 cm before contacting the ground. The wings were on the ground, with the right wing between 2 trees that were close together. The aircraft had not damaged the branches of these trees. The marks on the ground and the absence of damage to surrounding vegetation are consistent with a vertical descent.

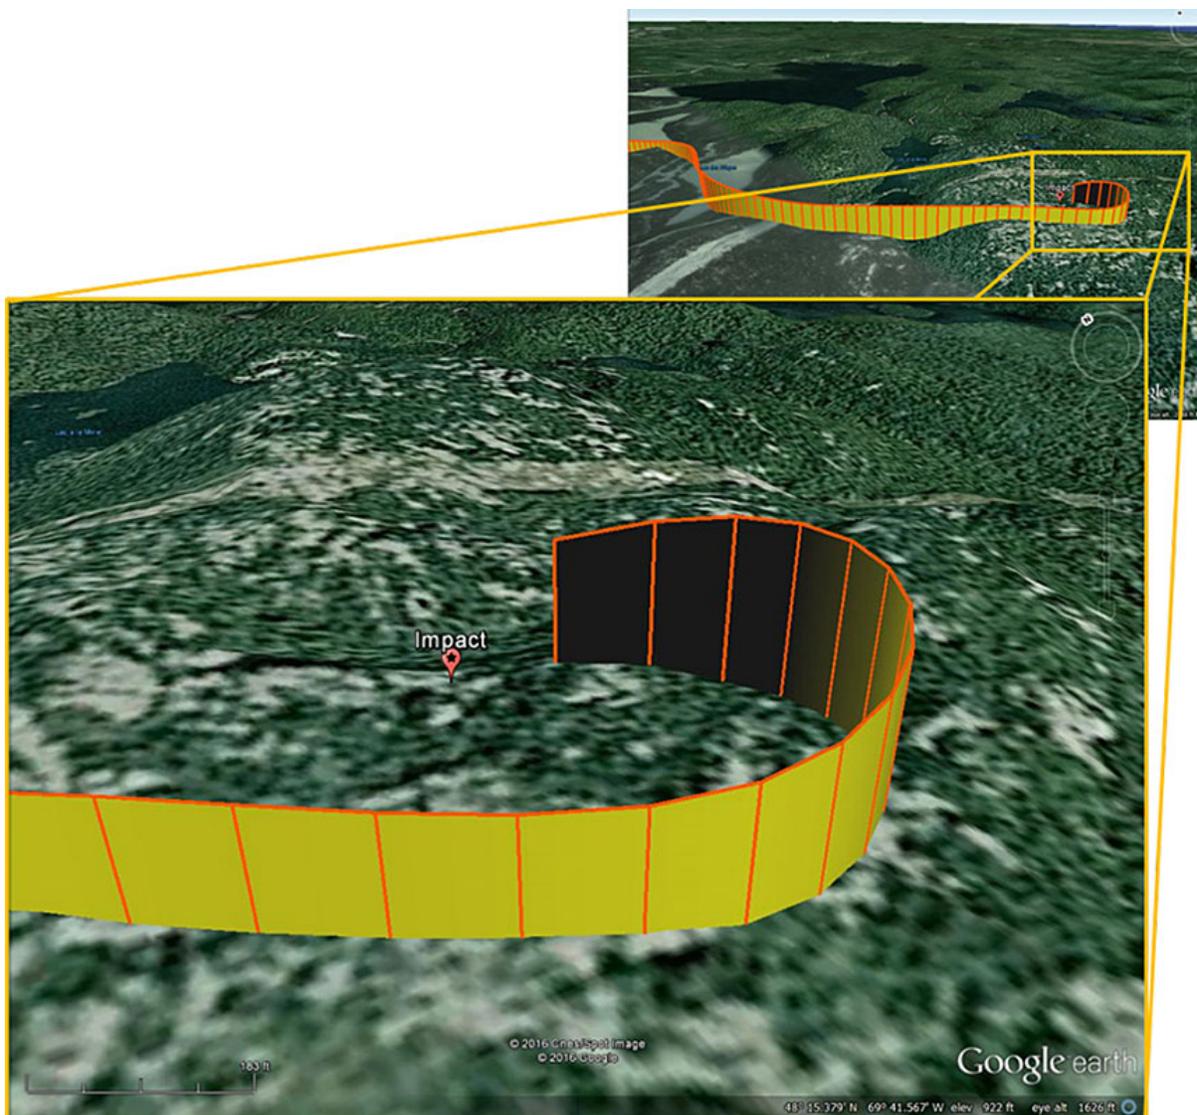
Figure 7. Final turn at end of last flight (Source: Google Earth, with TSB annotations)

Calculations indicate that the aircraft began its last turn at 1126:49 at an altitude of 1120 feet ASL, that is, approximately 110 feet AGL (Figure 7). The increase in the aircraft's angle of bank reduced the radius of the turn from 400 feet to 275 feet. At the start of the turn, the airspeed of the aircraft increased from 73 mph to 85 mph, as the angle of bank also increased.

The aircraft's airspeed then gradually slowed to 60 mph, with an angle of bank of approximately 50° in mid-turn.²⁶ During the turn, its altitude increased by approximately 40 feet and, taking into account the variations in the terrain elevation around the top of the hill, the aircraft was approximately 175 feet above the accident site when it stalled aerodynamically. It collided with the ground at 1127:07.

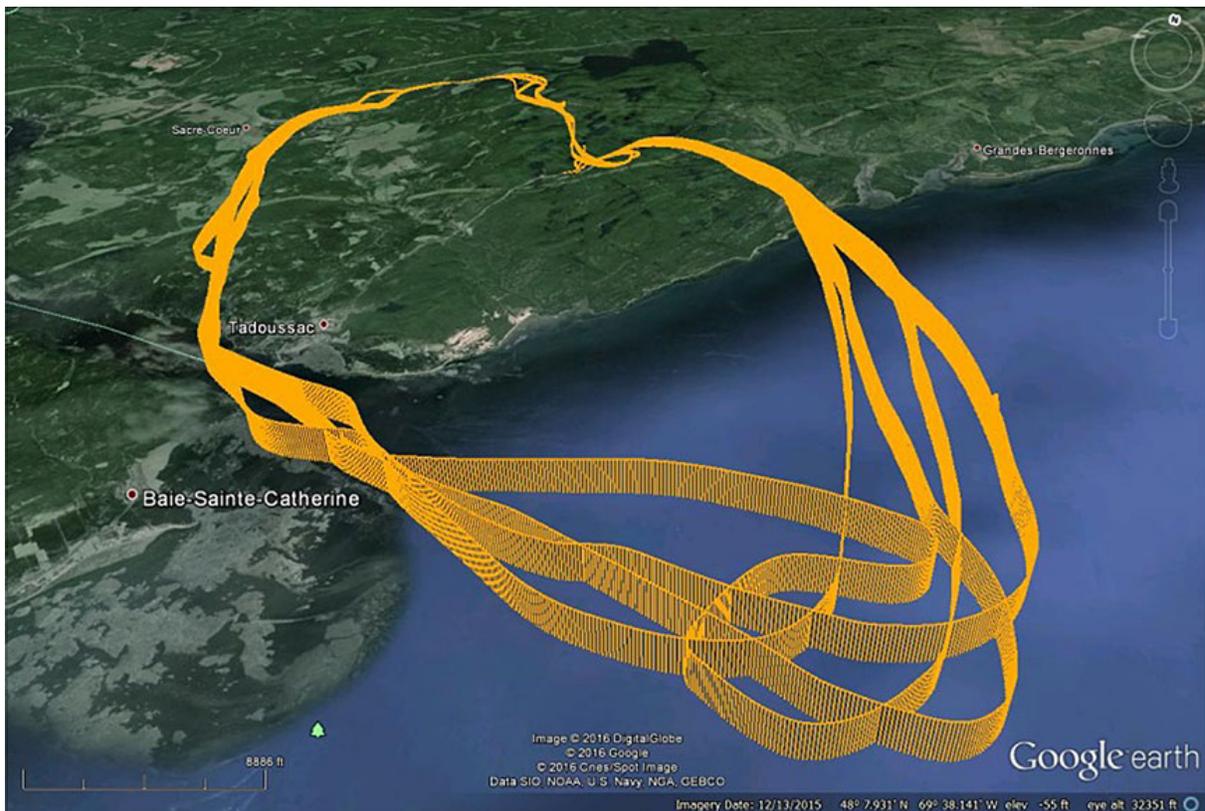
Figure 8. Flight paths on day of accident (Source: Google Earth, with TSB annotations)

The analysis of the GPS data²⁷ indicates that the occurrence flight path was substantially similar to that of the pilot's 20 most recent sightseeing flights (Figure 8). The data showed that the pilot regularly flew at low altitudes, sometimes making steep turns after flying over the wildlife reserve. For example, the 4 flights made on the day of the accident proceeded over Sacré-Coeur and then over a hill at low altitude (between 45 and 136 feet AGL).

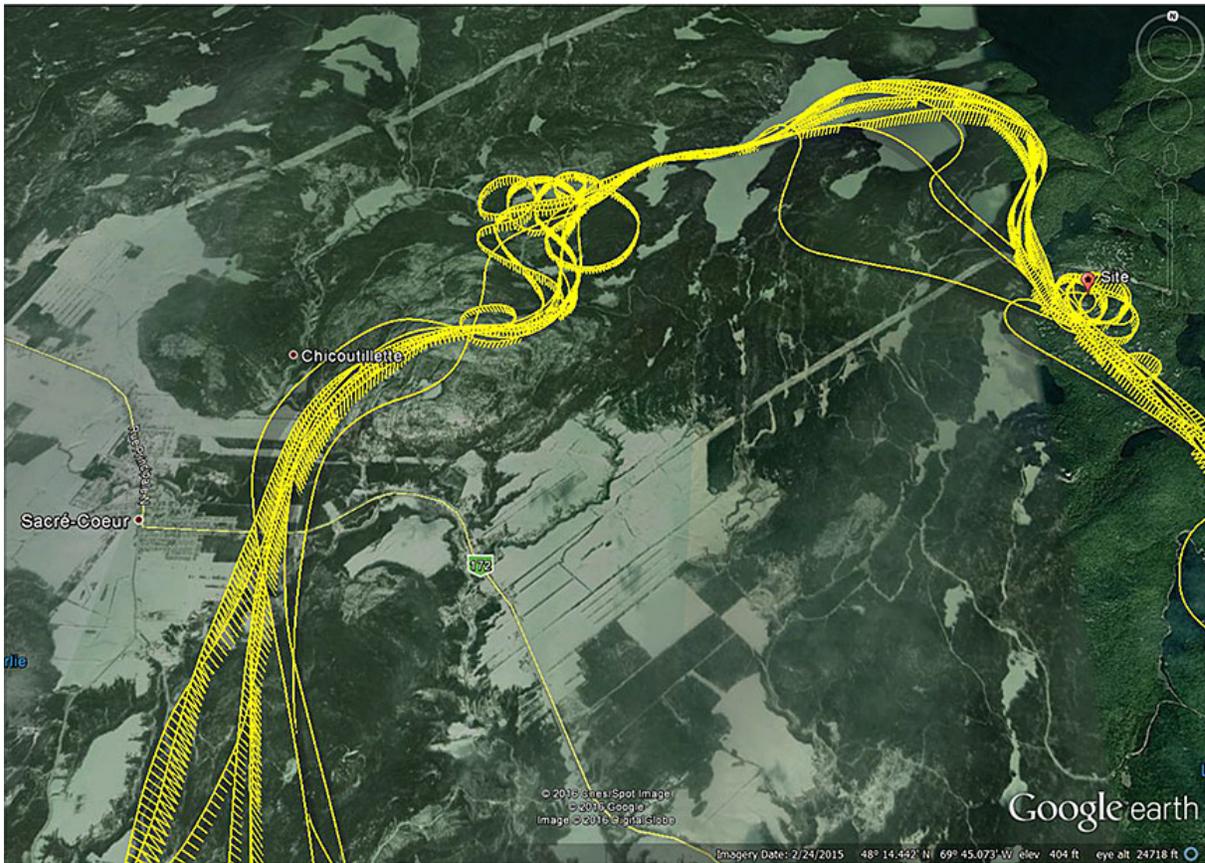
Figure 9. Flights on 17 August 2015 (Source: Google Earth, with TSB annotations)

Six days prior to the accident (on 17 August 2015), the pilot had flown at low altitude 12 times, with 8 of those overflights occurring above the accident site, where there had been sightings of a family of bears (Figure 9). When turning, C-FKRJ was at an altitude of between 150 and 350 feet AGL, its airspeed was between 56 and 74 mph, and its angles of bank were between 16° and 45° .

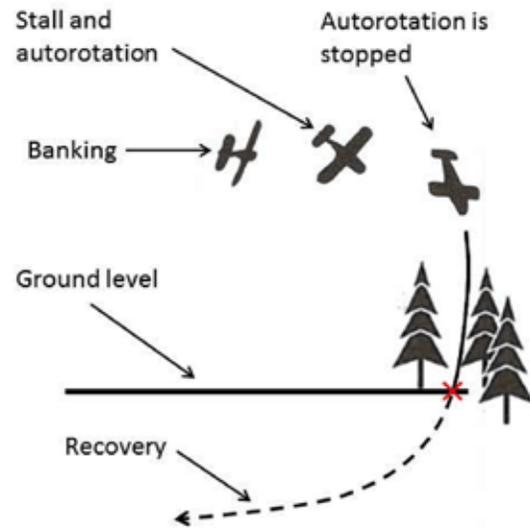
Figure 15. Incipient spin close to the ground (Source: Transport Canada, TP 1102, *Flight Training Manual*, 4th edition, with TSB annotations)

It was during this turn that the floatplane stalled aerodynamically, causing an incipient spin. Circumstances suggest that the increased load factor generated by the turn, possibly combined with the illusion associated with flying below the pivotal height, caused the left wing to stall. It should be noted, however, that stalling does not necessarily lead to an accident if it occurs at an altitude sufficient for control to be regained before a collision with the terrain. In this case, the pilot made a steep left turn, and an aerodynamic stall ensued, causing an incipient spin at an altitude insufficient to allow control of the aircraft to be regained prior to vertical collision with the terrain (Figure 15).
