No. 17

ITAVIA Airline Company, Douglas DC-3, I-TAVI, crashed into mountainous terrain south of Rome, Italy on 30 March 1963. Report released by the Directorate of Civil Aviation, Italy (undated)

ACCIDENT TO DC-3, I-TAVI, OF ITAVIA AIRLINE COMPANY, SOUTH OF ROME, ITALY.  
30 MARCH 1963

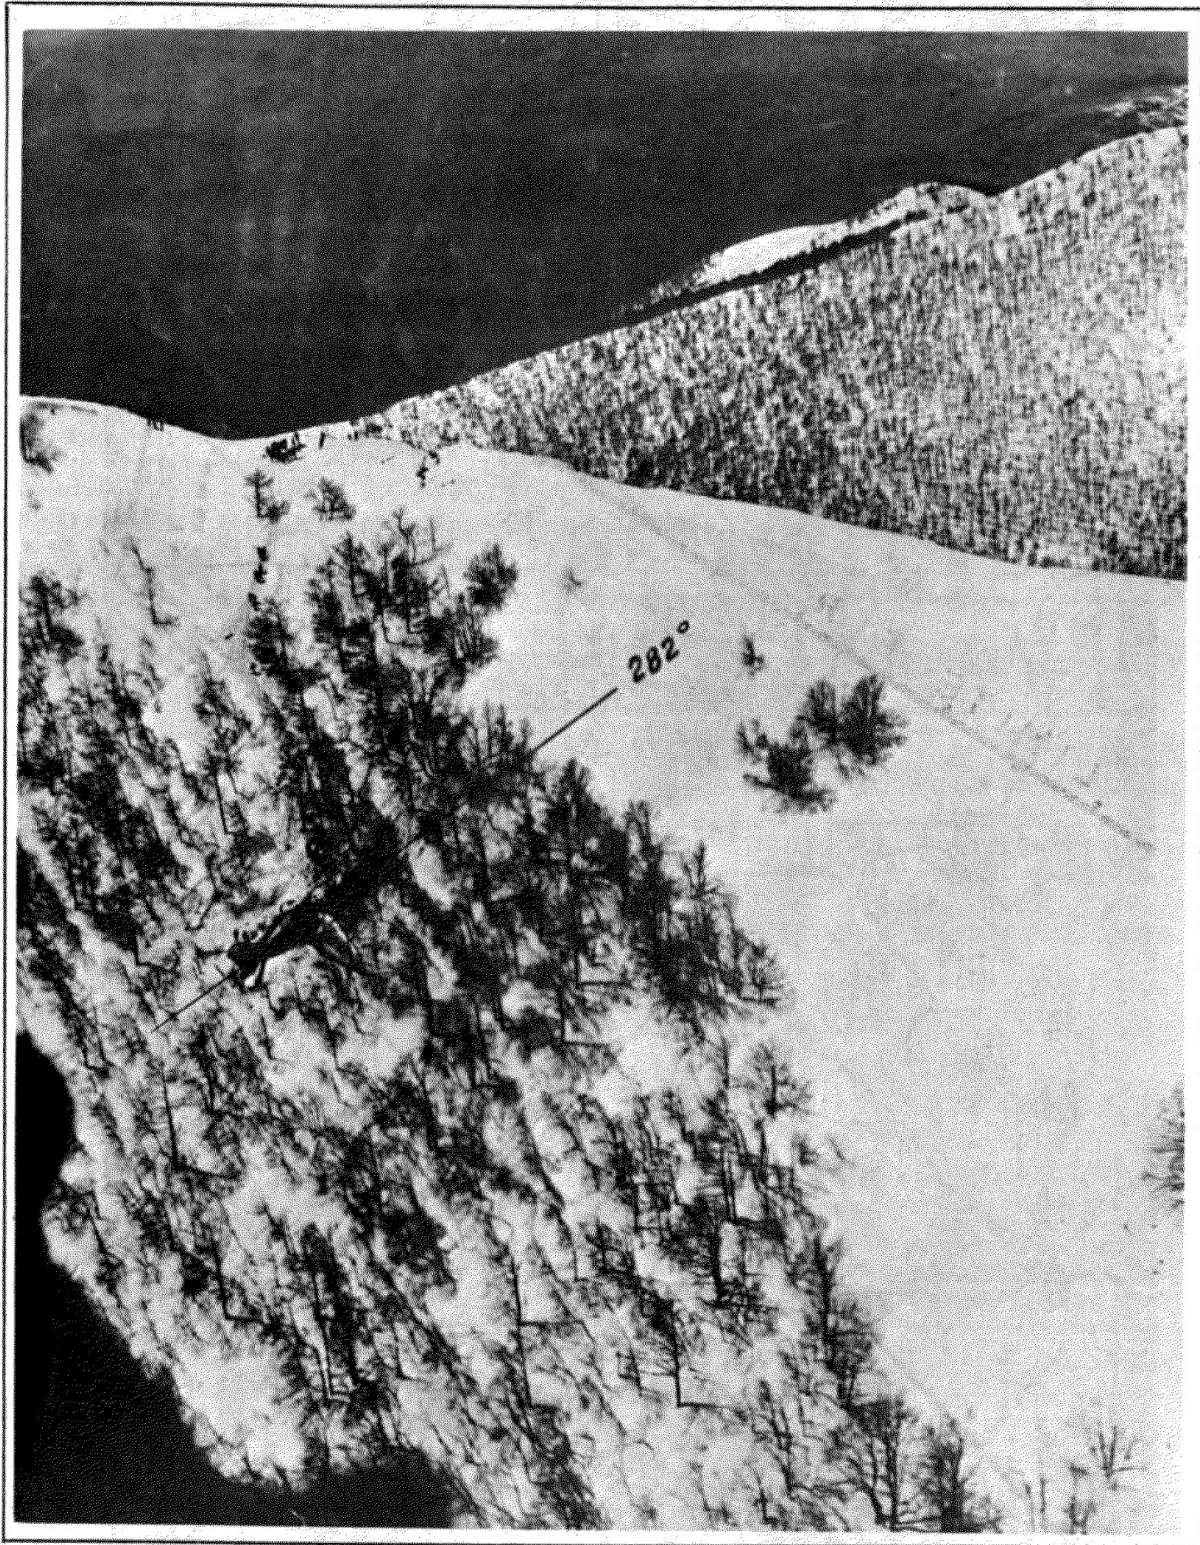
FIGURE 17

The accident site was located at 70 m from the mountain crest, which at this point reached an altitude of 1670 m. The wreckage was lying on the snow in a limited area with the axis of the fuselage oriented 282° and the nose of the aircraft pointing towards the mountain crest (See Figure 17).

The forward and central part of the fuselage was destroyed together with the left wing. The aft part of the fuselage and the tail assembly appeared to be intact.

Evidence at the accident site indicated that the aircraft was flying at a heading of approximately 300° in a nearly straight and level altitude and that it was converging with the slope of the mountain at an angle of approximately 60°. The left wing and propeller struck first some trees; the propeller became detached, the wing was bent backward and its tip together with the aileron broke off and was found 15 m to the left of the main wreckage. This swung the aircraft anticlockwise, the fuselage struck some trees, came into contact with the ground and was deflected upward by the slope to finally come to a halt on a large stump. The right side burst open and the bodies of the passengers were thrown outside.

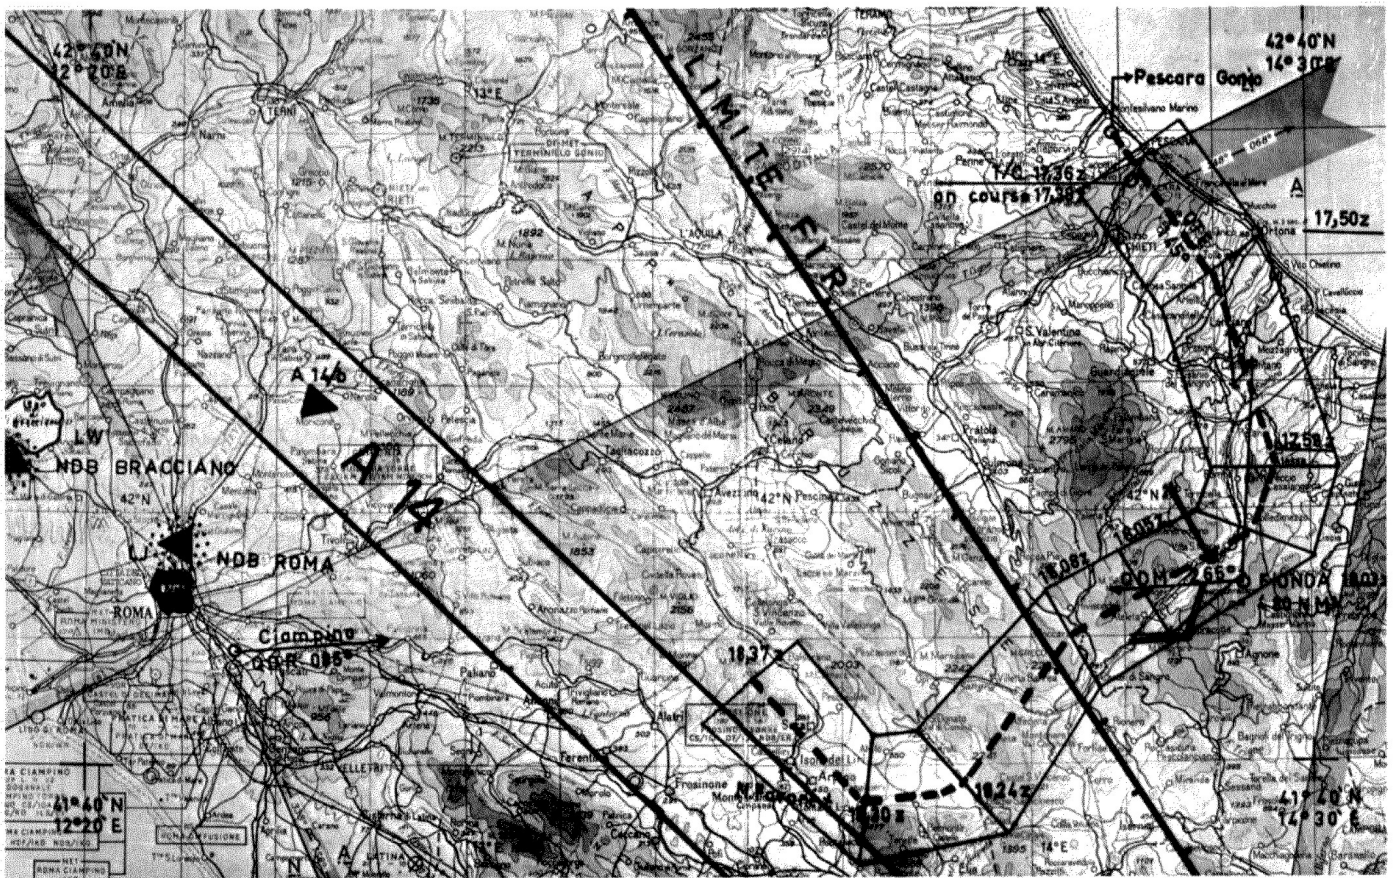
FIGURE 18

After take-off, the pilot intentionally departed from the flight plan and flew south of the approved direct route Pescara - Rome (See Figure 18). He, however, failed to report this change to the appropriate ATC units. During the first part of the flight, he received radar assistance from Pescara defence radar and was therefore able to circumnavigate cumulo-nimbus which were numerous at the time. At 1803 Pescara radar gave him a fix, and he reported accordingly to Rome ACC/FIC. This was the only accurate position report, all subsequent position reports and estimated time of arrival to reporting points were either incomplete or erroneous. The fact that the pilot enquired at 1816 hours if Rome had radar contact with him and reported at 1818 hours that he was crossing airway A 14 indicated that he believed being far more to the north-west than he really was. Furthermore, if he had been aware of his exact position he would never have requested, four minutes later, clearance to descend, as there were several peaks above 6 600 ft in the area.

An examination of the flight positions recorded by Rome 2 defence radar led to the conclusion that when the pilot reported seeing the lights of Rome and shortly after the Mount Cavo antennae, he actually was in the Arpino-Frosinone-Sora area and probably mistook the lights of Sora, or Frosinone, for those of Rome and the Mount Favone antennae for those of Mount Cavo. This erroneous estimate of his position made him believe that his radio compass was out of order, when he was unable to tune on Rome NDB "LJ". In fact, he was probably out of range to receive the radio beacon signals, especially with the presence of cumulo-nimbus in the area. The Rome surveillance radar was not able to pick up the aircraft that far away because of the weather conditions and the terrain. The unreliable indication given by the Ostia VOR, as reported by the pilot, might be explained by the fact that the aircraft was flying at low altitude over mountainous terrain. Furthermore, as the pilot reported that his instruments were only partly efficient due to flight conditions, it was concluded that after having lost the assistance of Pescara radar he ran into clouds and heavy turbulence and had difficulties in maintaining the aircraft altitude and route. No reasons were found to explain why the crew failed to request the assistance of the VDF stations available at Mounts Silvano and Guarcino and of Rome 2 defence radar. Whether the crew deliberately neglected such assistance or were unable to do so could not be determined. Fatigue was also considered as a possible contributing factor in this accident.
