No. 18

Bonanza Air Lines Inc., Fairchild F-27A, N 745L, accident at Las Vegas, Nevada, USA on 15 November 1964. Civil Aeronautics Board (USA) Aircraft Accident Report, File No. 1-0066 released 19 November 1965.

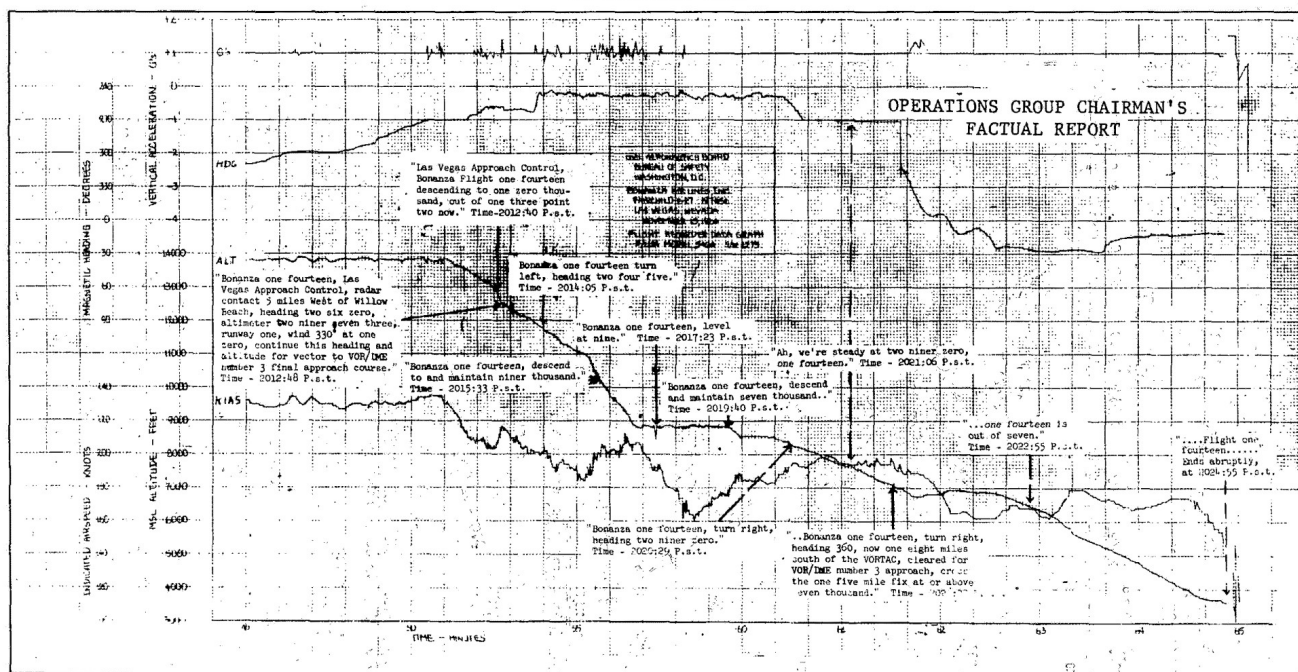
FIGURE 18-1

A Fairchild flight recorder was installed in the aircraft. The static ports for the flight recorder, altitude and airspeed instruments were located on the same panel. The recorder tape was recovered intact. Readout indicated compatibility with the clearances and instructions to the 15 mile DME fix. At approximately the 15 mile DME fix, the flight commenced a descent from approximately 7 000 ft AMSL which continued with no indication of level-off except for a few seconds at 3 700 ft AMSL. After this momentary level-off, the aircraft continued its descent until it crashed at approximately 3 575 ft AMSL. (See figure 18-1).

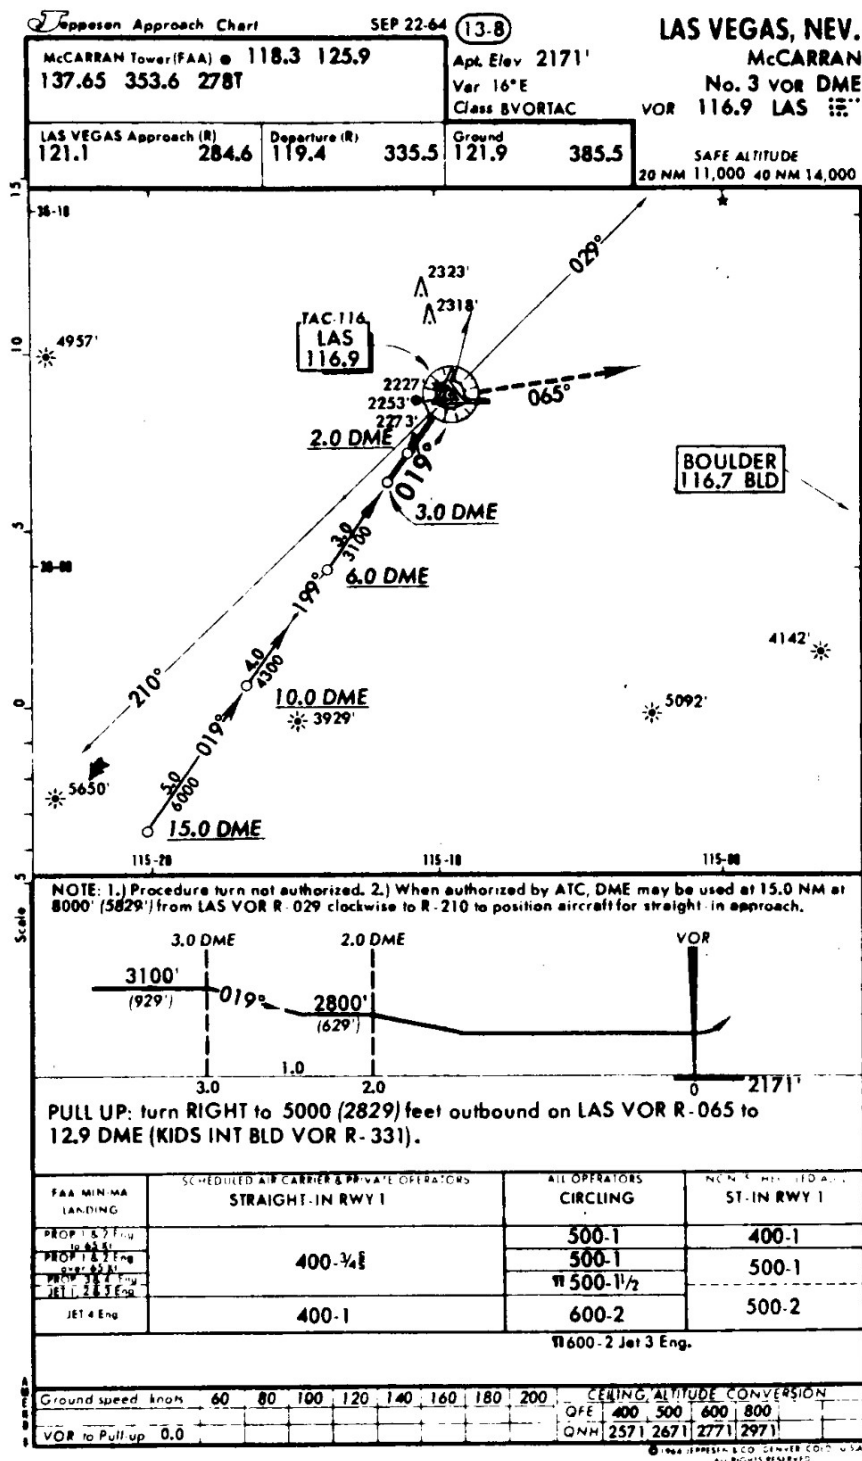
FIGURE 18-2

In accomplishing a DME-3 approach to Las Vegas the crew would have referred to a Jeppesen approach chart (see figure 18-2) which was used by the airline. The upper portion of the chart - the plan view - listed a series of fixes at 15, 10, 6 and 3 miles and the minimum altitudes between these fixes. The minimum altitude limitations were portrayed as 6 000 ft between the 15 and 10 mile DME fix, 4 300 ft between the 10 and 6 mile fix, and 3 100 ft between the 6 and 3 mile fix.

A profile view displayed on the lower half of the chart depicted the last 3 miles of the approach as a level altitude of 3 100 ft into the 3 mile fix then a descent to 2 800 ft to the 2 mile fix, and finally a descent to authorized minimum altitude at the airport. The 3 100 ft depicted on the profile view of the chart was indicated by numbers which were approximately twice the size of the numbers shown on the plan view.

- (3) The profile section of approach chart displayed no information for the segment of the approach between the 15 mile fix and the 6 mile fix, and a solid horizontal line between the 6 mile fix and the 3 mile fix, with an altitude of 3 100 ft. Further, the solid line was defined in the Chart Legend as "Flight Path," which implied that a descent to 3 100 ft was proper once the fix to which the flight has been cleared is reached.

With the exception of the DME approaches at Las Vegas, all approach charts used by the airline for all terminals it was regularly serving showed critical descent information in the profile section of the chart. Pilots conducting a DME approach at Las Vegas were therefore required to use a chart which, while similar in appearance, displayed critical descent information in a manner entirely different from all the other charts used for all other approaches (including those for conventional VOR approaches at Las Vegas).

The VOR/DME approach charts for Las Vegas portray the descent information in a manner different from all other approach charts used by Bonanza Air Lines, which could have led to misinterpretation if the charts were consulted superficially.

The probable cause of this accident was the misinterpretation of the approach chart by the pilot-in-command which resulted in a premature descent below obstructing terrain.

On 25 November 1964, the Civil Aeronautics Board by letter to the Federal Aviation Agency recommended "That the depiction of altitude restriction on the plan view of the approach plates be included on the extended profile of such plates in order to more clearly identify critical height above the terrain."
