No. 6

Canadian Pacific Air Lines Ltd., Douglas DC-8, CF-CPK, accident at Tokyo International Airport, Tokyo, Japan, on 4 March 1966. Report released by the Civil Aviation Bureau, Ministry of Transport, Japan on 4 March 1968

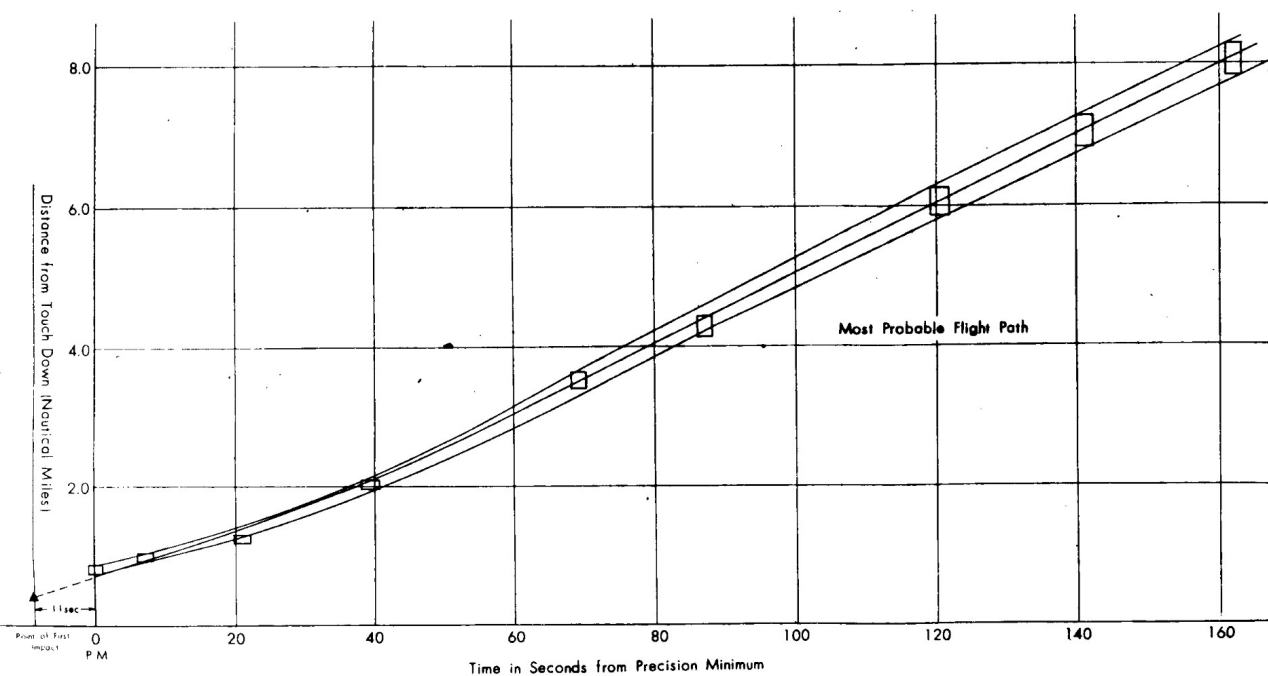
Fig. 6-1.- Time vs. Distance Error Envelope Curves and Most Probable Flight Path Between 8 Nautical Miles and Near P.M.

After the aircraft passed the P.M. (precision minimum), the aircraft requested the intensity of the lights to be reduced. Shortly thereafter, the aircraft made a sharp descent and its main landing gear wheel struck No. 14 approach light 2 800 ft from touchdown point approximately in an attitude of level flight. (See Fig. 6-1.)

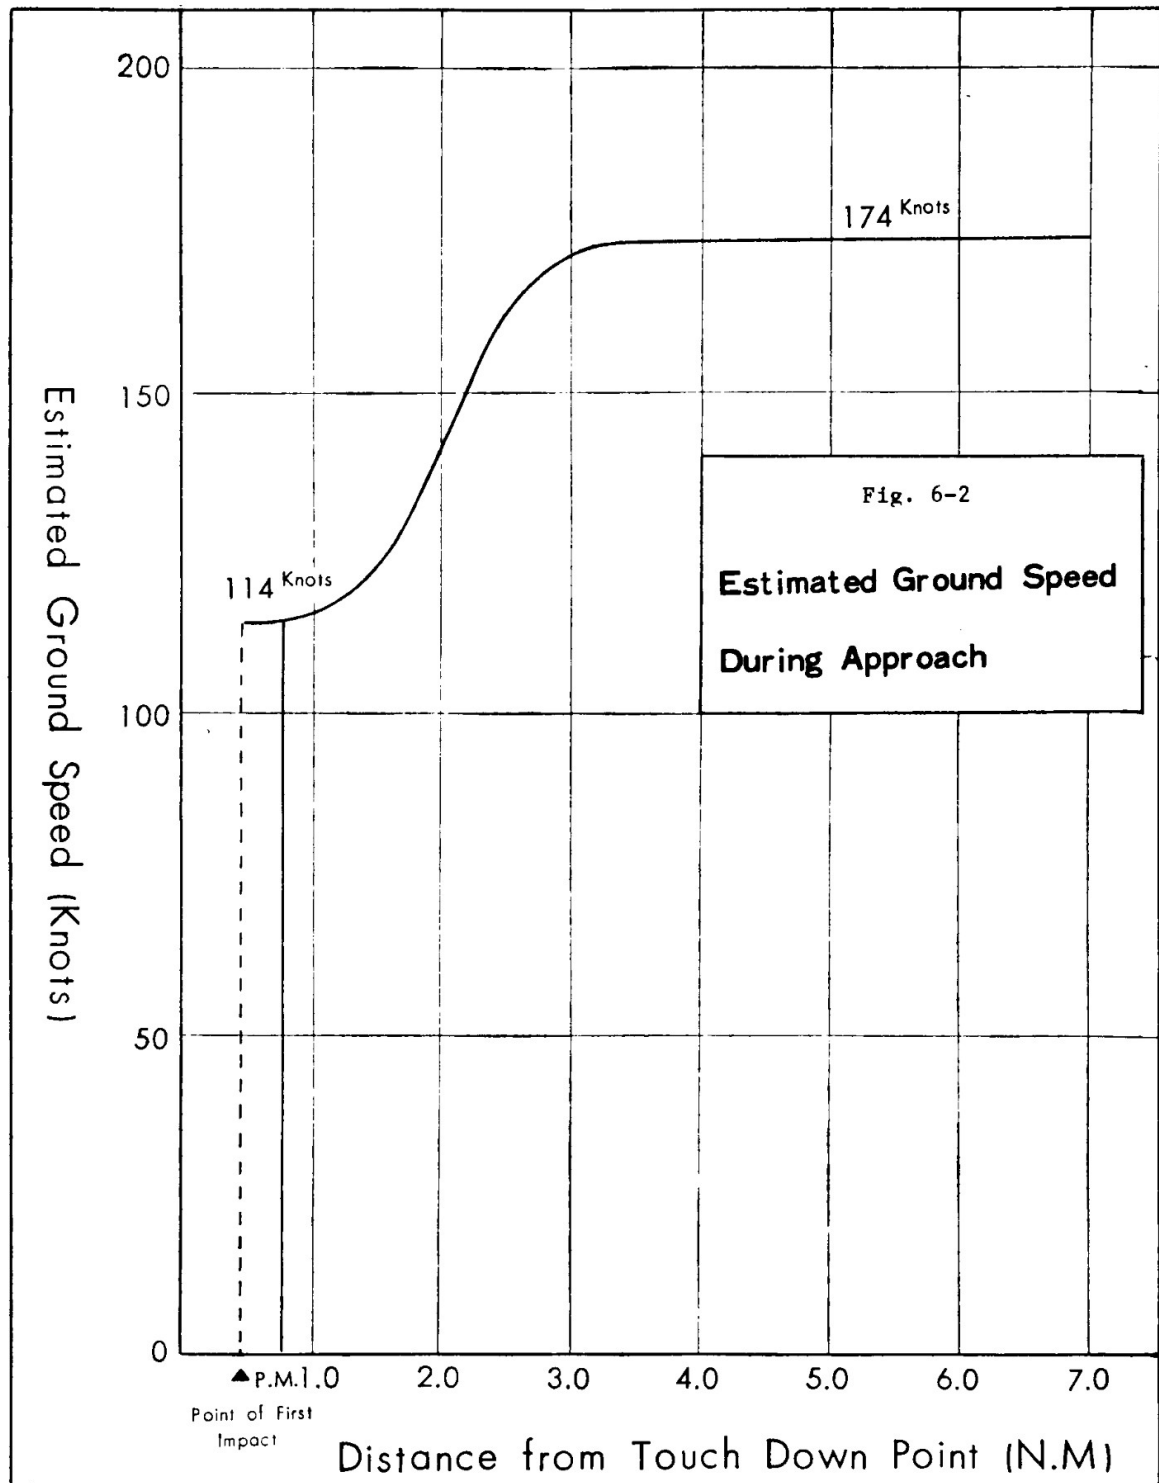
The first part of the descent for the final approach was smooth. The ground speed which was initially 174 kt, a little faster than normal, started to decrease in the vicinity of 3 NM and was reduced to 114 kt after passing one nautical mile (see Figure 6-2). The initial ground speeds having been somewhat faster than normal could indicate the existence of a considerable tail wind along the course or a desire of the pilot-in-command to expedite the landing. Adjustment of the throttle levers for obtaining a normal approach speed and for controlling a decrease in velocity of the tail wind at low altitude, might have resulted in a slightly low flight path after passing one nautical mile on final. The aircraft went below the glide path on two other occasions, once at the start of the GCA descent, and once at about 3 NM on final; in both cases, the deviation was less than 20 ft and prompt and precise corrective actions were taken in accordance with instructions of the final controller. This might indicate a high degree of proficiency of the pilot-in-command in manoeuvring the aircraft.

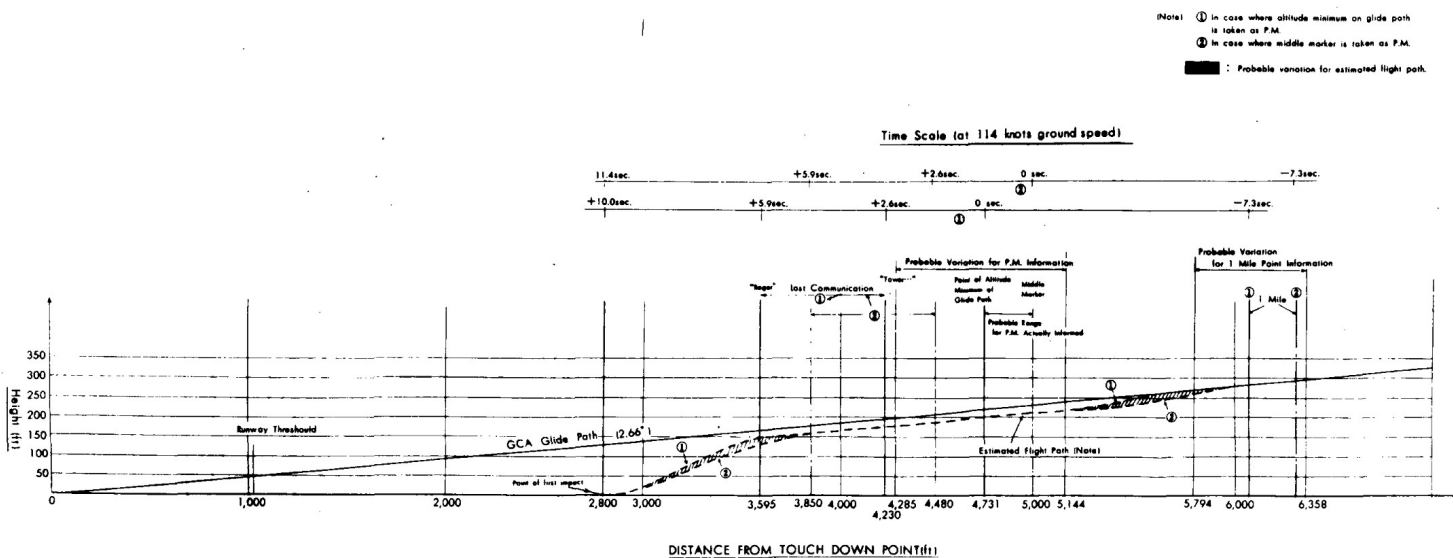
Fig. 6-3.- Estimated Flight Path after approx. 1 Nautical Mile

Due to the approach 20 ft below the glide path, the aircraft was informed of passing P.M. in the vicinity of the ILS middle marker (see Figure 6-3). It was not believed that the pilot-in-command who had a great deal of experience at TIA and had the ILS glide slope as a reference, could have had doubts regarding his position at this stage and mistaken the approach lights for runway lights. However, judging solely from the initial attitude of almost level flight in which the aircraft struck the approach lights, it might be concluded that a landing manoeuvre was being made at this point although this was considered to be unlikely.
