No. 21

Czechoslovakia State Airlines, Ilyushin IL-18D, OK-WAI, accident at Gander International Airport, Newfoundland, Canada, on 5 September 1967.
Accident Report Serial No. F-462, not dated, released by the
Aircraft Accident Investigation Division, Civil Aviation
Branch, Department of Transport, Canada

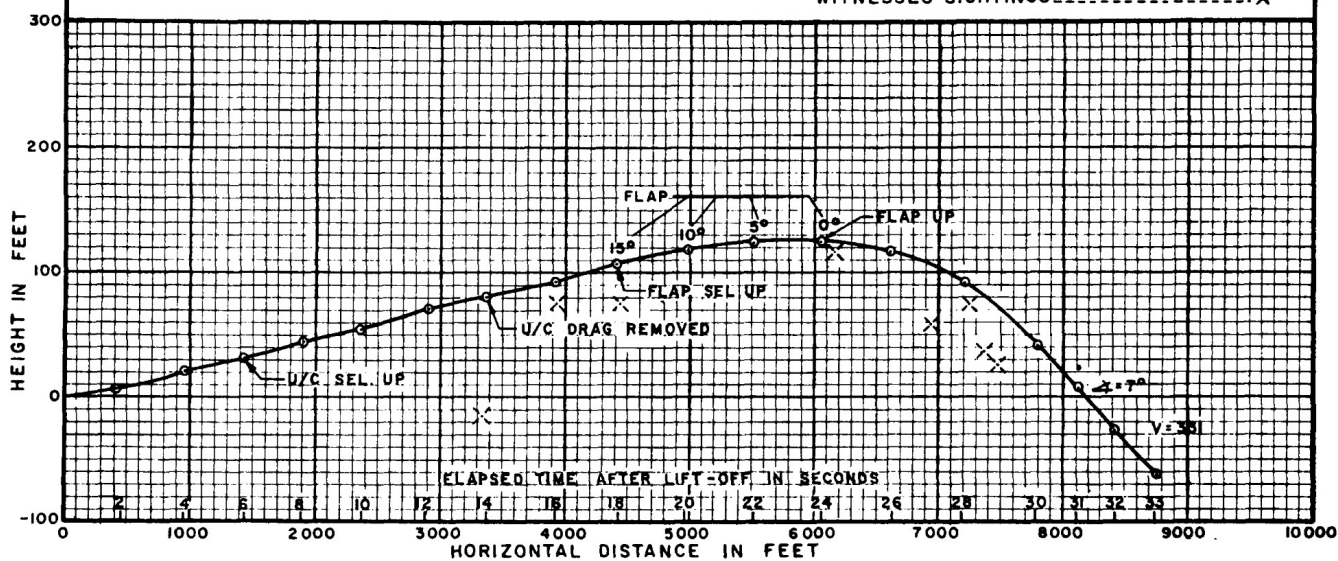
Figure 21-1

From the propeller cuts in the shrubs and initial impact marks, it was determined that the initial ground contact was made with the aircraft in an approximate 6° nose-down attitude with the wings nearly level. Calculations based on the distance between the propeller cuts and governed engine rpm, indicated that the aircraft ground speed was about 196 kt (331 ft/sec) or 363 km/hr. All pertinent reported, calculated and factual flight path and performance information was programmed in a digital computer and a series of flight paths were developed. One of the computed flight paths (see Figure 21-1) met most of the pre-determined conditions and was selected as the probable flight profile. From a study of this data the following conclusions were reached:

- (a) The aircraft could not have attained the known impact velocity if a stall had occurred;
- (b) The maximum height reached was approximately 125 ft above the point where the aircraft left the runway.

ILLUSTRATION, INCLUDING REPORTED WITNESS SIGHTINGS, OF A COMPUTER
CALCULATED FLIGHT PATH WHICH MOST NEARLY RESEMBLES THAT
ASSUMED TO HAVE BEEN TAKEN BY THE AIRCRAFT OK-WAI.
