## **1.1 RESEÑA DEL VUELO**

**El 6 de Febrero de 1996, aproximadamente a las 03:45 horas UTC. la aeronave Boeing 757, matrícula TC-GEN operada por la firma Birgenair como un vuelo fletado por la Línea Aérea Alas Nacionales se accidentó minutos después del despegue, del Aeropuerto Internacional Gregorio Luperón, Puerto Plata, República Dominicana. El vuelo se efectuaba bajo un plan de vuelo por instrumentos (IFR). La aeronave se destruyó y los 176 pasajeros y 13 tripulantes perecieron. Dicho vuelo se originó a las 03:40 con destino a Frankfurt, Alemania con escala en Gander, Canadá y Shonefeld Berlín, Alemania.**

**La causa probable del accidente fue la falta por parte de la tripulación de vuelo de reconocer la activación del sacudidor de palanca (stick-shaker) como una advertencia inminente de una entrada en pérdida aerodinámica y la falla de la tripulación de ejecutar los procedimientos para recuperación de la entrada en pérdida. Antes de la advertencia de sacudidor de palanca (Stick-shaker), existía una confusión de la tripulación de vuelo debido a indicaciones erróneas de aumento de velocidad relativa y un aviso de sobre-velocidad.**

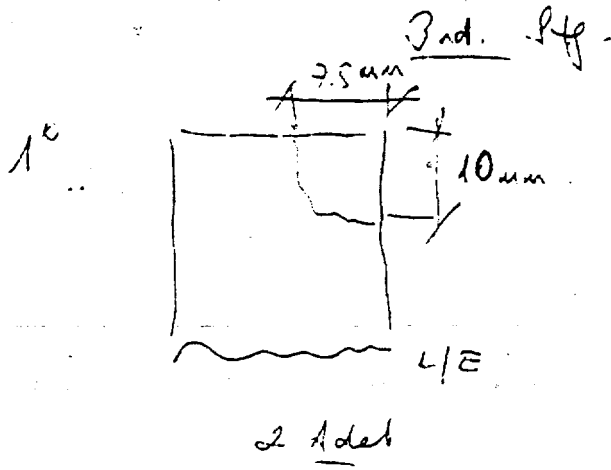
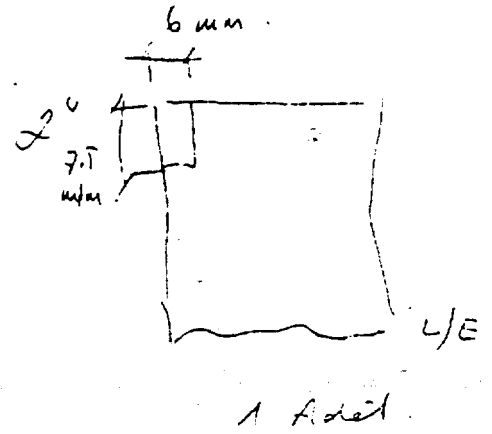
3°	Zone B.	L/E	Dent	2.5 mm.
4°	Zone B	L/E	Teal	2 mm
5°	Zone A	L/E	Dent	1 mm.
6°	Zone A	L/E	Dent	1.5 mm.

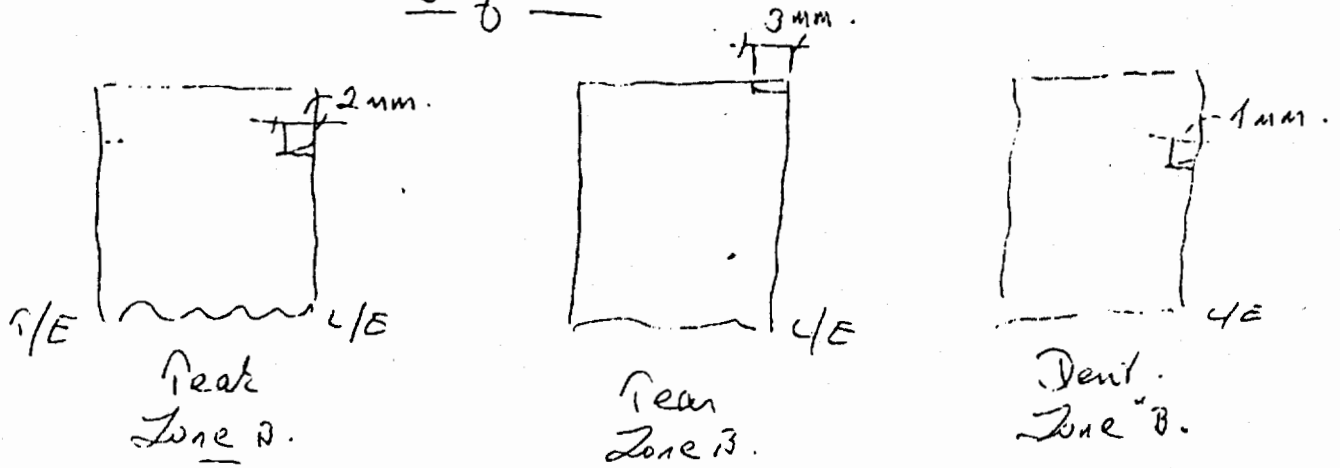
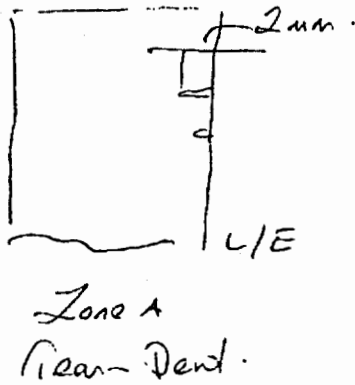
Fig 4

- ⑤ - Three blades have nicks in leading edge and Zone B. Ranging from 2mm long x 2mm deep.
- One blade has nicks in leading edge Zone A. Ranging from 2mm long x 2mm deep.
  - Four blades have bends and dents in leading edge and Zone B. Ranging from 2mm long x 2.5mm deep.
