#### FINAL REPORT of AIR ACCIDENT

airplane, Challenger CL-604 (CL-600-2B16)

D-ARWE (Federal Republic of Germany)

25 December 2007, 21 h 02 min UTC

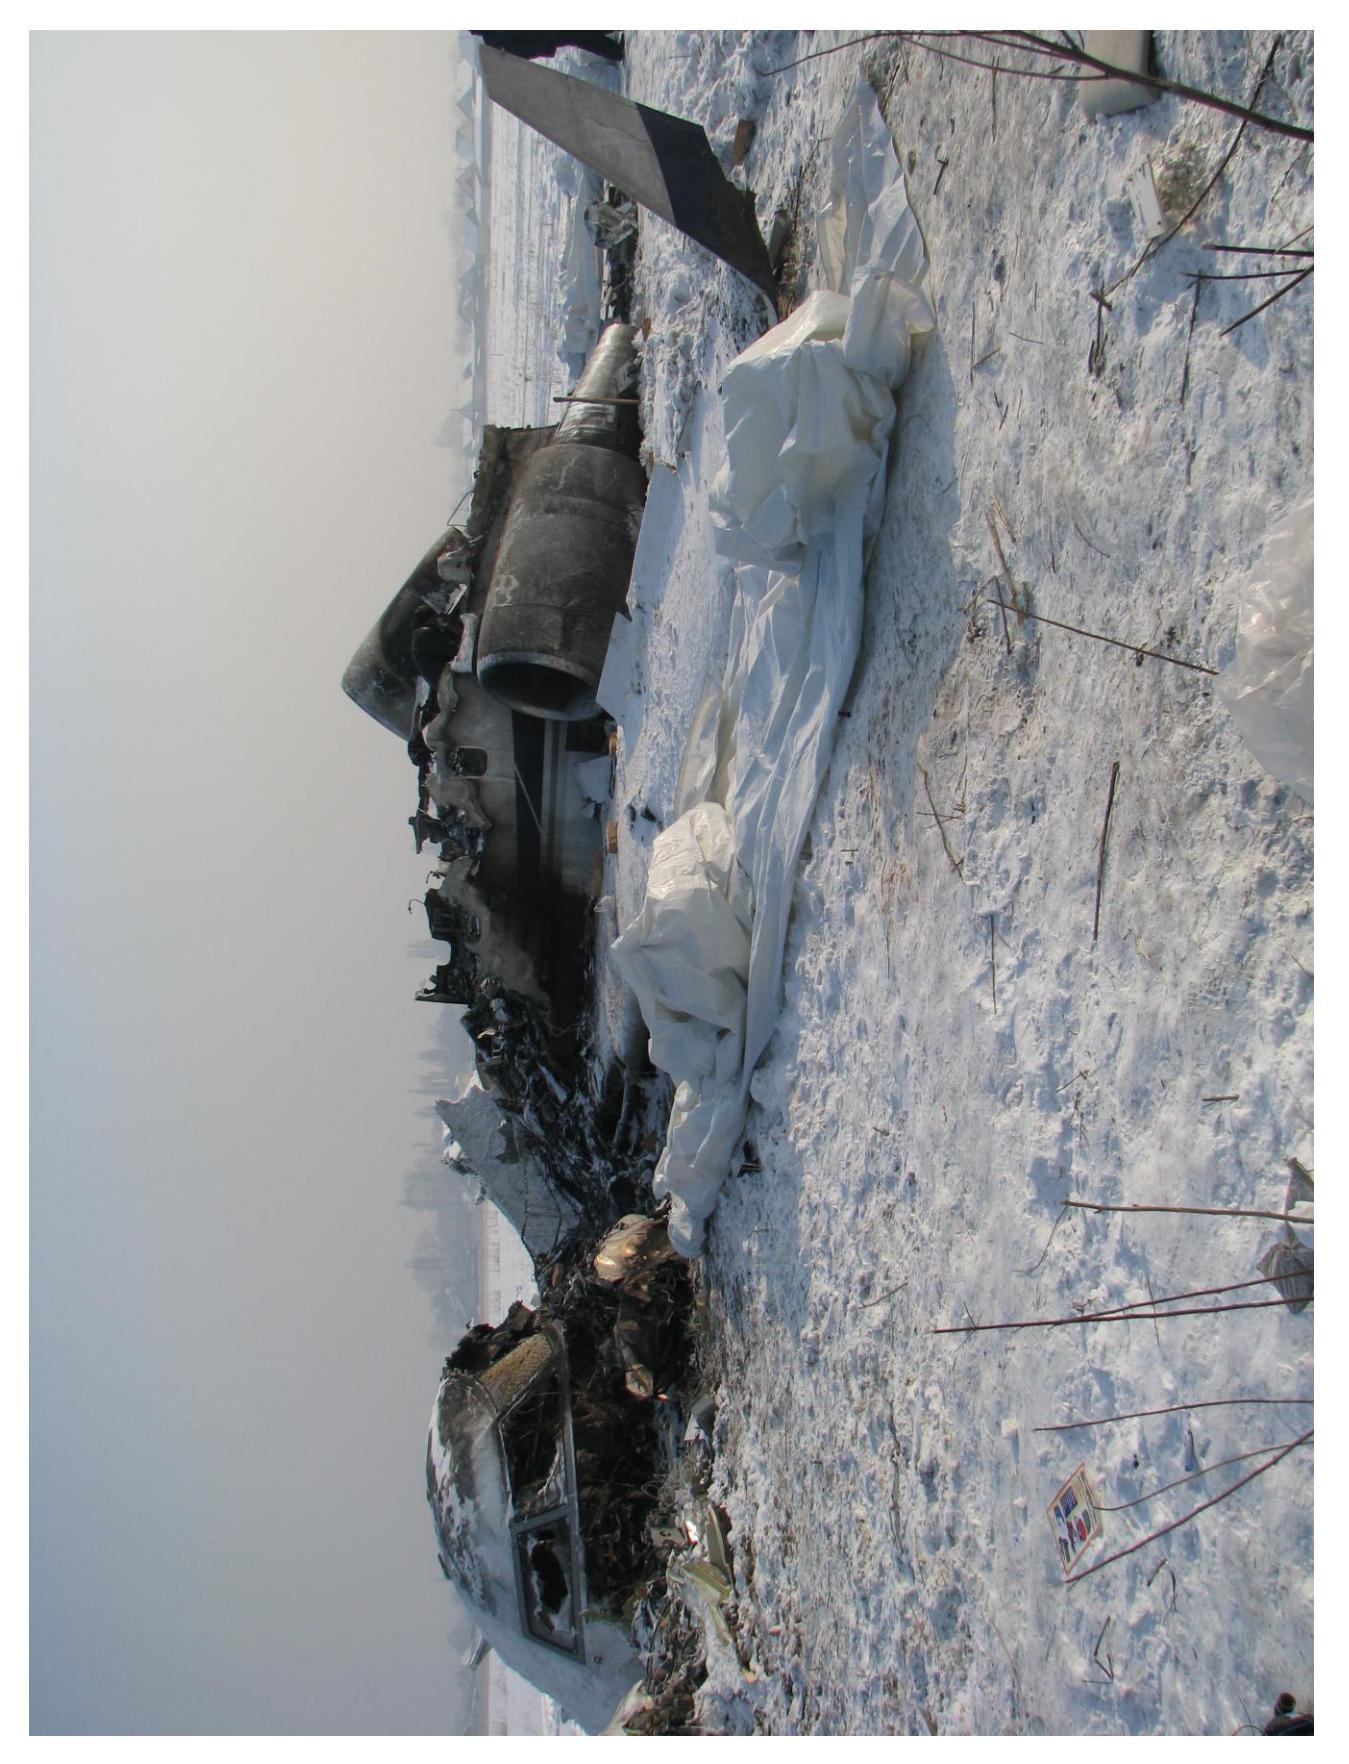
The turn was probably abrupt enough to destroy the fuselage into three large fragments – cockpit, middle and tail part of the fuselage, forming by the time they finally stopped a compact group of wreckage (Figure 1). Further, probably due to the emerged ground fire the aircraft was significantly burnt.

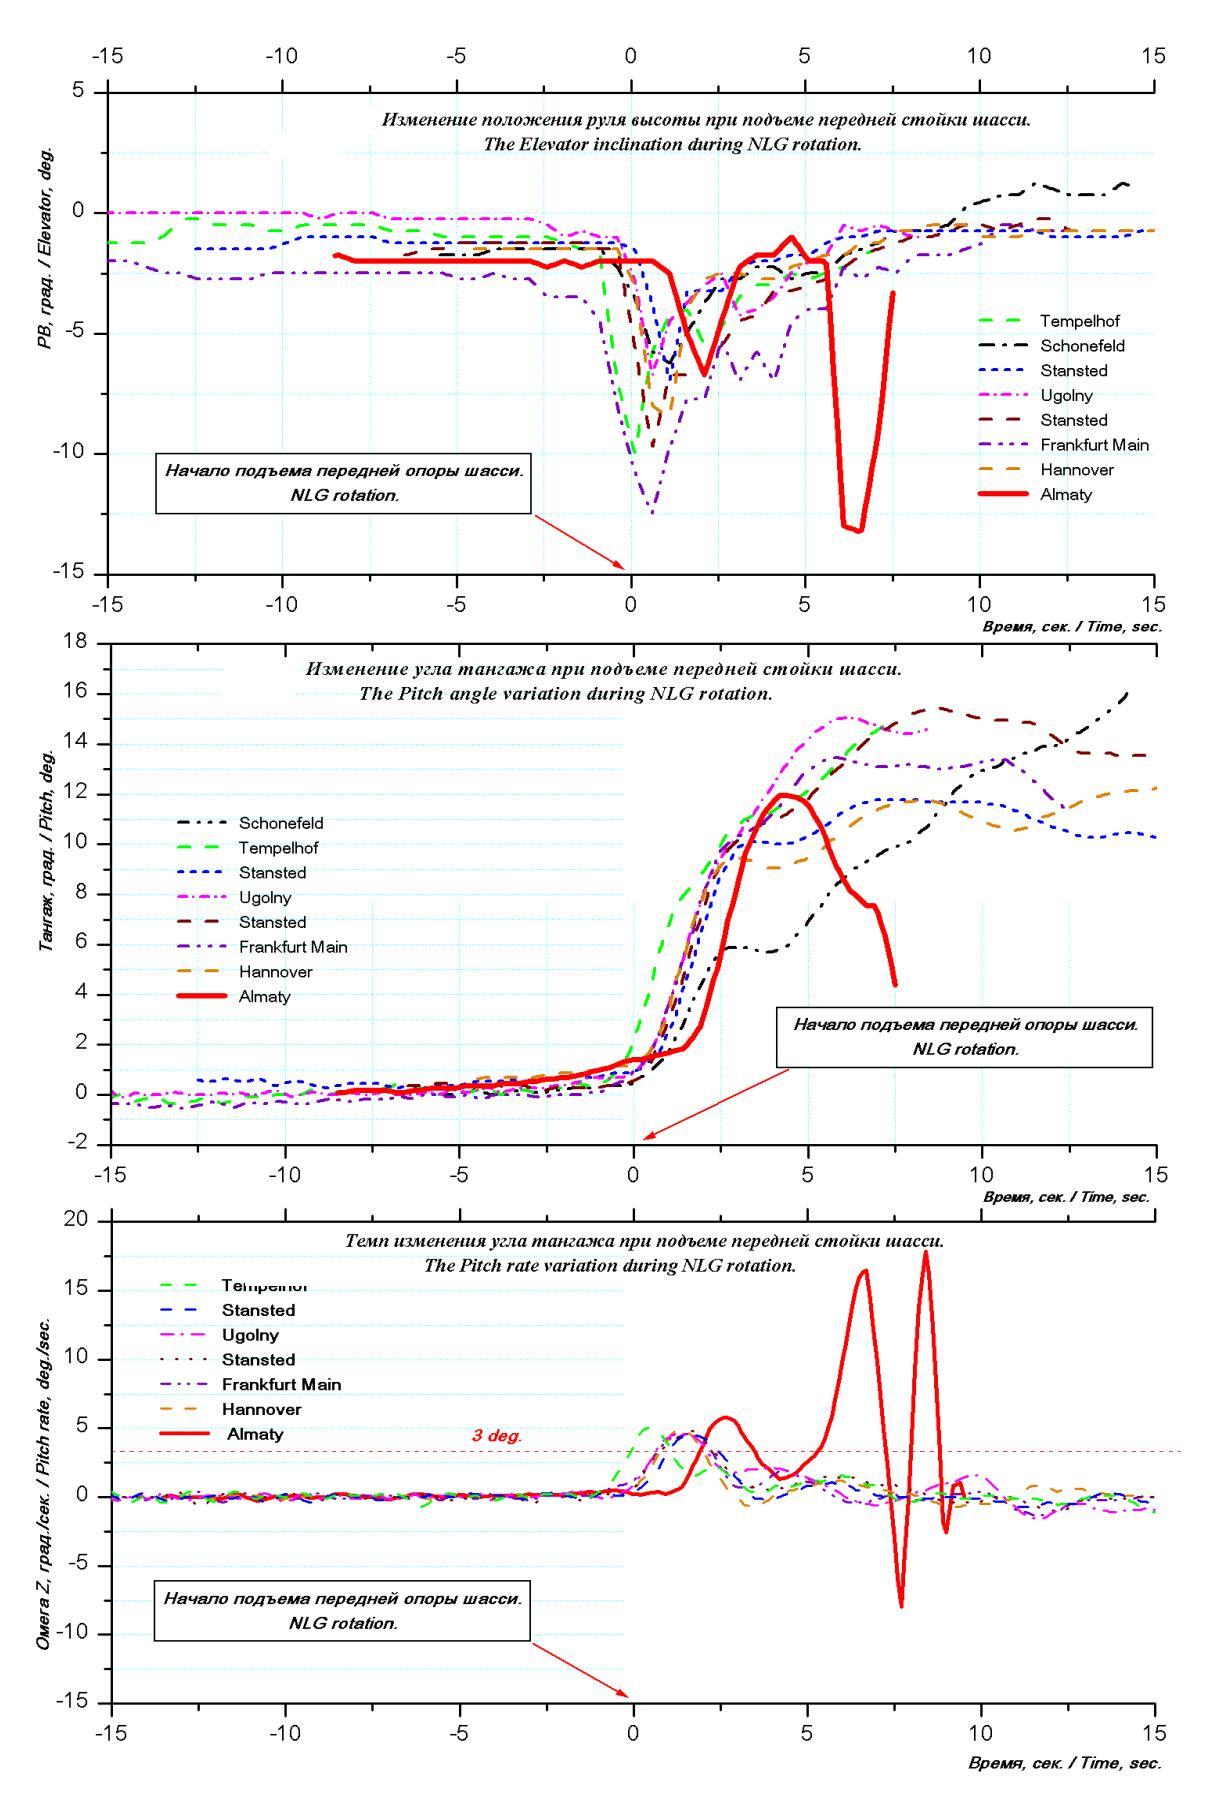
Figure 5. Changes in the elevator position and pitch angle of the CL-604 D-ARWE aircraft at liftoff

The rotation started at 21:02:17 at a speed of 150 knots. Further the co-pilot pushed the control column and by 21:02:17,5 the elevator reached -2,2°, i.e. close to its position during the takeoff run. It could be assumed that by pushing the control column the pilot was trying to decrease the intensity of the increasing pitch angle. According to the CL-604 OM (Part 1, Chapter 6 "Supplementary Procedures", Section "Cold weather Operations", Para 8.E.) it is not recommended to exceed the rate of rotation (pitch rate) more than 3 degrees per second. The crew must be ready for higher than usual increase of initial climb speed.

According to the estimations the pitch rate during the takeoff run of the CL-604 D-ARWE within 21:02:16,5... 21:02:17,5 peaked at 5,8 degrees/second, which is twice as high as the maximum limit. The analysis of the FDR data for the previous flights revealed that in almost all flights the pitch rate exceeded the established limitations (Figure 5). Most probably this was caused by the fact that the crew could not monitor this parameter with use of flight instruments. Therefore, when assessing pitch rate the crew has to rely on their personal sensations.
