National Transportation Safety Board Aviation Accident Final Report

Location:	Plain City, Ohio	Accident Number:	CEN19FA100
Date & Time:	March 17, 2019, 17:45 Local	Registration:	N424TW
Aircraft:	Cessna 421	Aircraft Damage:	Destroyed
Defining Event:	Loss of control in flight	Injuries:	1 Fatal
Flight Conducted Under:	Part 91: General aviation

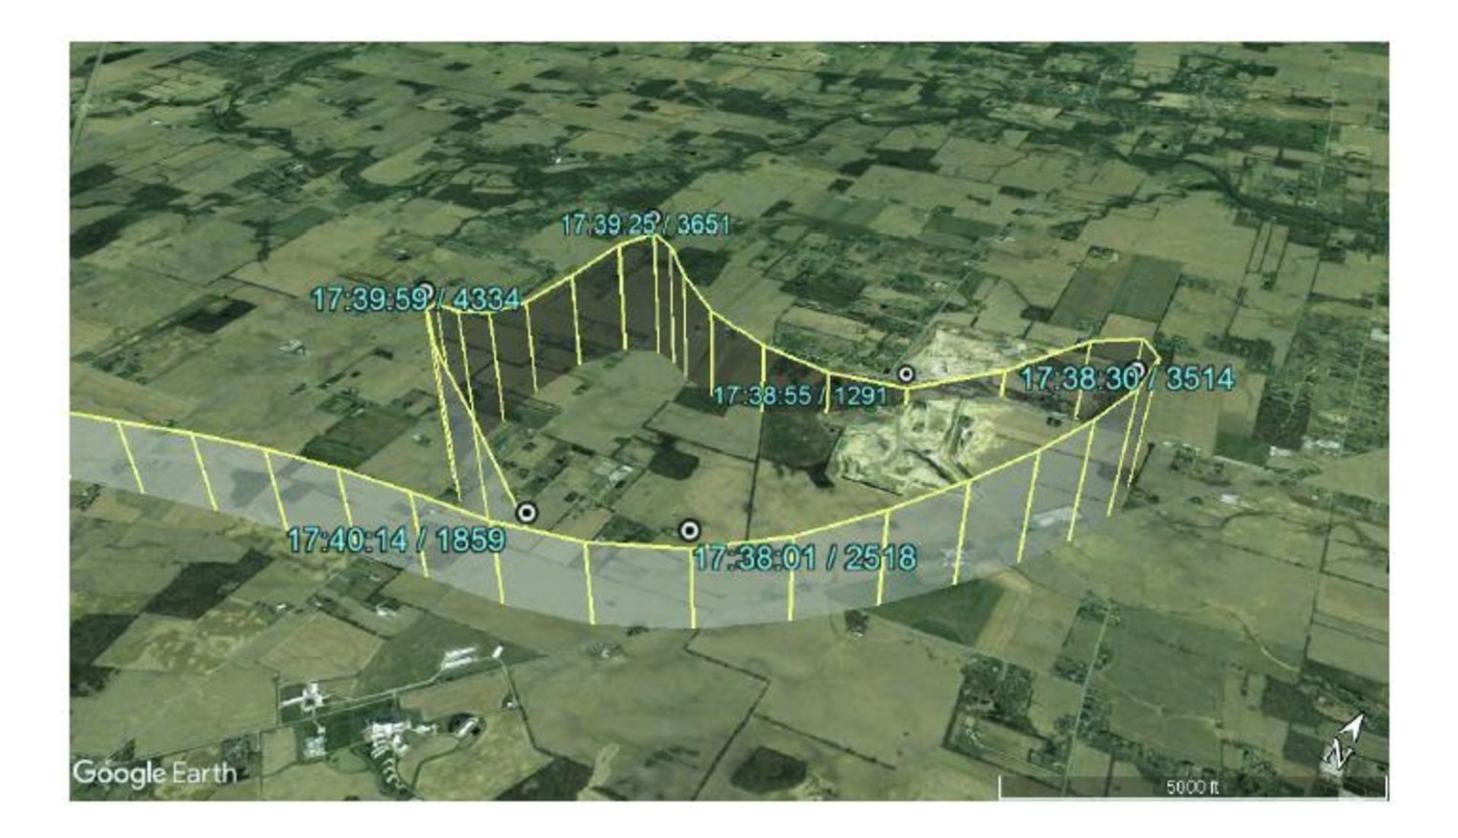
Figure 1: Airplane's Final Flight Track

A review of recovered data from onboard avionics indicated that, about 17 minutes after takeoff, the airplane's indicated airspeed began to decay while its groundspeed, as calculated from position information, remained steady. About 1 minute later, fuel flow increased from 38 gallons per hour (gph) to 60 gph, consistent with an increase in engine power. At this time, the indicated airspeed had decayed to about 100 knots (kts), while the groundspeed remained about 150 kts. For the final approximate 2.5 minutes of the flight, the airplane was in a left turn. The airplane entered a climb to about 3,500 ft msl, then began descending around 5,000 ft per minute. The data recorded "SINK RATE" and "PULL UP PULL UP" annunciations, and the airplane's rate of descent was arrested about 300 ft above ground level (agl). The airplane subsequently entered two additional sets of climbs and descents, receiving the same annunciations; however, the pilot did not recover from the third descent. During this time, the airplane's groundspeed, and likely airspeed, exceeded the airplane's maneuvering speed (Va) of 150 kts, and during both the first and final "SINK RATE" annunciations, the airplane's groundspeed exceeded its maximum structural cruising speed (Vno) of 200 kts.
