# **Aviation Investigation Final Report**

Location:	Hattiesburg, Mississippi	Accident Number:	CEN21FA209
Date & Time:	May 4, 2021, 23:01 Local	Registration:	N322TA
Aircraft:	Mitsubishi MU2B	Aircraft Damage:	Destroyed
Defining Event:	Loss of control in flight	Injuries:	4 Fatal, 2 Minor
Flight Conducted Under:	Part 91: General aviation - Personal

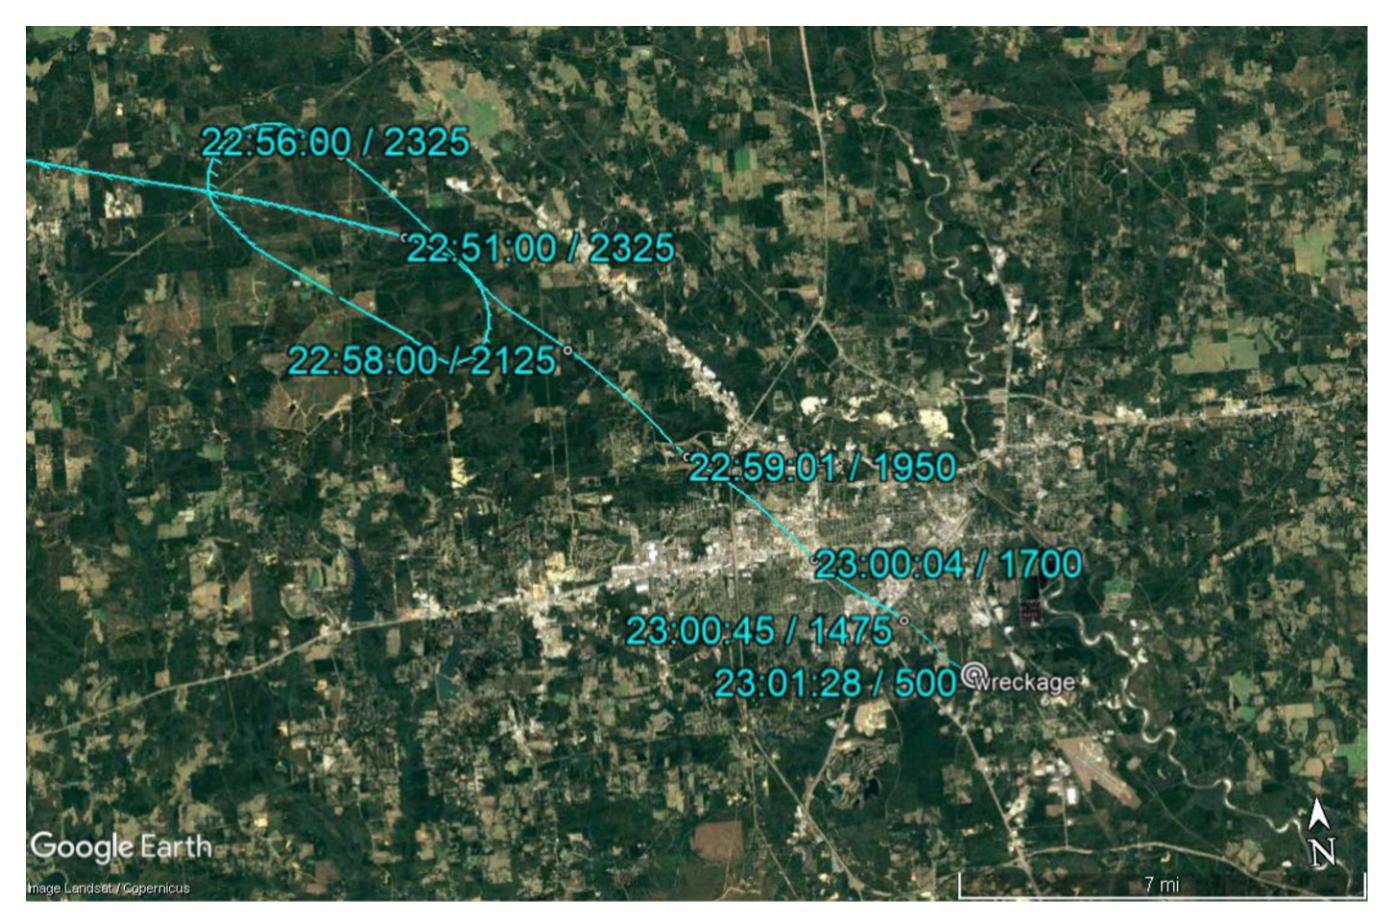
Automatic Dependent Surveillance–Broadcast (ADS-B) data provided by the Federal Aviation Administration captured the accident flight. About 2251, the pilot began to fly the procedure turn for the RNAV approach; at 2252:12, the airplane's airspeed was 88 knots. The airspeed fluctuated before the airplane accelerated back to 140 knots as the airplane crossed HILGA and descended to 2,000 ft msl. As the airplane approached the final approach fix (CUPPA), the airplane descended before the fix and crossed it 300 ft low. The airplane's descent stopped for about 30 seconds, and the airplane then descended about 1,300 ft per minute. The airplane's airspeed decreased as the airplane continued to descend; at 2301:24, when the airplane's airspeed was about 85 knots its altitude was 500 ft msl. The last recorded data point showed the airplane at an altitude of about 460 ft msl and 750 ft from the accident site. The airplane impacted the front of an occupied residence, and a postimpact fire ensued. Figure 1 shows the airplane's approach path and wreckage location.

Figure 1. Airplane's approach path with accident site location with times and altitudes annotated.

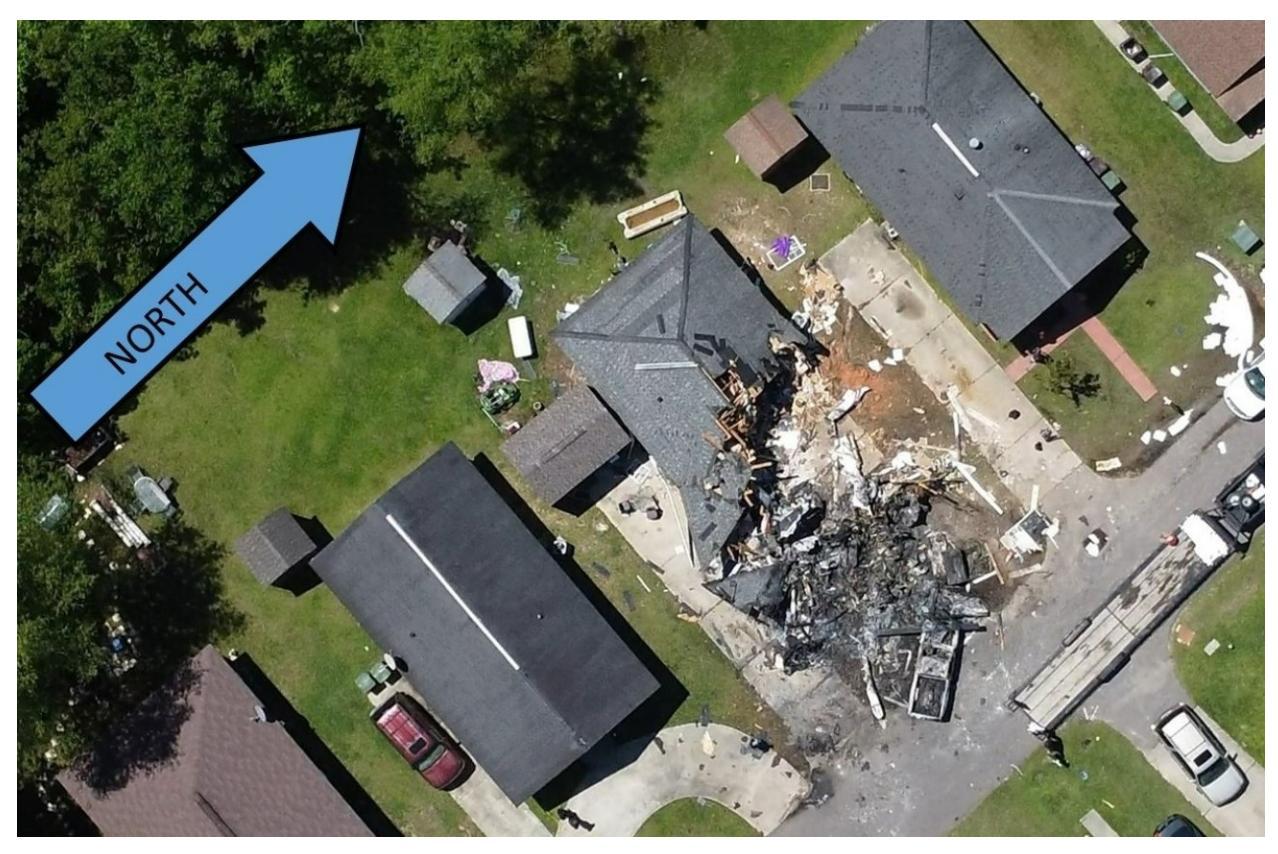
The accident site was located 2.24 miles from the approach end of runway 13. The postimpact fire consumed most of the airplane and the residence. The accident site was largely contained to one area with a small debris field, consistent with a low-energy impact, as shown in figure 2.

Figure 2. Accident site.
