# **Aviation Investigation Final Report**

Location:	Bethel, Alaska	Accident Number:	ANC22LA007
Date & Time:	November 20, 2021, 17:55 Local	Registration:	N9794M
Aircraft:	Cessna 207A	Aircraft Damage:	Substantial
Defining Event:	Fire/smoke (non-impact)	Injuries:	6 None
Flight Conducted Under:	Part 135: Air taxi & commuter - Scheduled

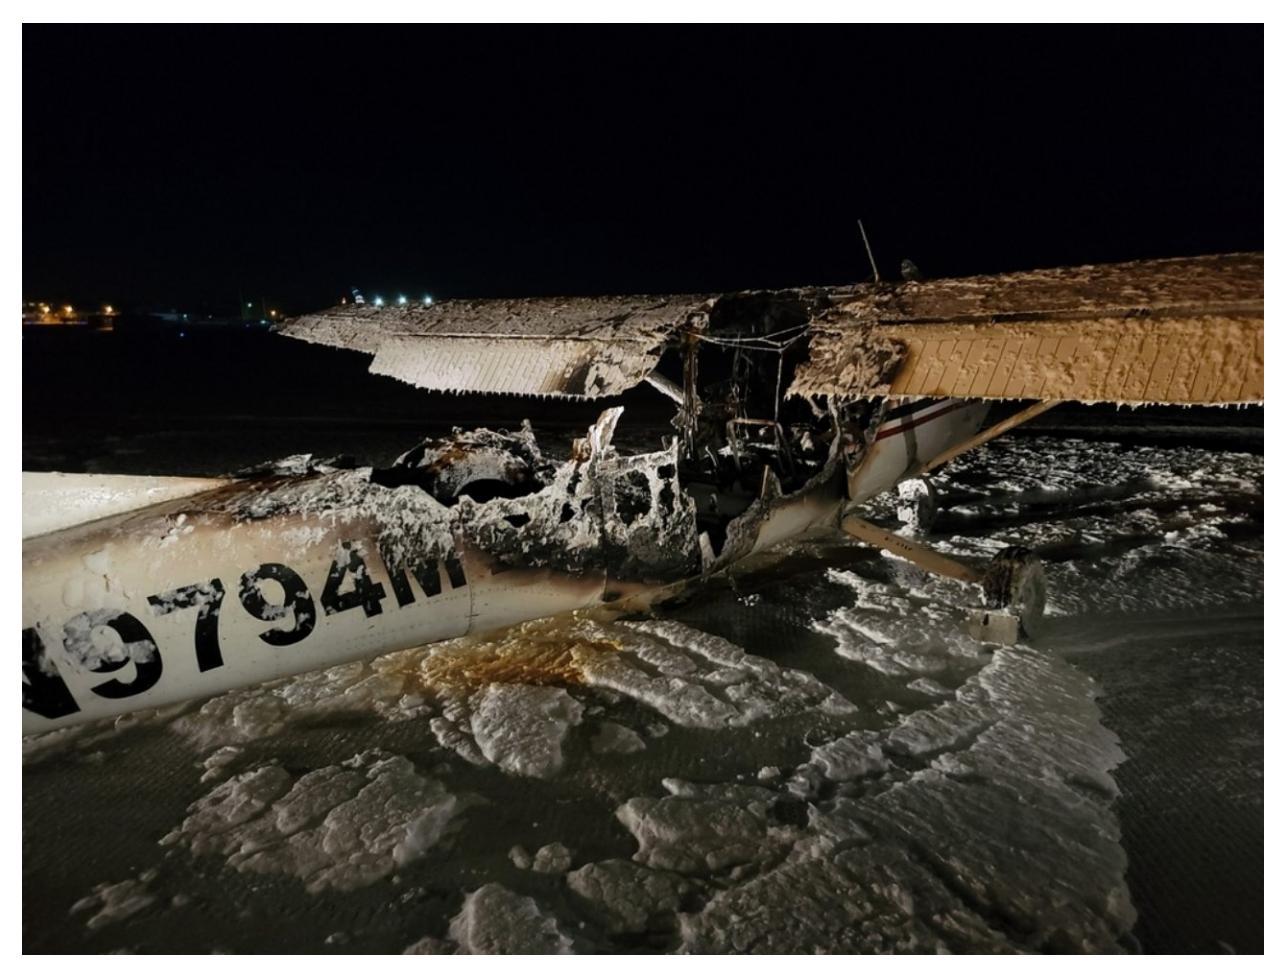
The pilot reported that after all the passengers had safely departed the airplane, heavy smoke filled the cockpit and passenger compartment, and he saw a candle-like flame behind the pilot and co-pilot seats, just beneath the floorboards of the airplane. Moments after all the passengers and pilot had exited the airplane, it was immediately engulfed in flames. See figure 1.

Figure 1 Photo of accident airplane while still on Runway 1L.
