Aviation Investigation Final Report

Location:	Medford, Oregon	Accident Number:	WPR22FA055
Date & Time:	December 5, 2021, 16:52 Local	Registration:	N64BR
Aircraft:	Piper PA-31-350	Aircraft Damage:	Destroyed
Defining Event:	Unknown or undetermined	Injuries:	2 Fatal
Flight Conducted Under:	Part 91: General aviation - Personal

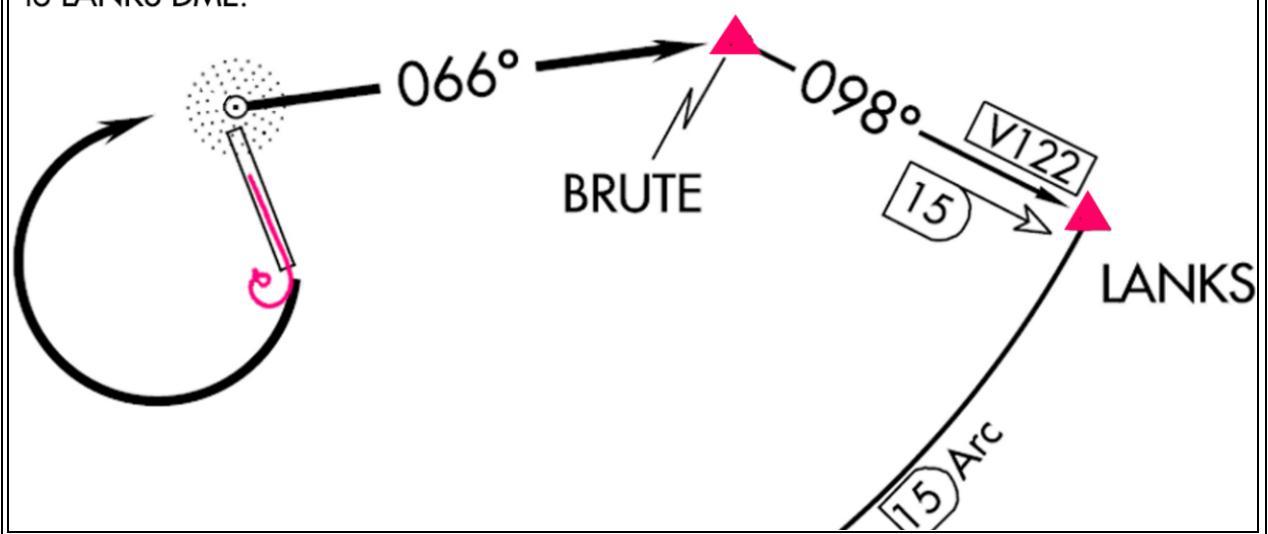
Figure 1: The Airplane's Flight Track Overlayed a Visual Depiction of the BRUTE7 Departure

The exact radio communication times could not be confirmed for the accident flight. The pilot received an instrument flight rules (IFR) clearance and was issued the BRUTE7 departure procedure with the LANKS transition. The published BRUTE SEVEN Standard Instrument Departure (SID) with a takeoff from runway 14 consisted of a "climbing right turn direct MEF [Medford] NDB [nondirectional beacon]," and continue to the BRUTE intersection on a bearing of 066°.

After receiving the clearance, the controller informed the pilot the overcast layer base was at 200 ft above ground level (agl) the tops of the layer was at 2,500 ft. After the airplane departed the pilot made a radio communication to the controller asking "will you be calling my turn for the BRUTE7?" The controller replied that he would not be calling his turn and that the pilot should fly the departure as published making a climbing right turn to overfly the approach end of runway 14 before proceeding to the BRUTE intersection (Figure 1 below). The pilot acknowledged the communication, which was his last transmission. Several seconds later, the controller stated that he was receiving a low-altitude alert that the airplane's altitude was showing 1,700 ft. He made several attempts to reach the pilot with no response.

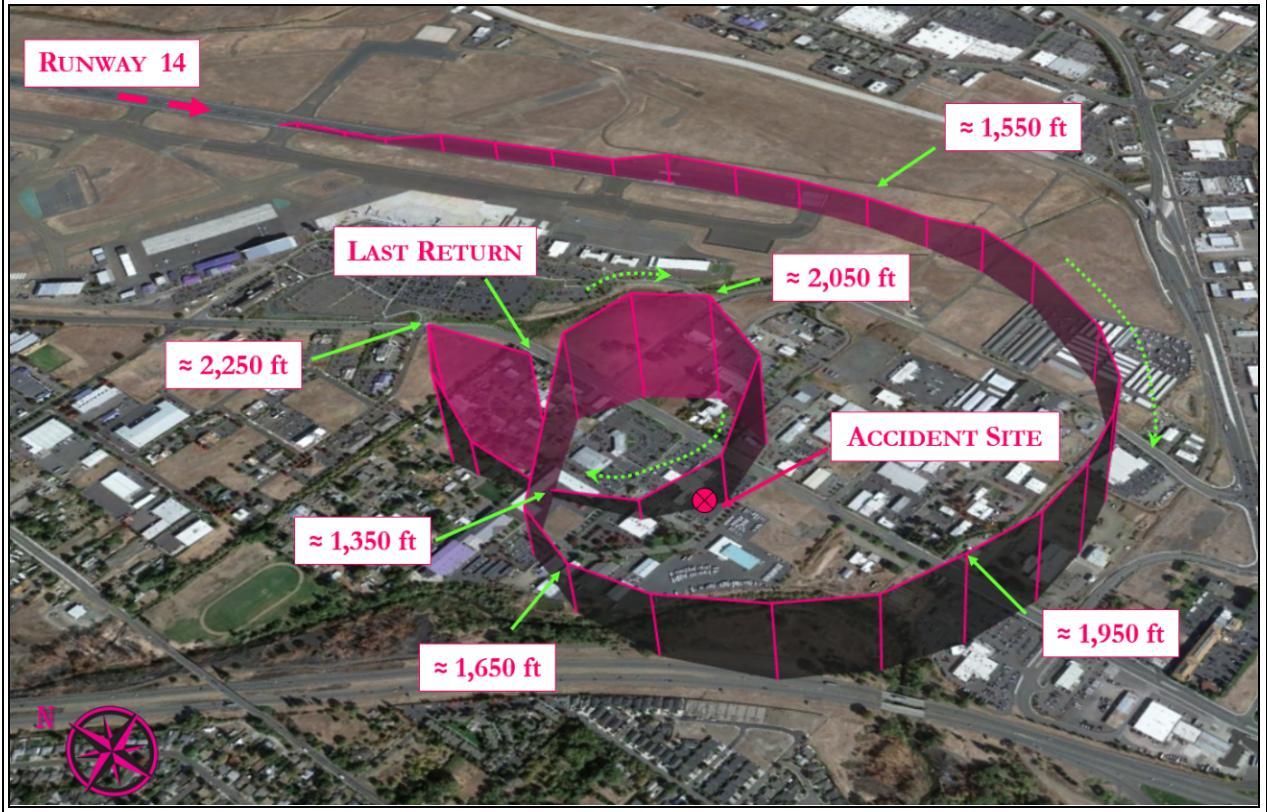
Figure 2: The Airplane's ADS-B Flight Track

The radar and automatic dependent surveillance-broadcast (ADS-B) information indicated that the airplane arrived in the run-up area for runway 14 about 1643 and then continued onto the runway about 6 minutes thereafter. The airplane departed about 1649:30 and, after crossing over the south end of the runway, it climbed to about 1,550 ft mean sea level, equivalent to 200 ft agl (Figure 2 below). The airplane then began a gradual right turn and climbed to 1,950 ft, maintaining an airspeed between 120-130 kts. As the airplane turn continued to the north, the altitude momentarily decreased to 1,650 ft (about 350 ft agl) with the airspeed increasing to 160 kts. Thereafter, the airplane then increased the bank angle and made a 360-degree turn, initially climbing to 2,050 ft. At the completion of the turn, the airplane descended to 1,350 ft, consistent with it maneuvering below the cloud layer. The airspeed increased to about 160 kts and several seconds later, the airplane climbed to 2,250 ft with the derived airspeed showing below 15 kts. Six seconds later was the last radar return, located about 990 ft north-northwest of the accident site.

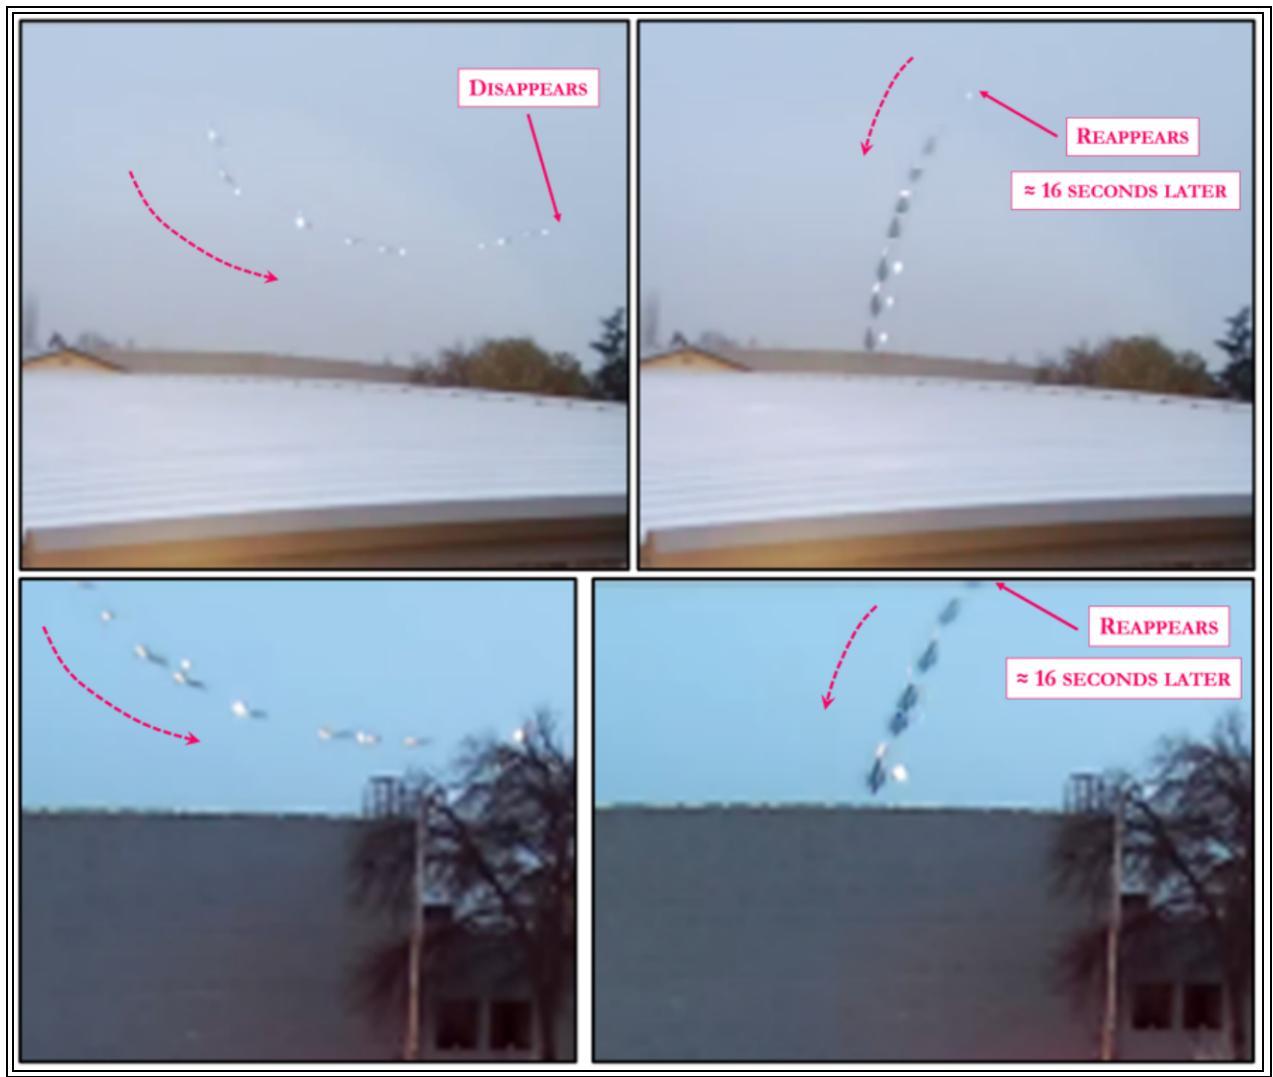
Figure 3: Excerpts of Security Camera Footage

Video footage was obtained from several fixed security cameras on buildings around the accident site. A review of the footage revealed that the airplane descended below the cloud layer and then climbed back up. About 16 seconds thereafter, the airplane is seen descending in a near-vertical attitude (Figure 3 below). The airplane's position and strobe light appeared to be illuminated throughout the video.

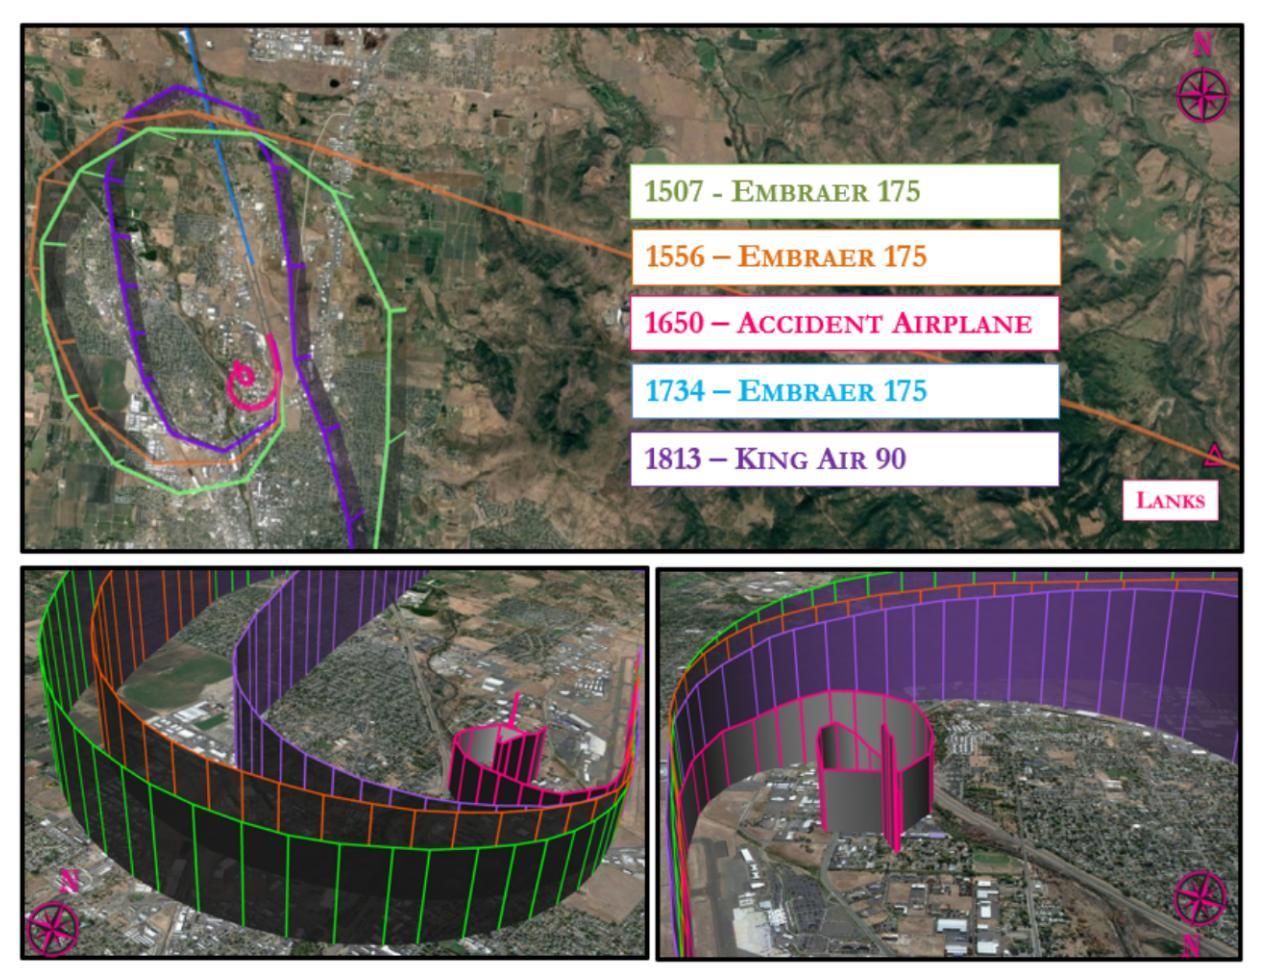
Figure 4: Other Departures Flight Paths Before and After the Accident Flight

Investigators compiled a comparison of ADS-B data from two airplanes that departed before the accident airplane (at 1507 and 1556) and two that departed after (1734 and 1813). A

comparison of flight tracks from the three airplanes that departed runway 14 revealed that the accident airplane had started its right turn earlier than the other three airplanes, and the radius of its turn was tighter than the other three airplanes. (Figure 4 below).
