Piper PA31-350 Chieftain VH-MZK Spencer Gulf SA

31 May 2000

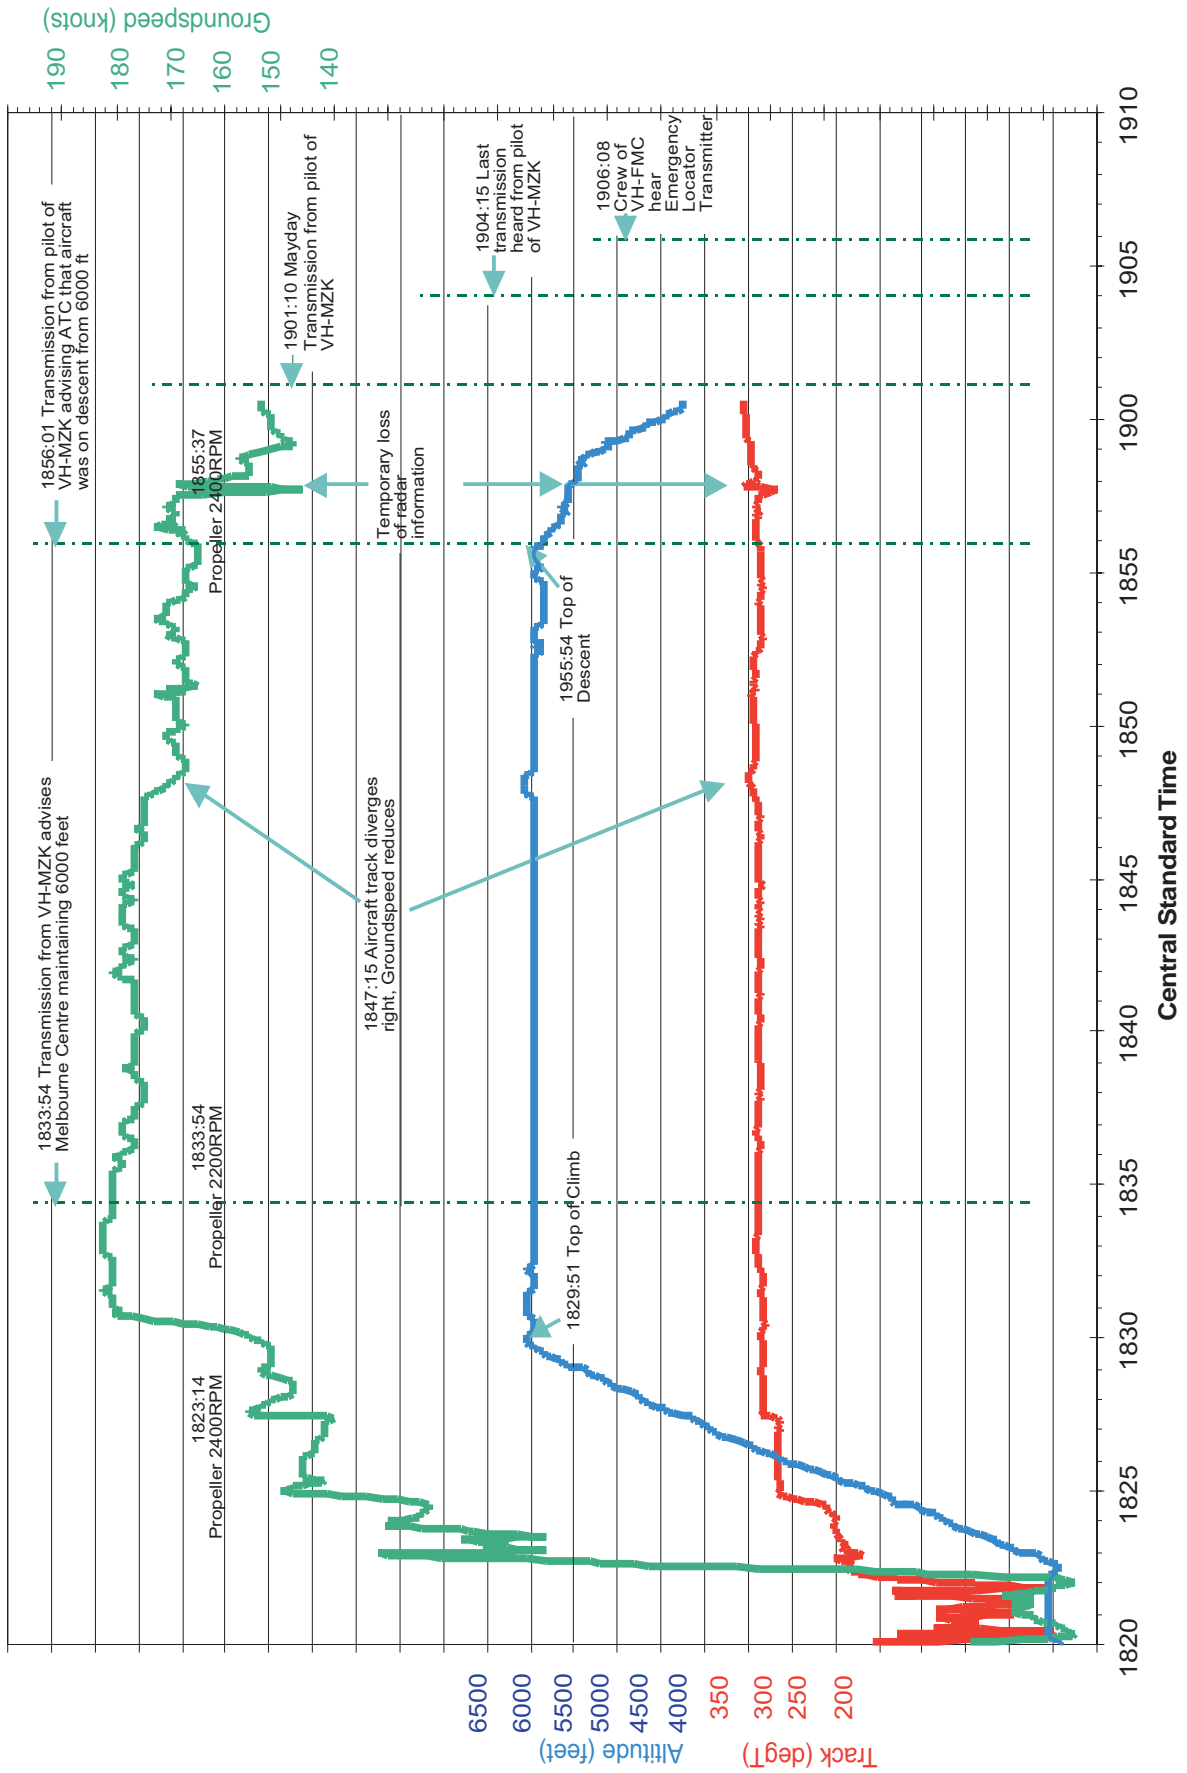
1.2 Injuries to persons

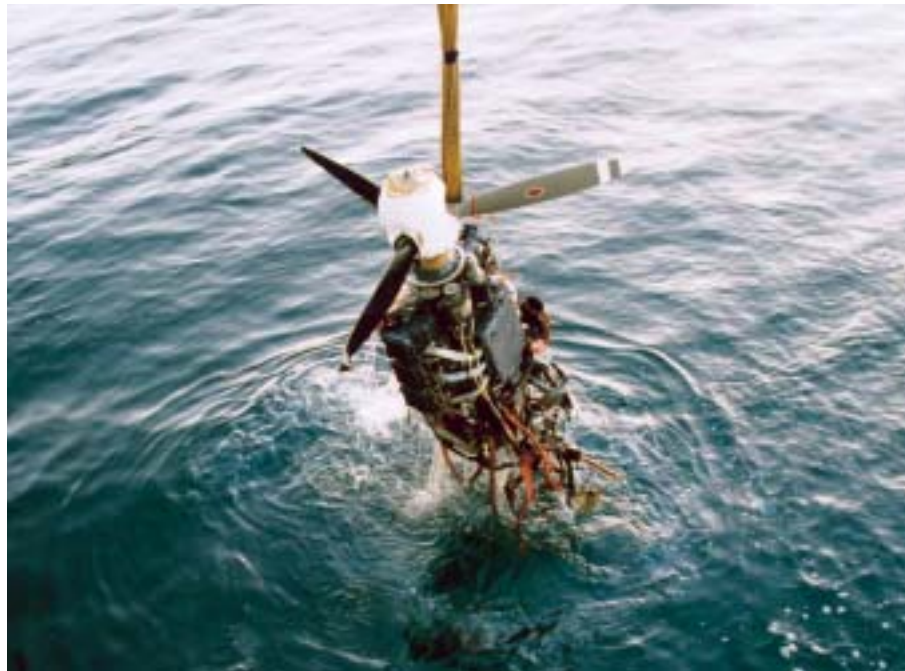
**Figure 11:
Left engine/propeller**

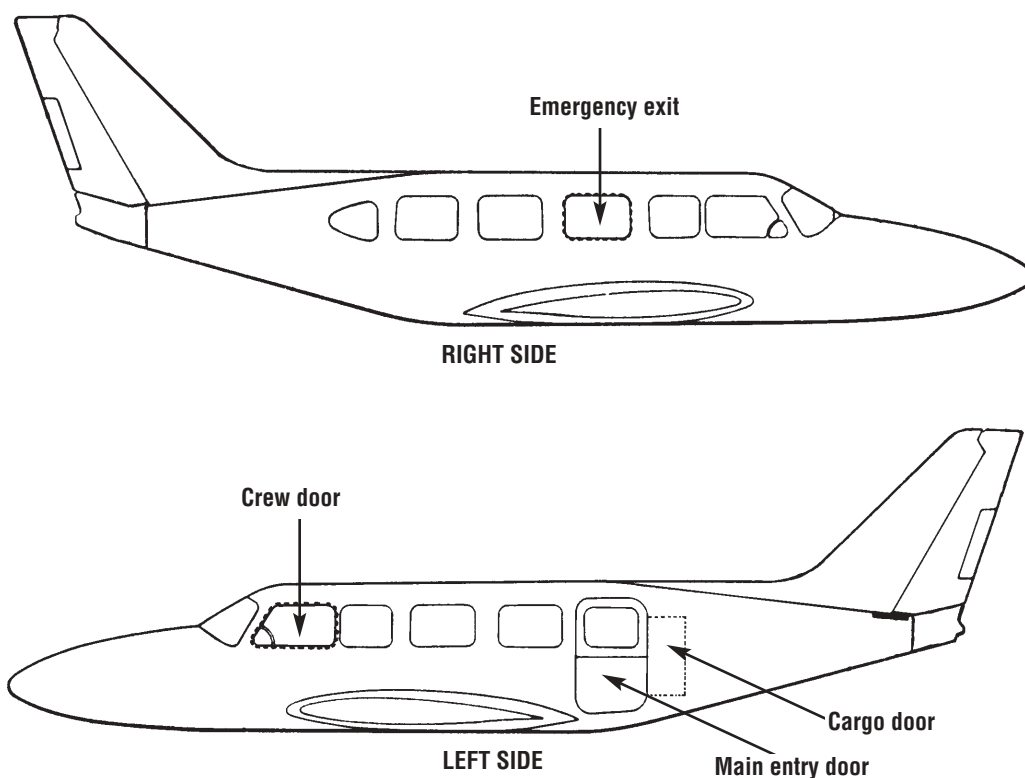
Figure 12:
Location of Windows, doors and emergency exit.

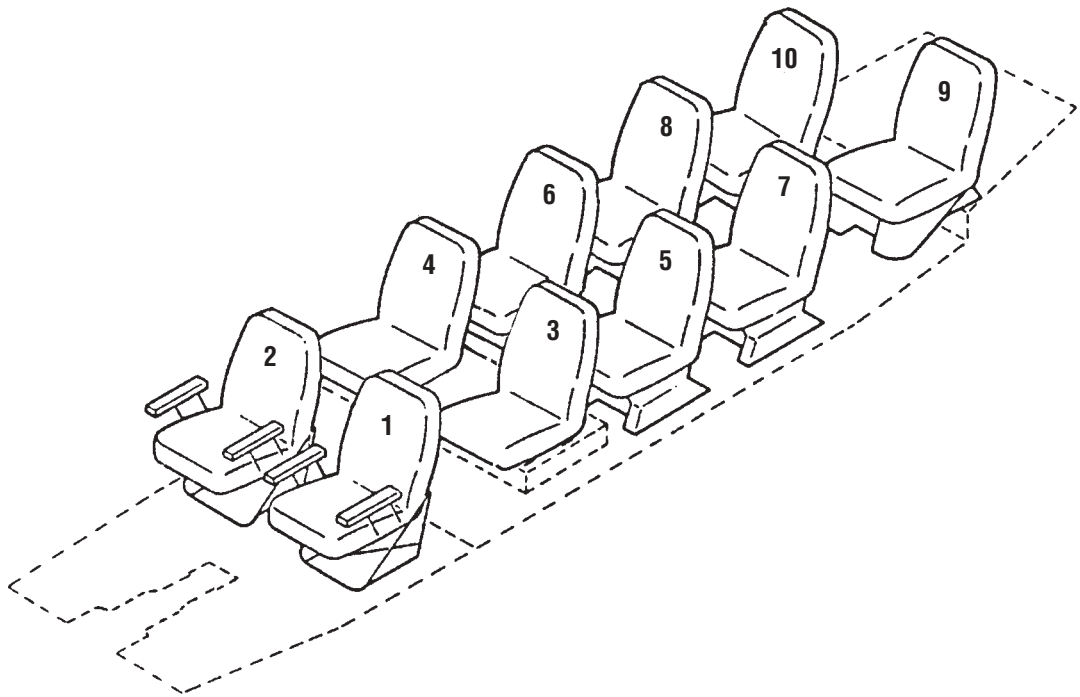
**Table 4:
Results of seat and seat harness examination**

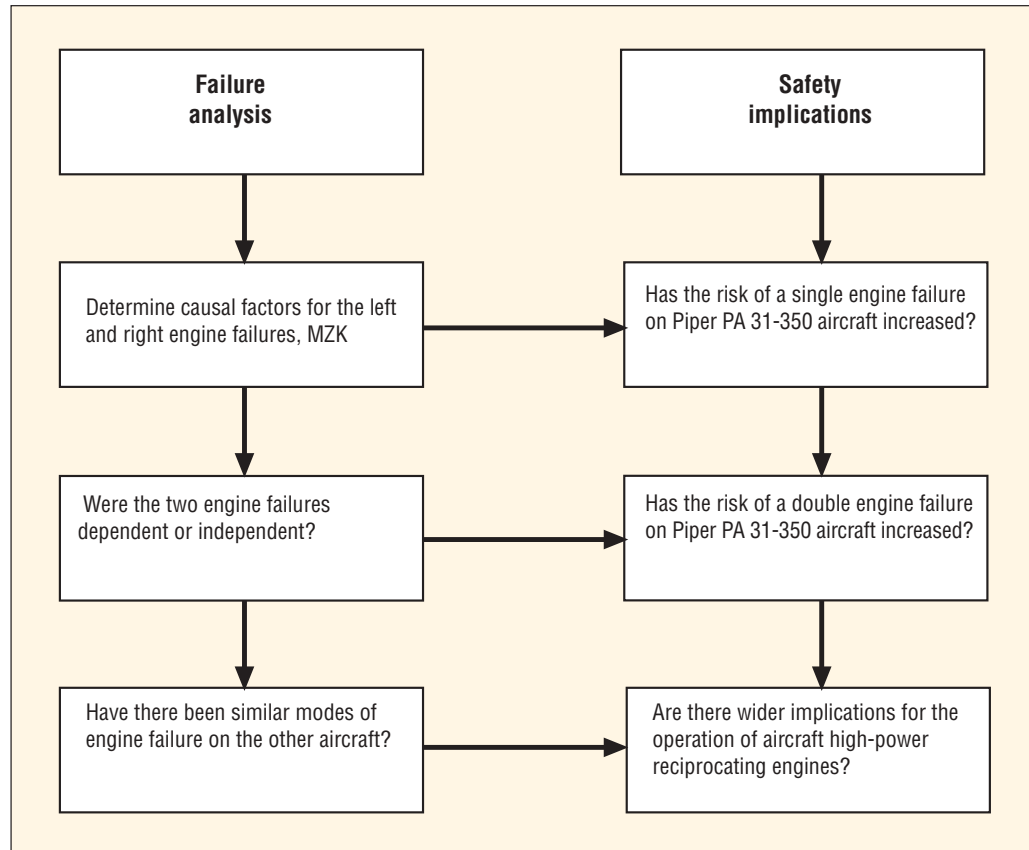
1.17.2 Right propulsion system failure analysis

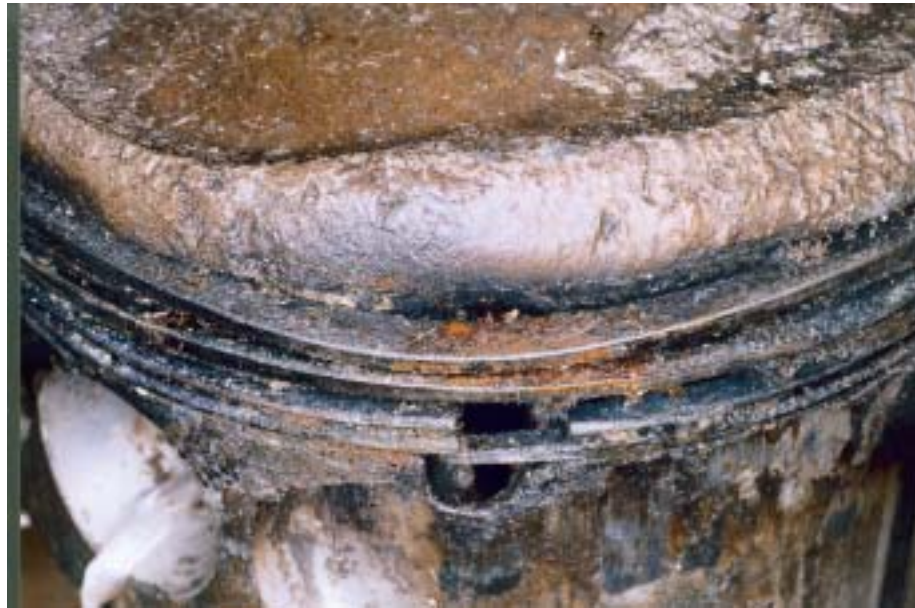
Figure 15b:
The microstructure of the Number 6 piston in the region affected by overheating

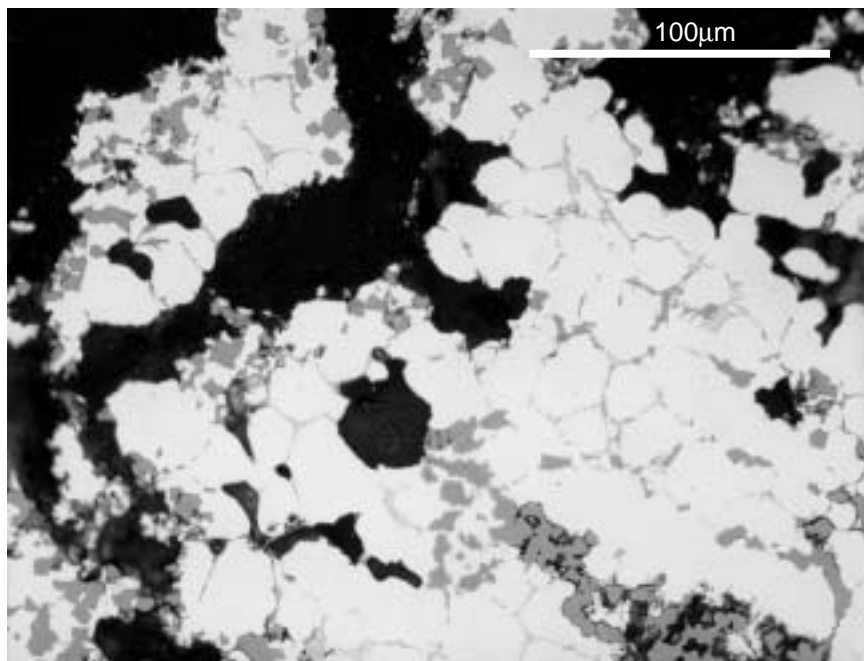
It was also noted during the disassembly examination that material had been lost from the combustion chamber surface of the Number 6 cylinder head. The region of material loss was confined to an area extending from the upper spark plug to the exhaust valve seat (see fig. 16). Molten material from the piston and cylinder head had solidified on the spark plugs fitted to the cylinder. Non-destructive examination of the spark plug electrode region at magnifications up to 20X, revealed that the ceramic insulator surrounding the electrode was intact.

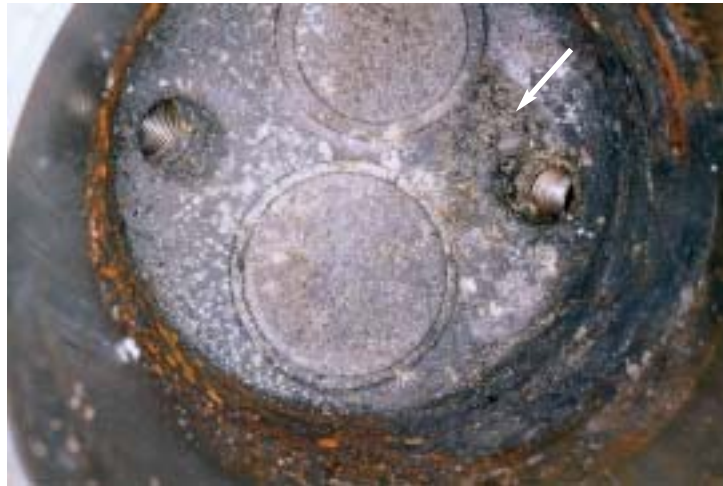
Figure 16b:
The spark plugs removed from the Number 6 cylinder, right engine MZK, showing the deposits of aluminium alloy on the electrodes, top (a), bottom (b)

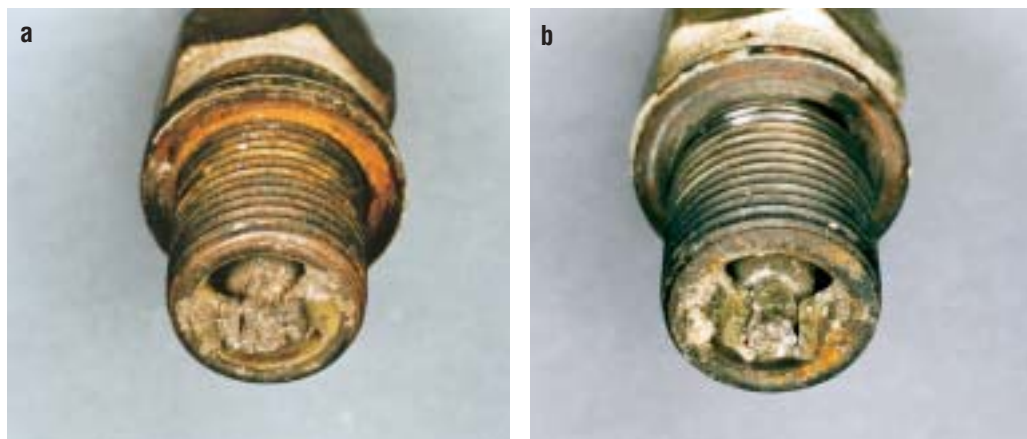
Characteristics of the defect

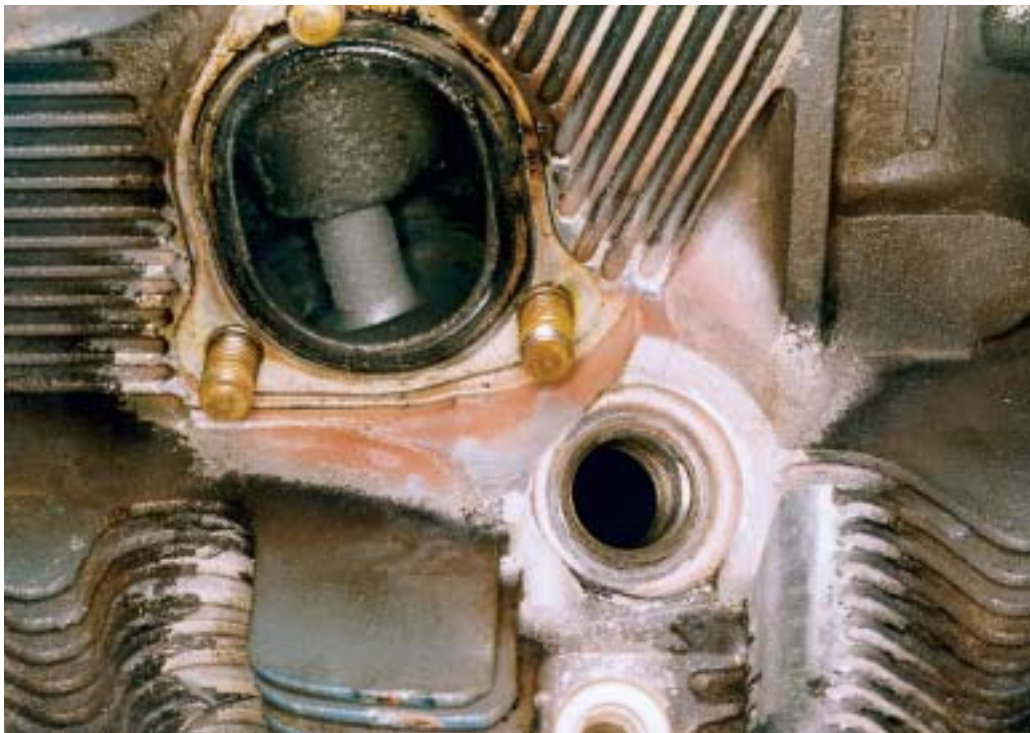
Figure 17:
View of Lycoming T10-540 cylinder head showing the relationship between the upper spark plug and the exhaust port

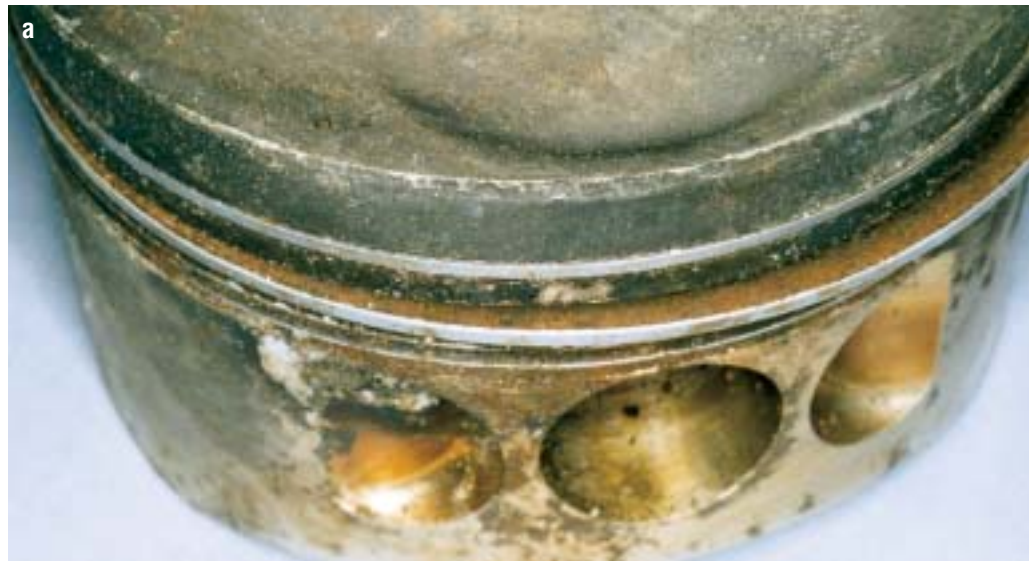
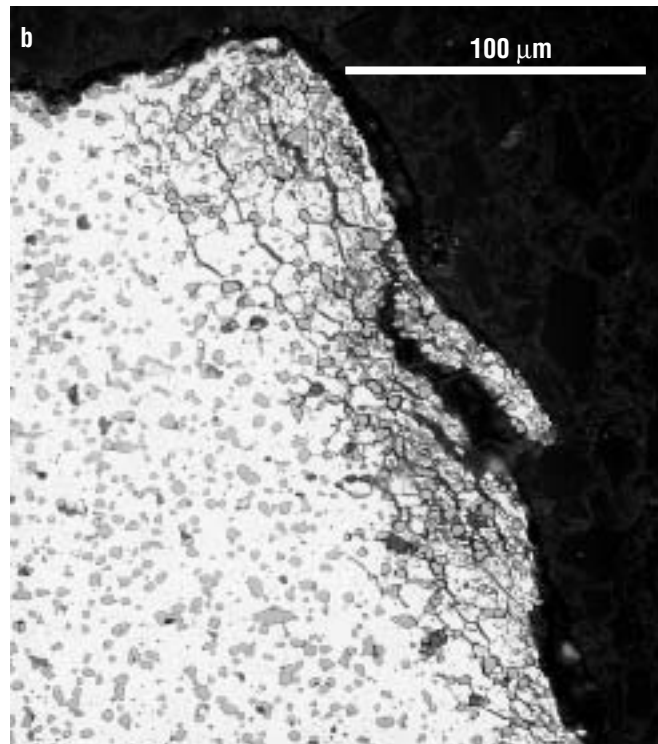
Localised melting of the cylinder head combustion chamber surface was restricted to the Number 6 cylinder.

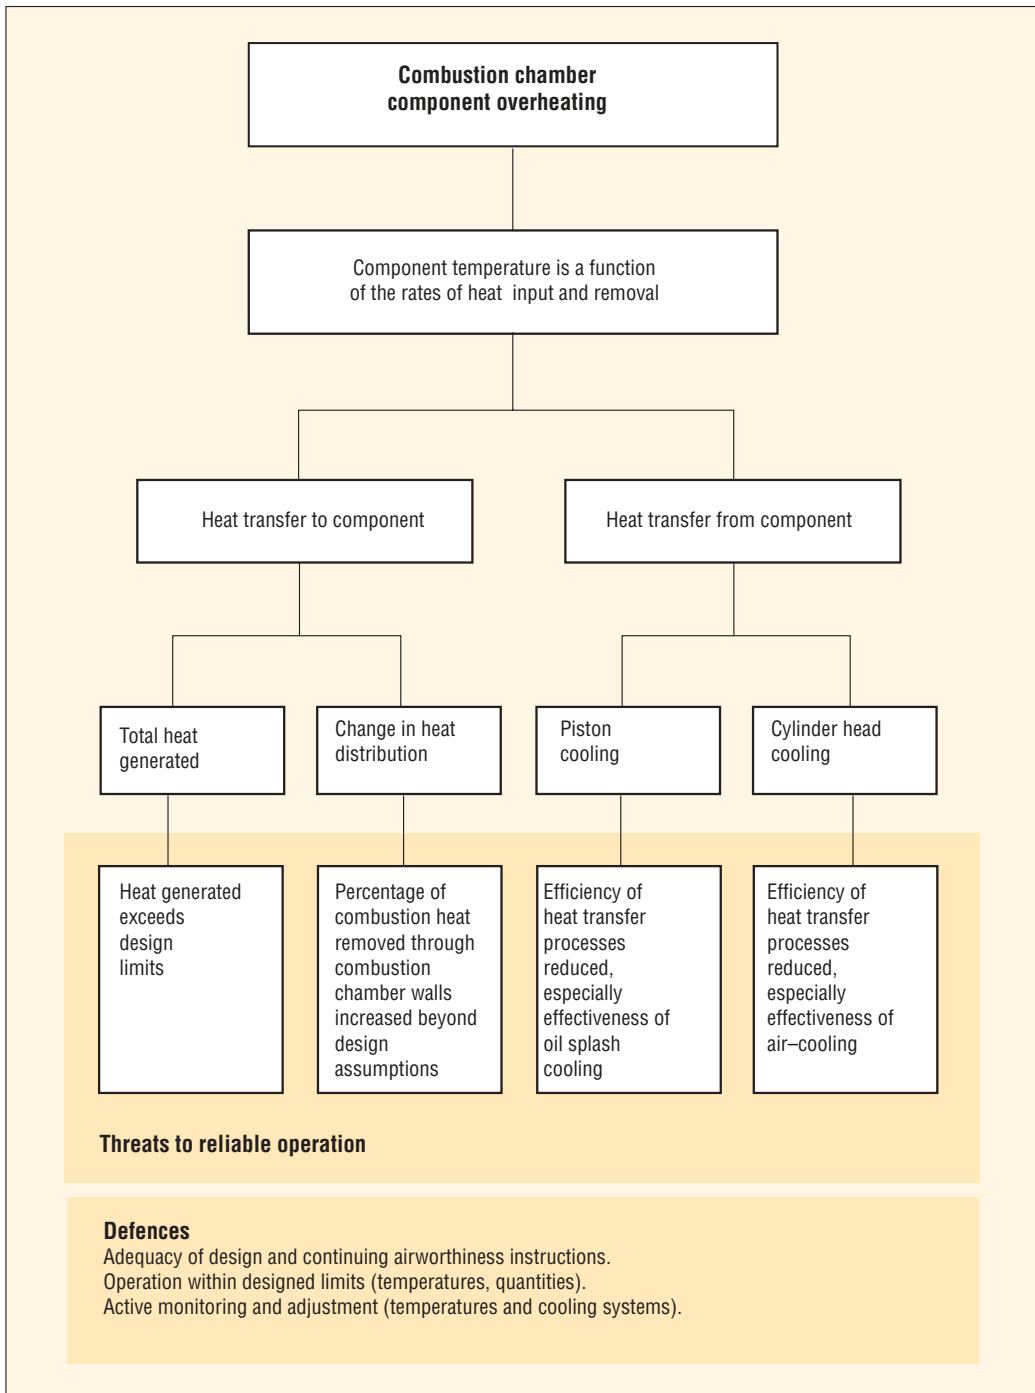
The total heat generated per unit time of engine operation is a function of the mass flow of fuel and air through the engine. The maximum rate of heat generation coincides with the maximum power setting of the engine and is limited by design.

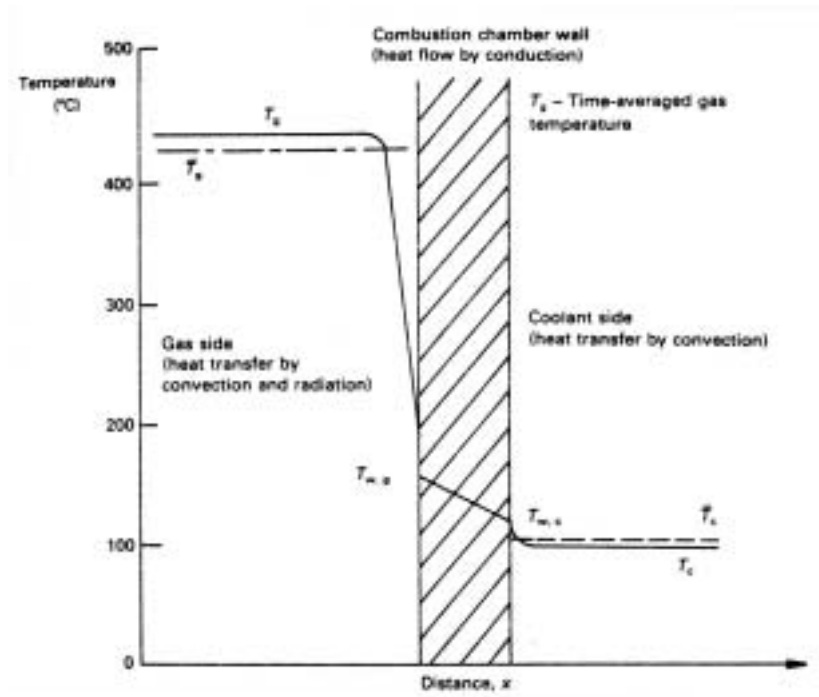
Changes in heat transfer conditions will result in changes in the operating temperatures of combustion chamber components and may result in the components being heated to temperatures greater than the design limits.

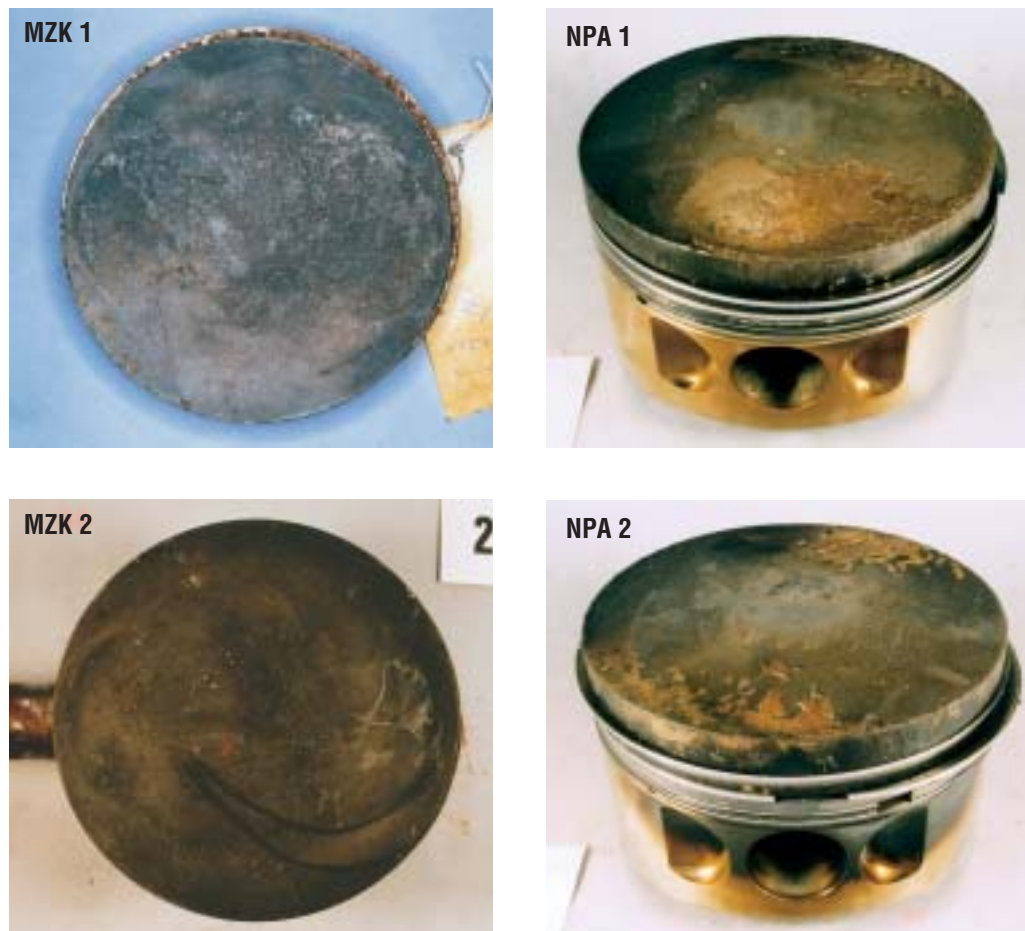
Figure 23:
Comparison of piston crown deposits, right engine MZK (left) , and right engine VH-NPA (right)

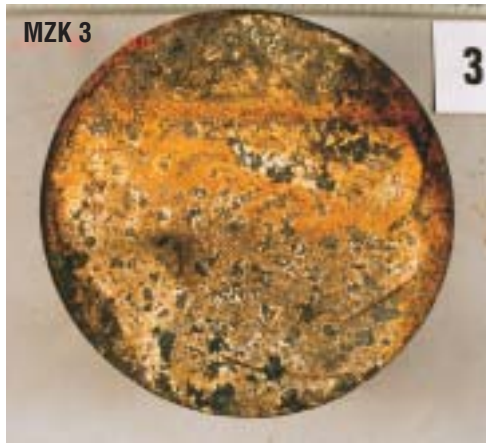
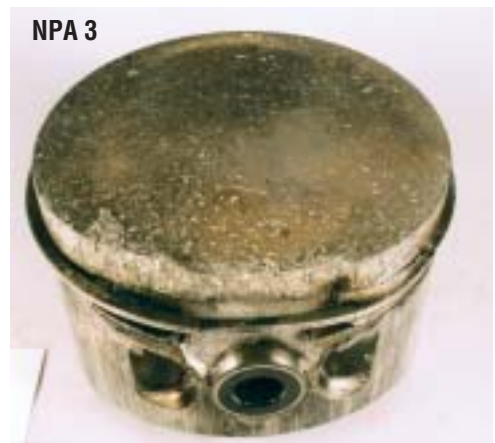
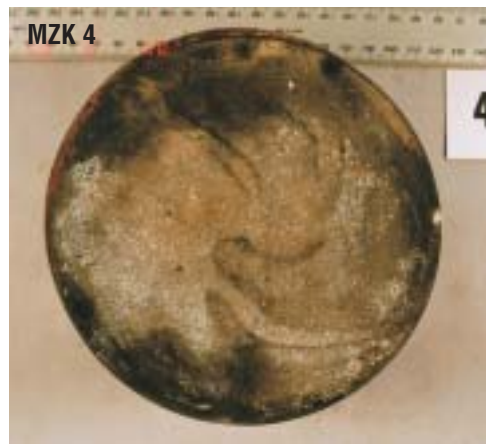
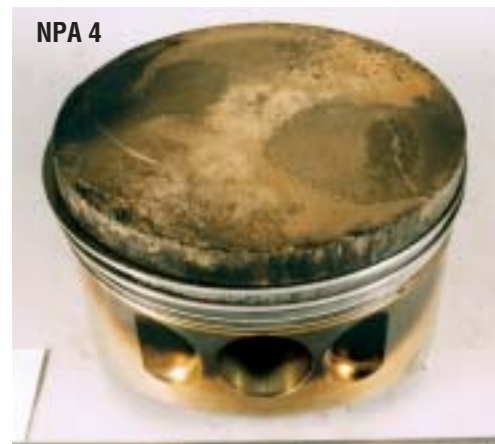
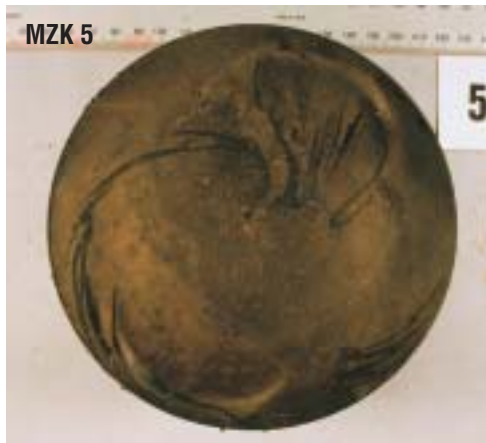
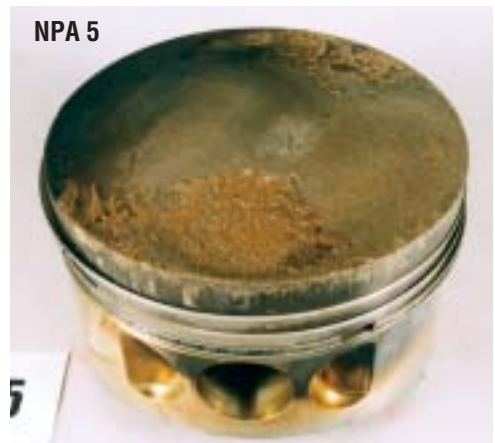
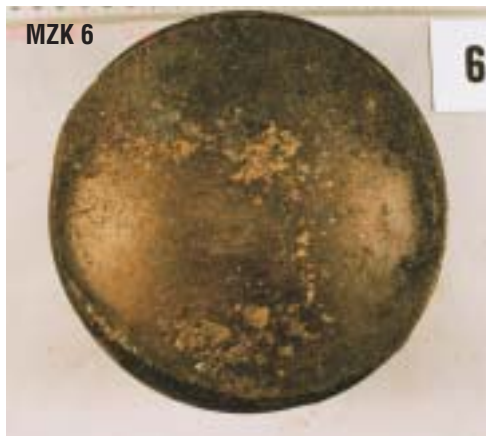
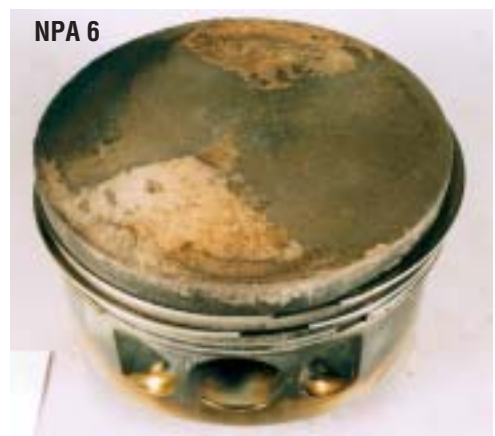
The distinctive carbon 'swirl' pattern deposits present on the pistons recovered from the right engine of MZK were similar to the deposits shown in an illustration on the Sacramento Sky Ranch web site¹⁸ (see fig. 24). The illustration shows a piston from a Continental IO-520 engine that had been damaged by edge melting. Piston overheating was attributed to detonation/preignition that resulted from the combustion of contaminated fuel. The octane (performance) rating of the aviation gasoline had been reduced by the addition of aviation turbine fuel. It is likely that failure would have occurred, in this case, after a short time of operation under high-power, rich-mixture, conditions.

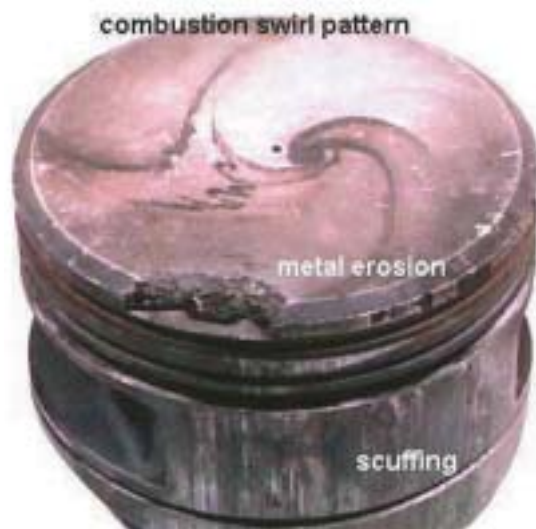
Fuel-air charge detonation, with consequent effects on the combustion chamber heat transfer, may occur over the range of rich to lean mixtures. The characteristics of the piston crown deposits remaining on the pistons from MZK's right engine indicate that detonation is likely to have occurred under rich mixture conditions. That is, the detonation-free operating limits were exceeded at a high engine power setting.

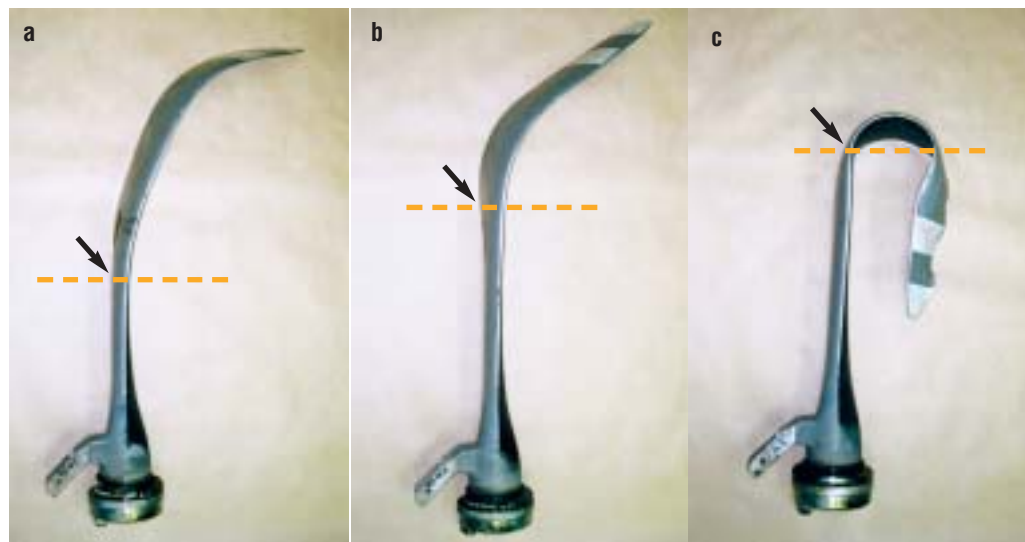
The progressive increase in bending, from blade Number 3 (least i.e. point of bending furthest from the blade root) through to blade Number 1 (greatest i.e. point of bending closest to blade root), is consistent with the aircraft descending into a dense medium (water) with a significant forward velocity.

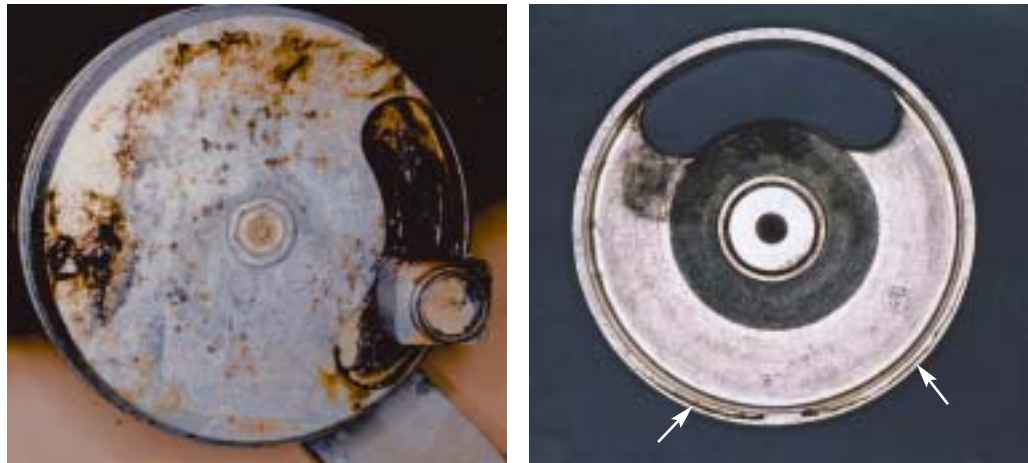
The alignment of the pitch change fork on the actuator shaft had been altered by the rearward rotation of the Number 1 propeller blade (see fig. 27).

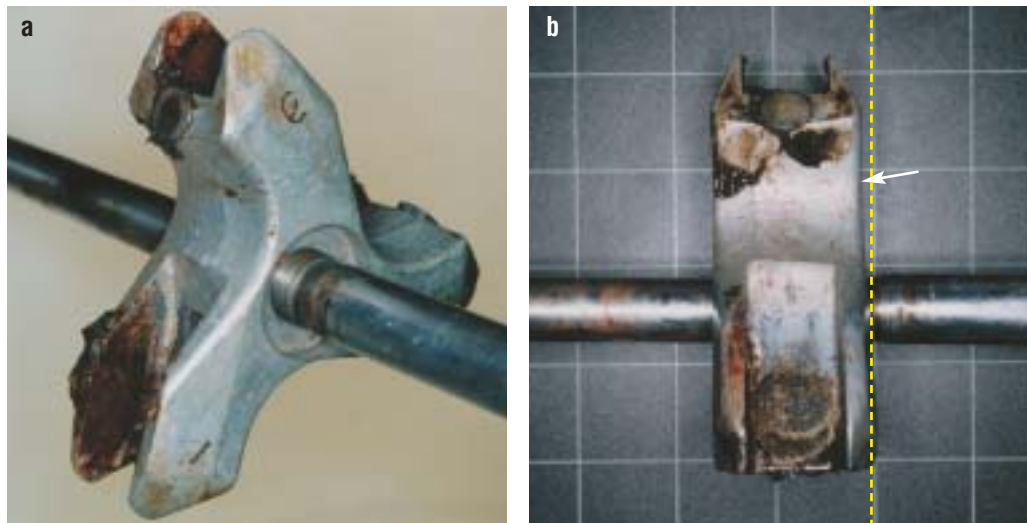
The damage sustained by the right propeller indicates that a high force acted on the front face of the blade, through contact with water, while the blade was in a normal operating pitch range (i.e. not feathered), resulting in combined bending and twisting, while the aircraft was moving forward.

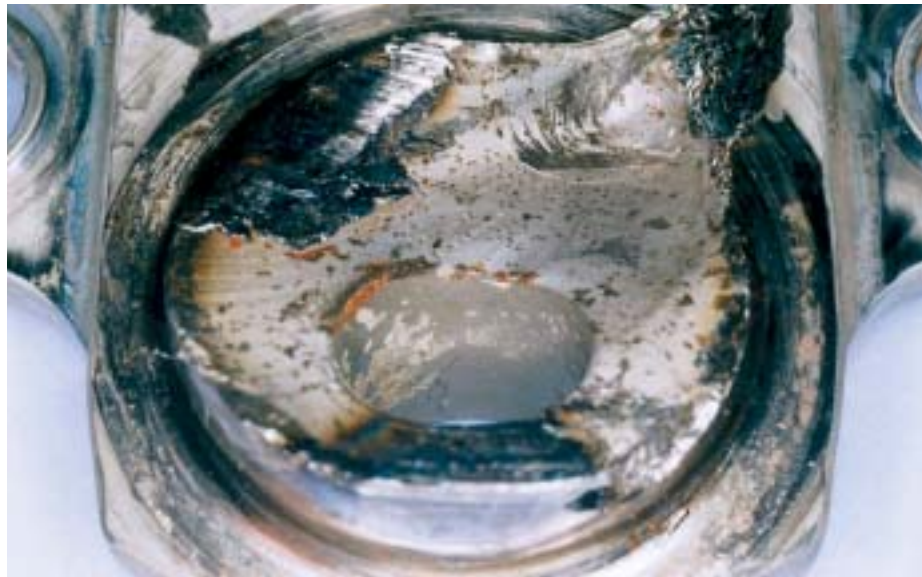
Figure 29:
Crankshaft journal fracture, journal side, Number 6 journal, left engine MZK

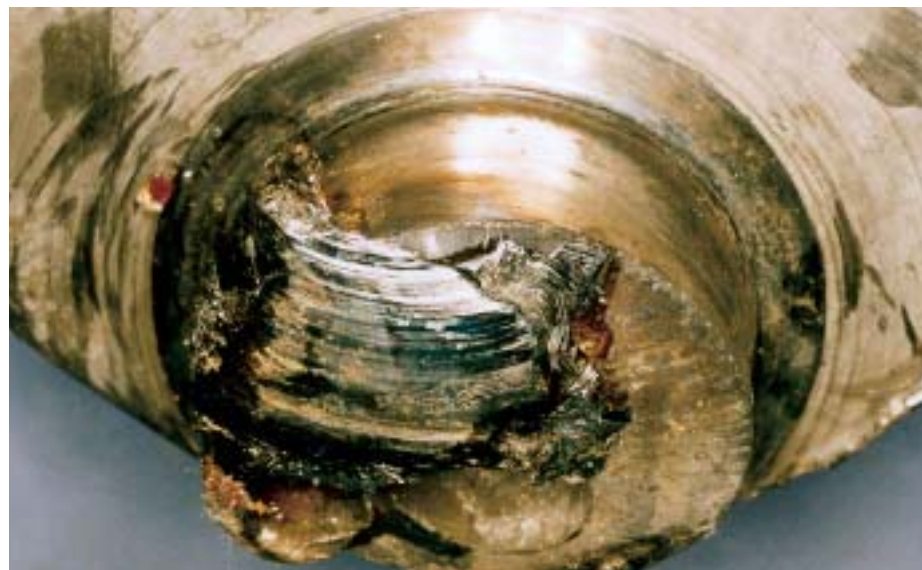
¹⁹ Crankshaft journals of Lycoming engines are numbered from the front of the engine (i.e. Number 6 crankshaft journal is at the rear of the engine).

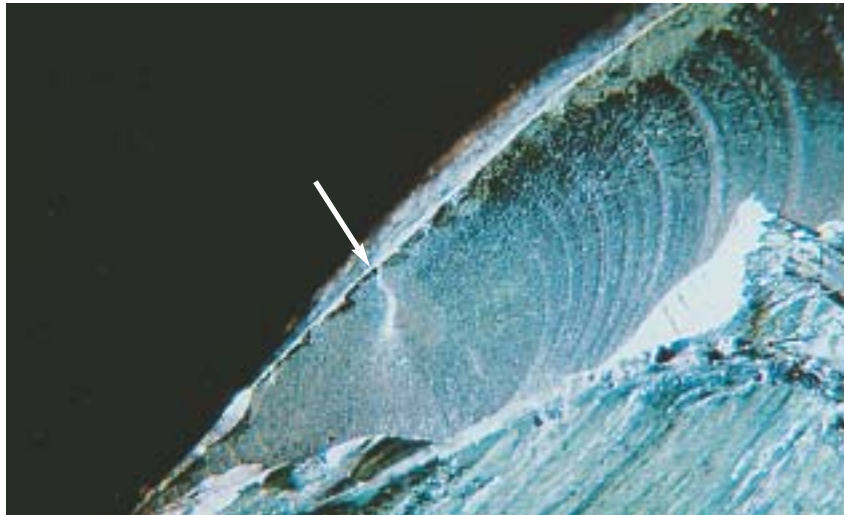
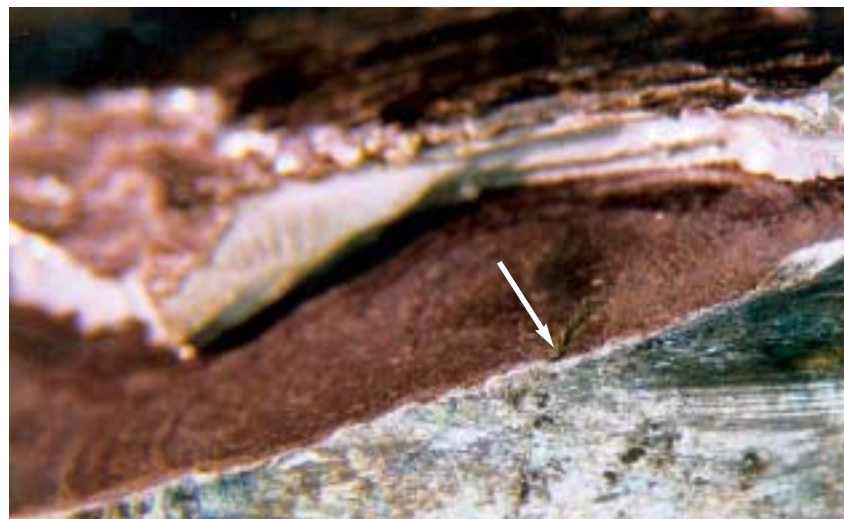
Fatigue crack growth

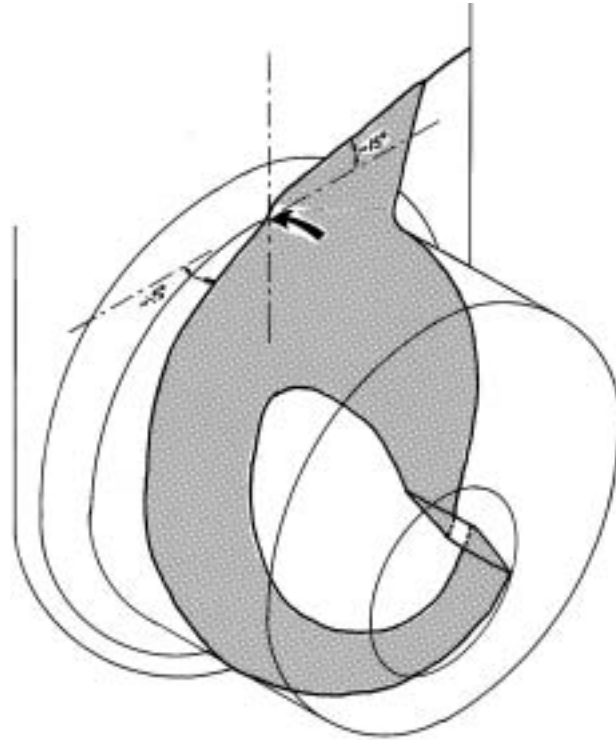
Figure 31:
Schematic showing the plane of fatigue crack growth (shaded) and the orientation of the plane of crack growth with respect to the axis of the crankarm. The site of fatigue initiation is arrowed.

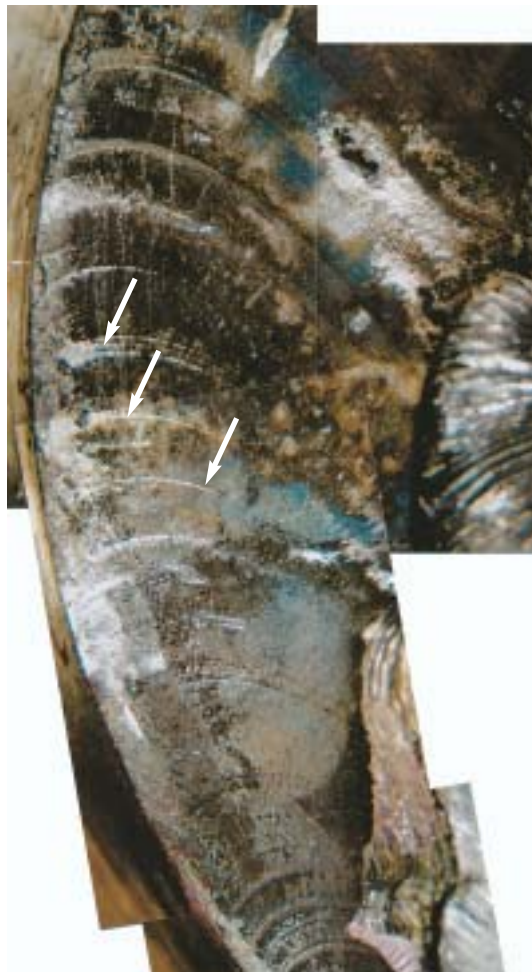
The incremental extension of a fatigue crack is a function of both the tensile stress created by the applied loads or strains and the geometry of the crack at the time of incremental extension – in short, the stress intensity at the crack tip. Because of this relationship only the higher stresses in the variable amplitude stress spectrum will contribute to crack growth at small crack sizes. As the crack size increases the lesser alternating stresses will contribute to crack growth.

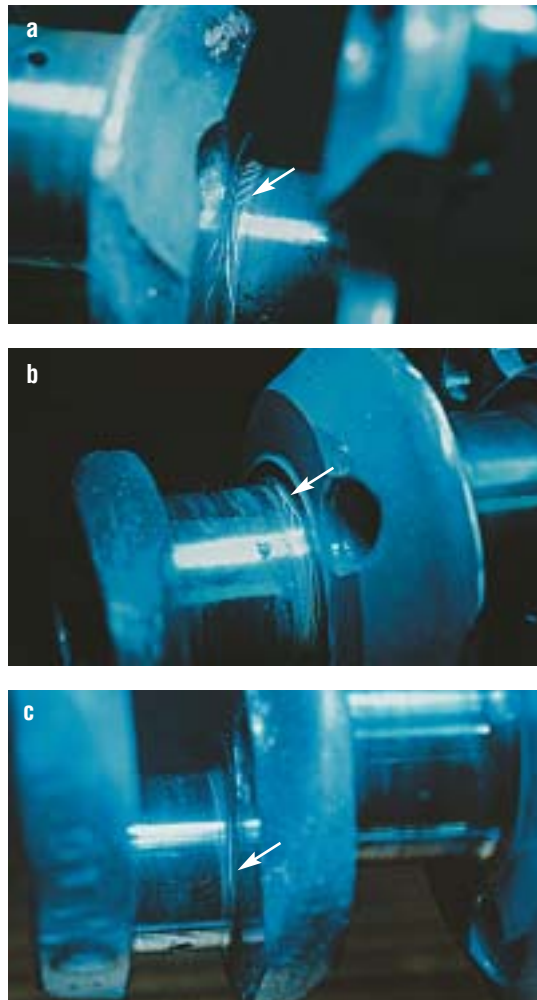
Regions of cracking from the forward fillet radius of the Number 5 connecting rod journal and the rear fillet radius of the Number 3 main bearing journal were opened in the laboratory to allow the crack surfaces to be examined. In each case, the mechanism of cracking was identified as fatigue (see fig. 34). Fatigue cracking initiated at the journal surfaces and, in each case, was not restricted to one particular site or defect. The nature of the orientation of the cracks and the initiation of cracking are consistent with an abnormal loading condition.

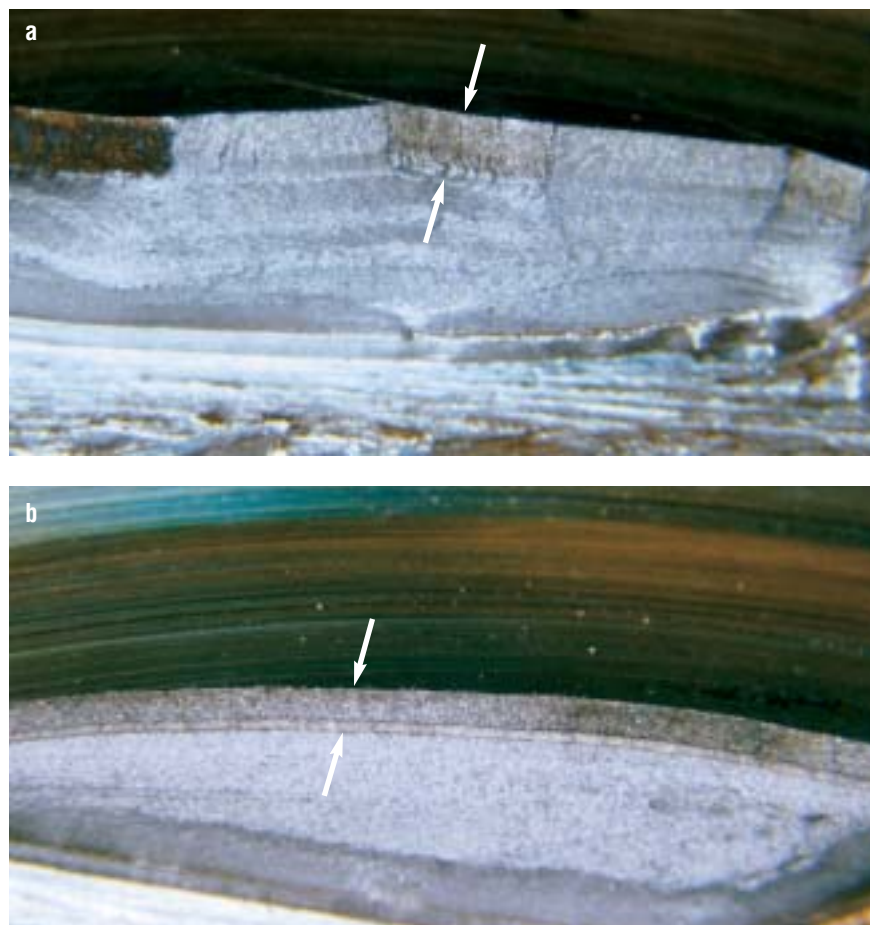
Figure 34:
Fatigue crack features, Number 5 connecting rod journal (a, c) and Number 3 main journal (b, d).
An example of brittle fracture in the journal surface zone is shown for comparison (e)

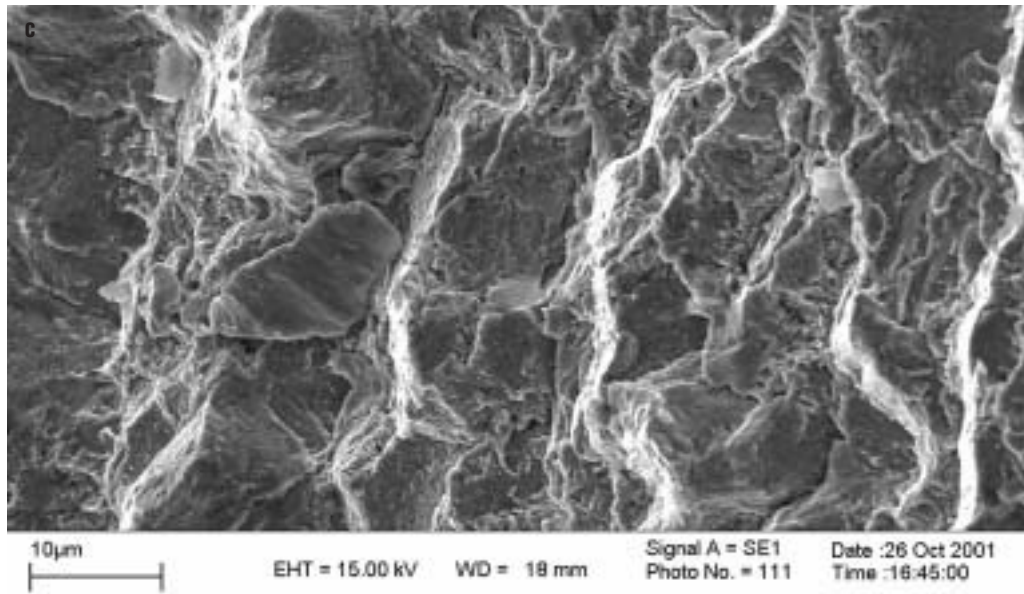
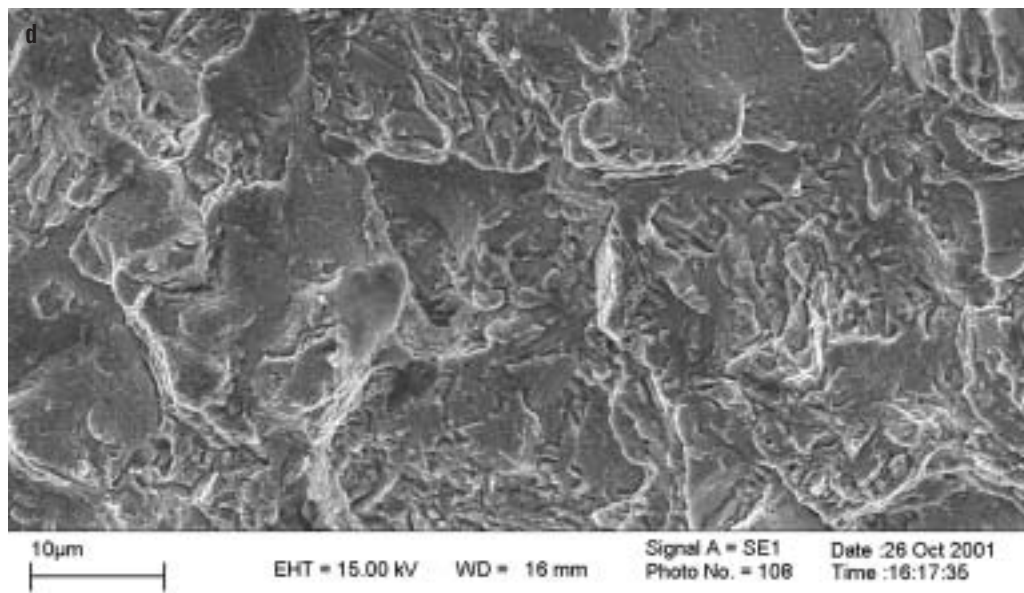
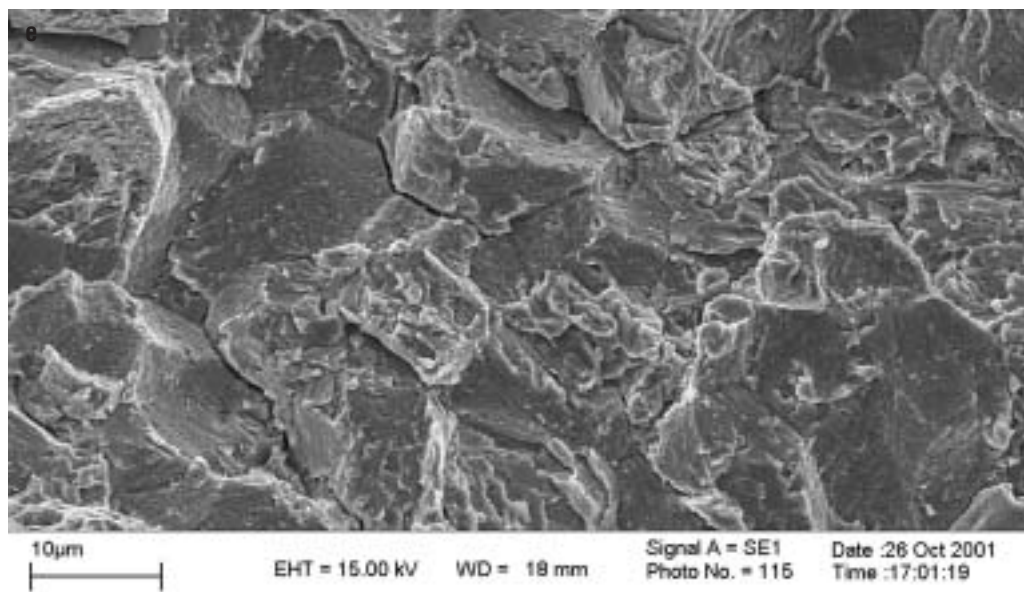
Crankshaft manufacture
