Piper PA31-350 Chieftain VH-MZK Spencer Gulf SA

31 May 2000

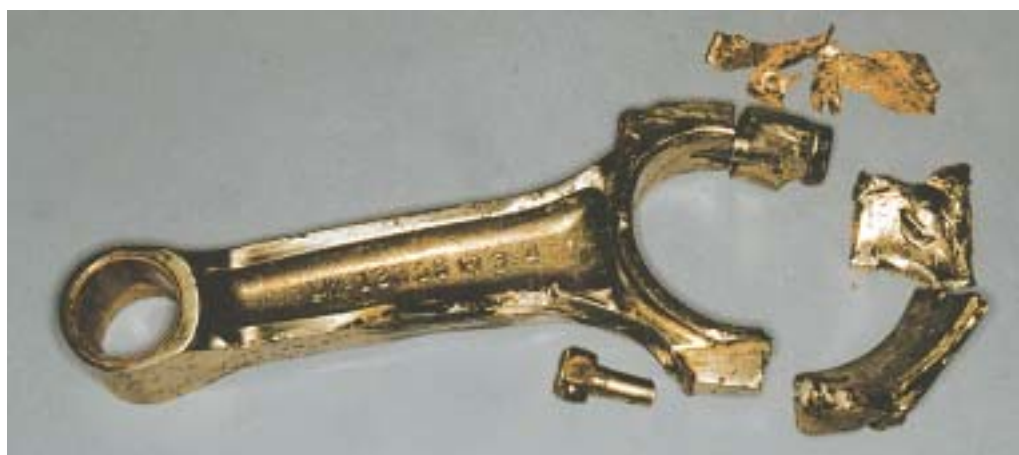
Figure 36:
The regions of fatigue fracture in the Number 6 connecting rod big end bearing housing, detailed views of the fatigue fracture surface are shown in (a, b)

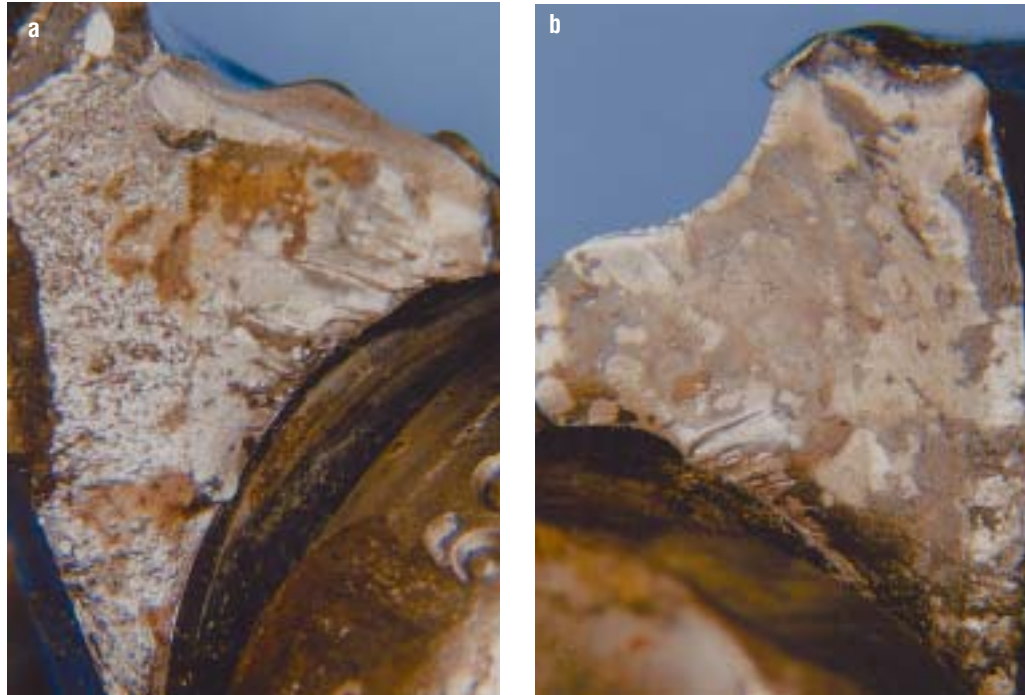
The mating surfaces of the big end bearing housing had been affected by fretting and galling²¹. That type of surface damage indicated that sliding movements over small distances had occurred between the mating surface during engine operation.

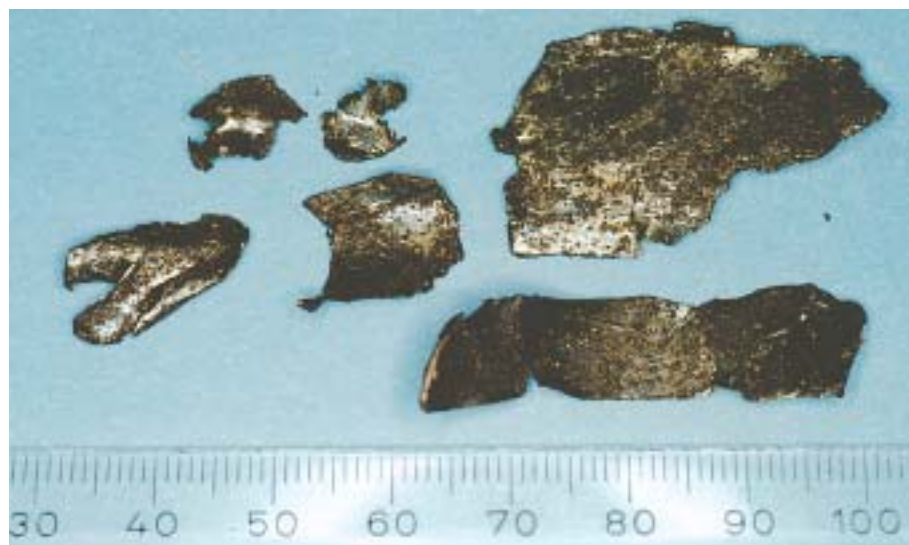
21 Fretting is a wear process in which material is removed by oxidation and abrasion from contacting surfaces subjected to repeated sliding over small distances. Galling is the process of adhesive wear in which repeated welding on a microscale and subsequent weld zone fracture occurs between two surfaces that are subjected to repeated sliding over small distances.

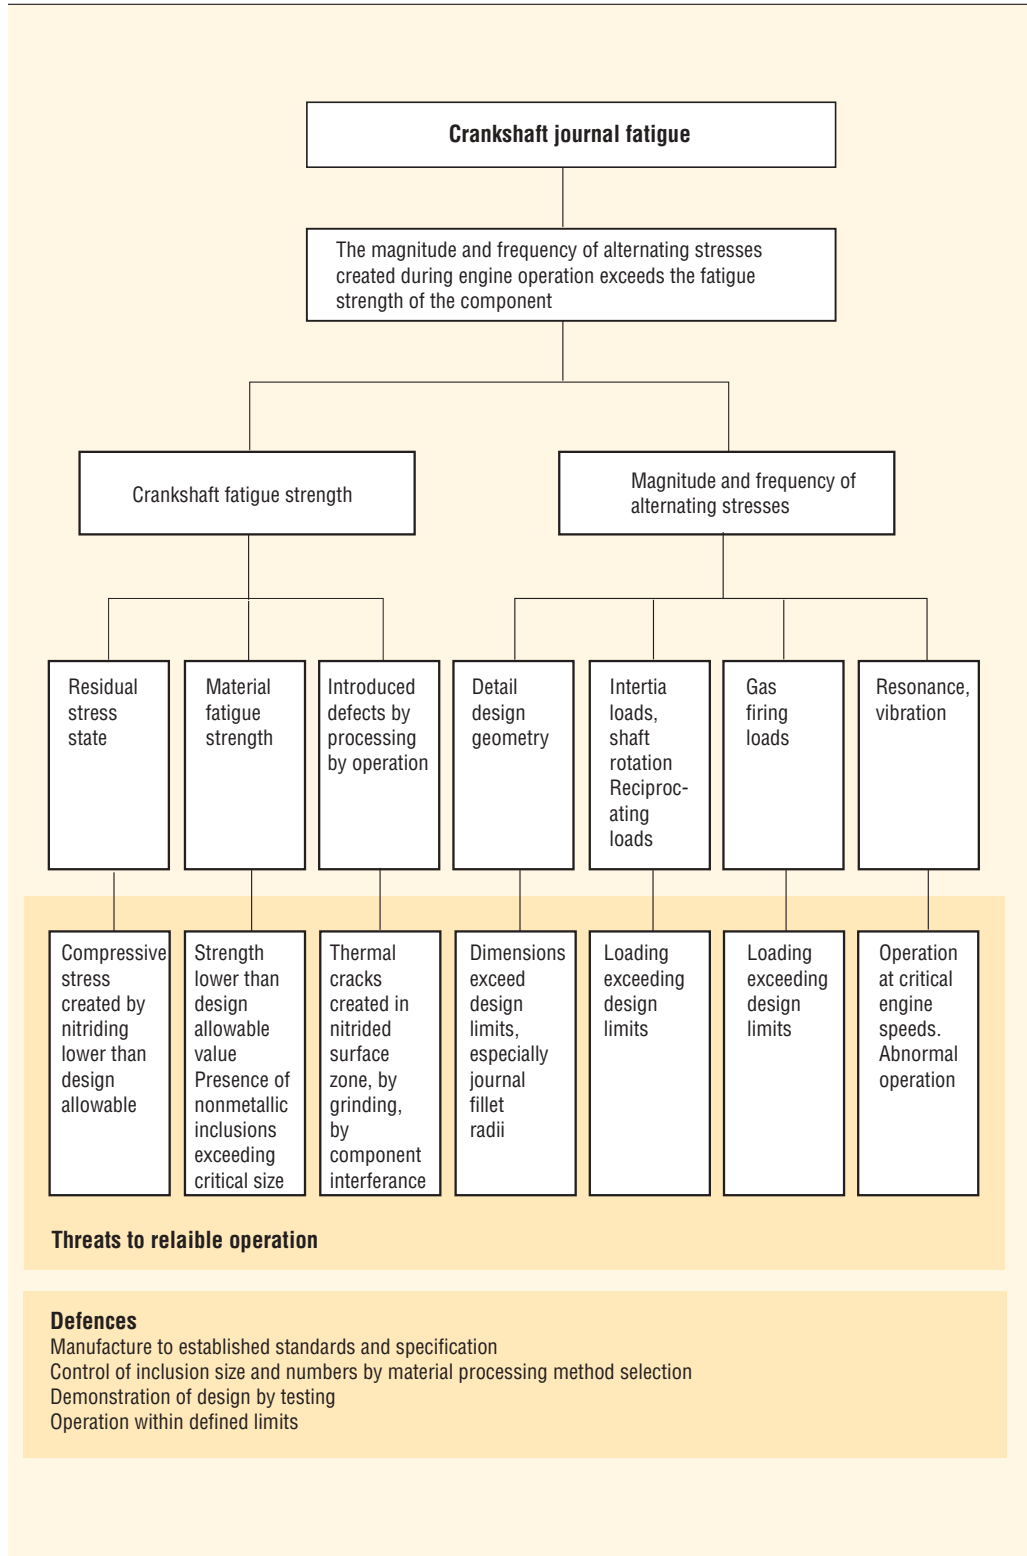
The crankshaft of an aircraft engine is designed to have an operational life that is not limited by the development of cracks and fracture. Crankshafts do not have a fixed time retirement life (safe life) based on a need to remove the component from service prior to the development of fatigue cracking. Generally, crankshafts are subjected to inspection at specified operational intervals and are removed when dimensional limits are exceeded in areas that are subjected to wear.

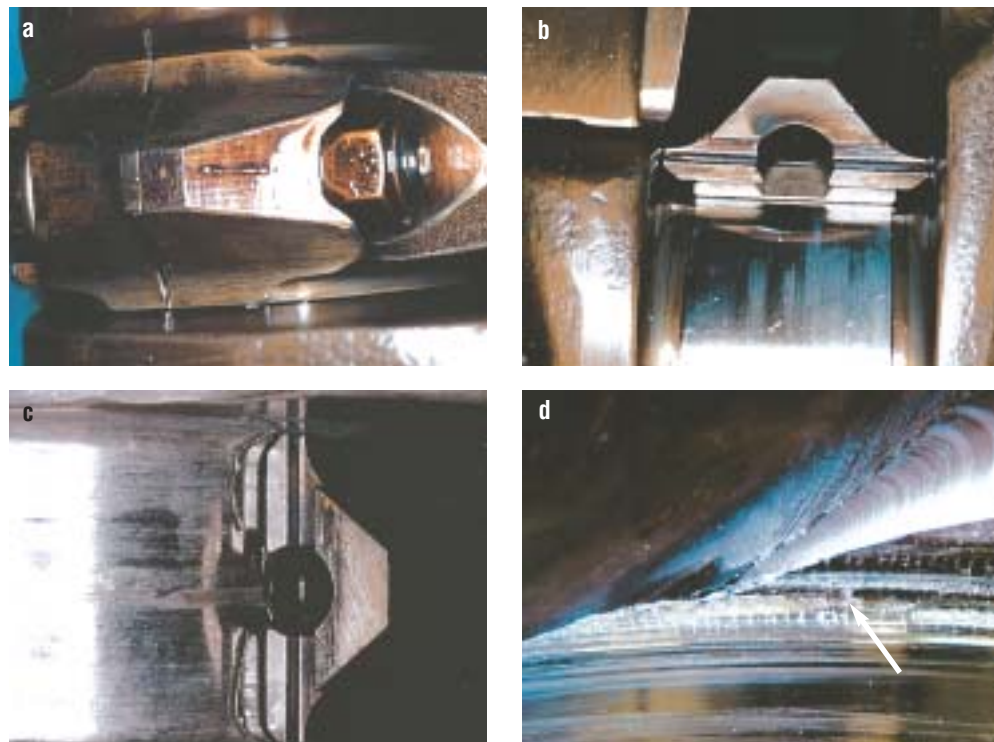
Connecting rod big end housing fatigue analysis

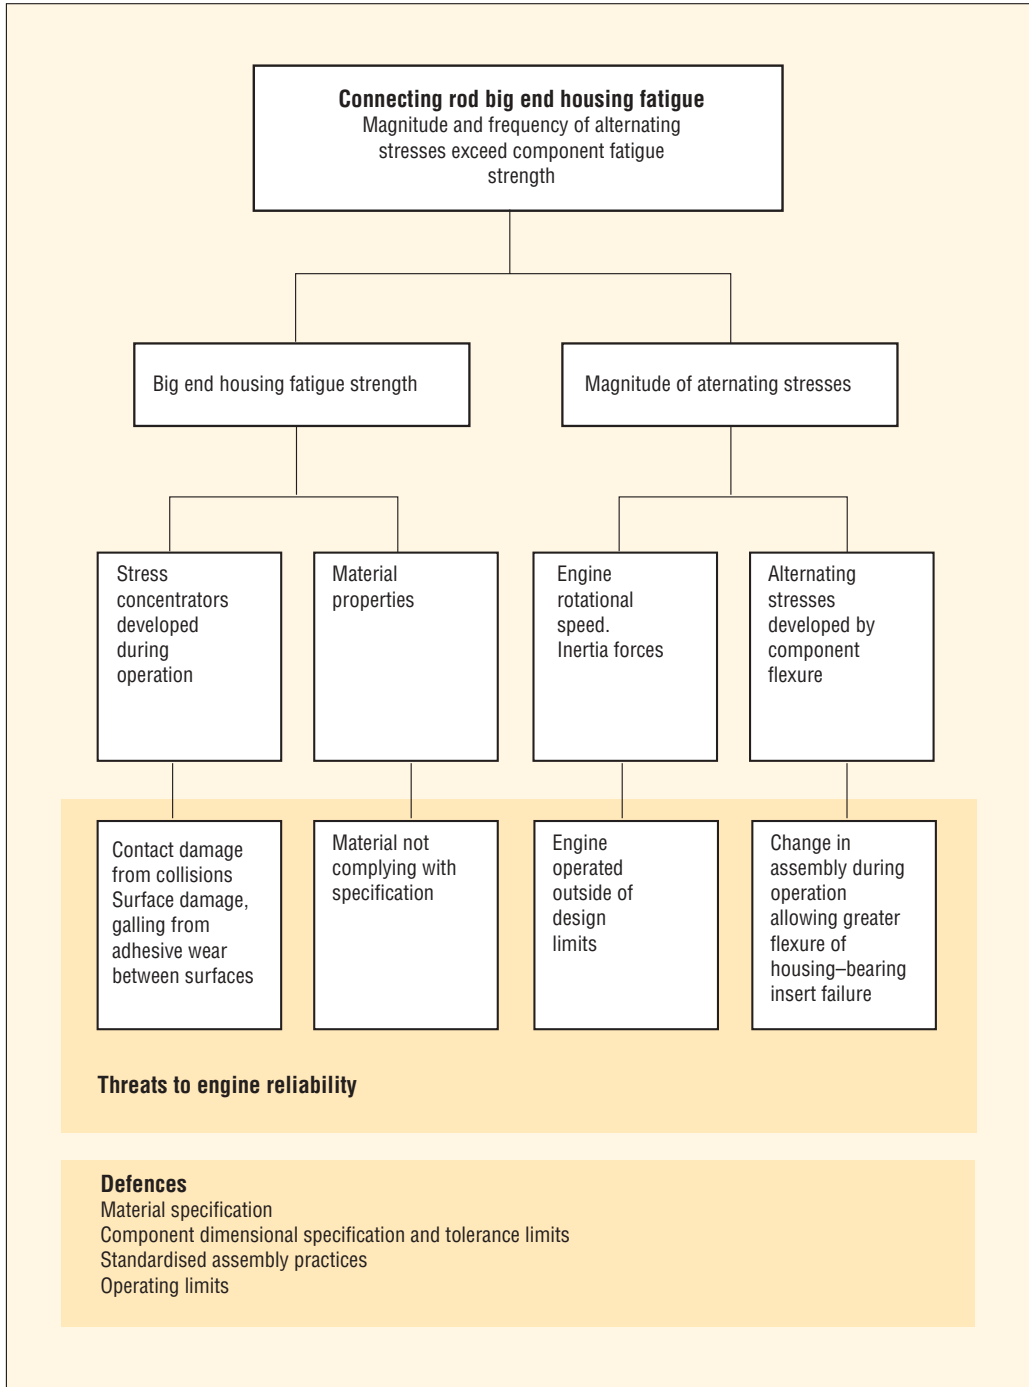
Fatigue cracking in the Number 6 connecting rod initiated at the outer surface of the housing. Initiation of fatigue cracking at the outer surface is an indicator of a change in the big end bearing housing assembly that leads to increased flexure of the housing and high alternating stresses at the outer surface. Increased bearing clearance associated with bearing breakdown leads to increased housing flexure and fatigue initiation at the housing outer surface.

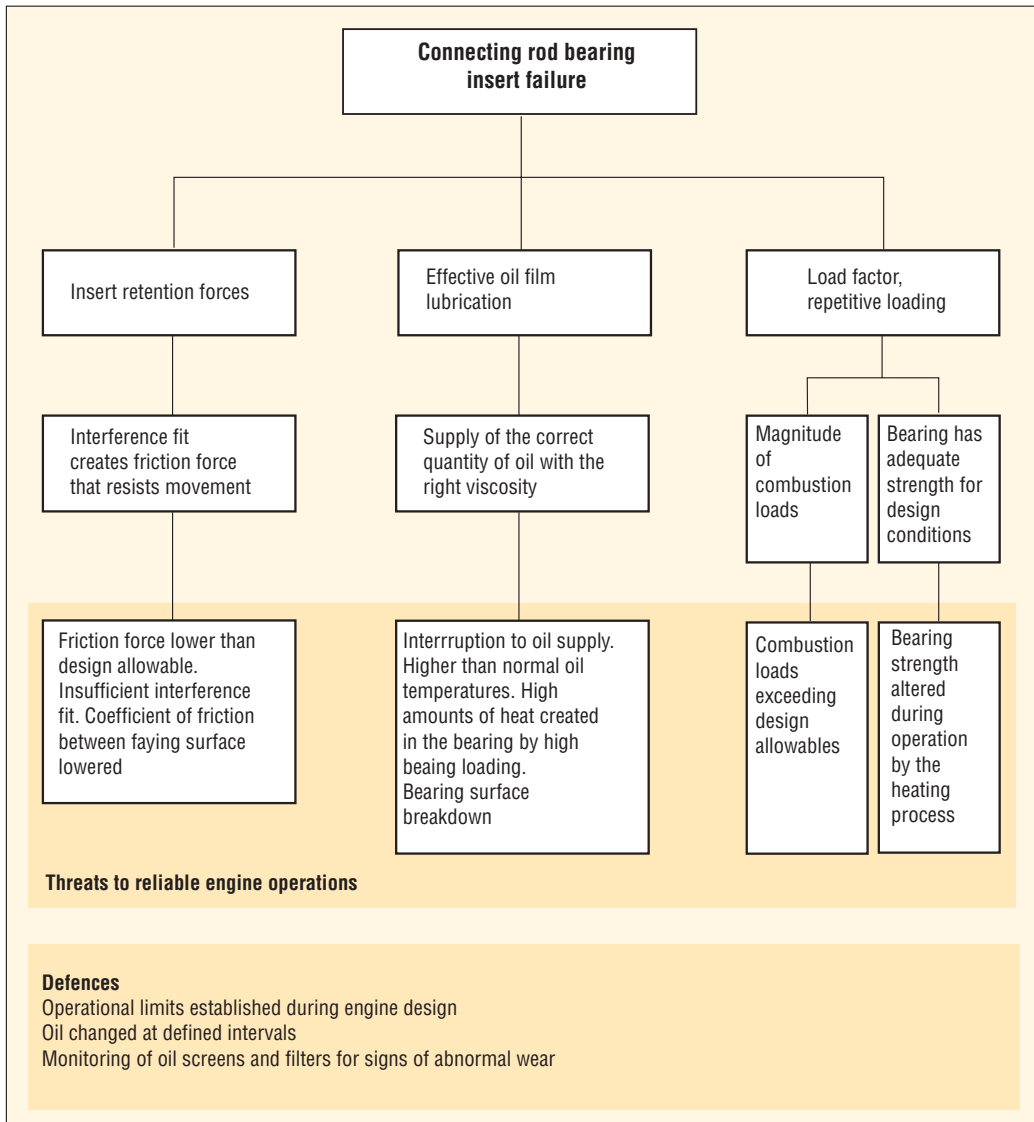
The connecting rod big end bearings of Lycoming TIO-540 engines are based on the use of precision insert bearings. These bearing inserts consist of three layers; a top layer of a lead–tin bearing alloy (babbitt alloy), an intermediate layer of an aluminium–tin bearing alloy and a low–carbon steel backing layer. The bearing inserts are retained in the connecting rod housing by the interference fit forces created during assembly. Under normal operation, an oil film separates the bearing surfaces and transmits the forces between the components. The oil film is established by the slight eccentric rotation of the journal within the bearing in an action known as hydrodynamic lubrication.

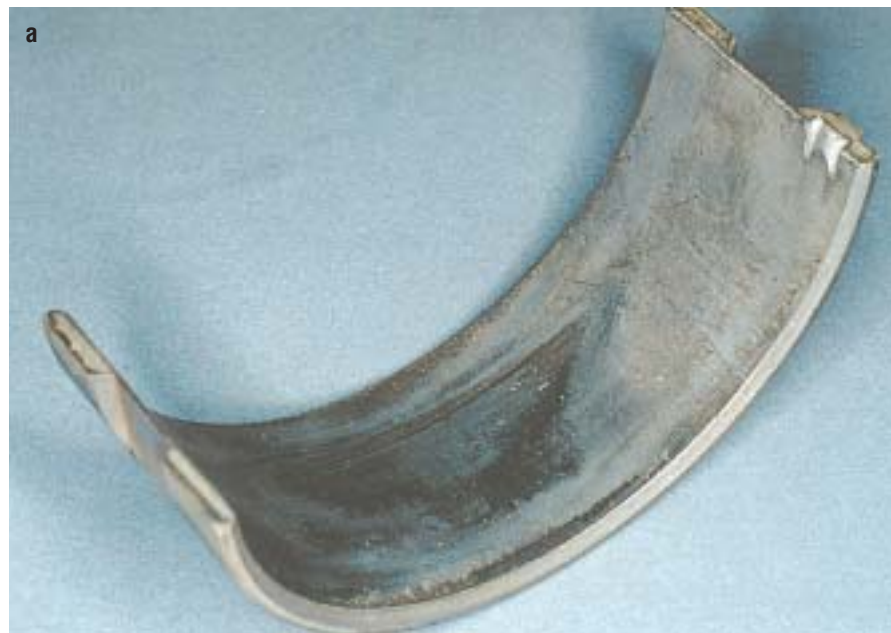
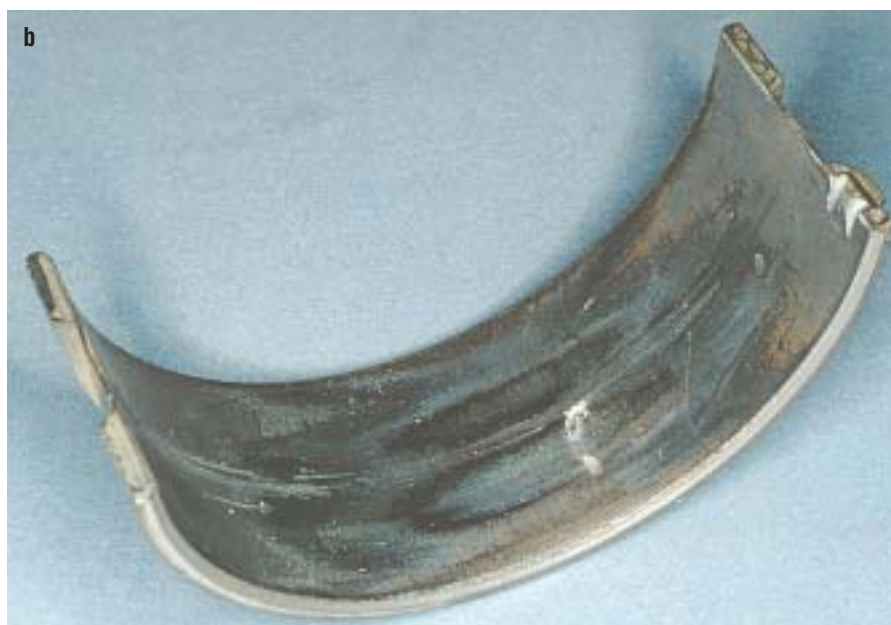
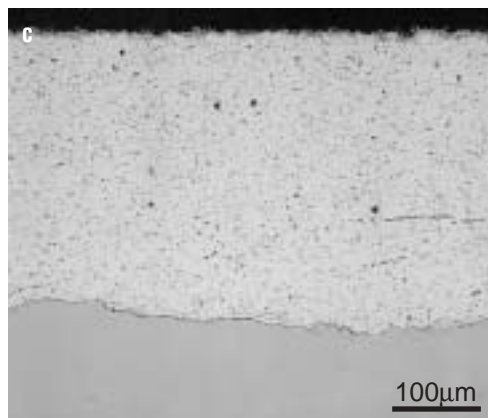
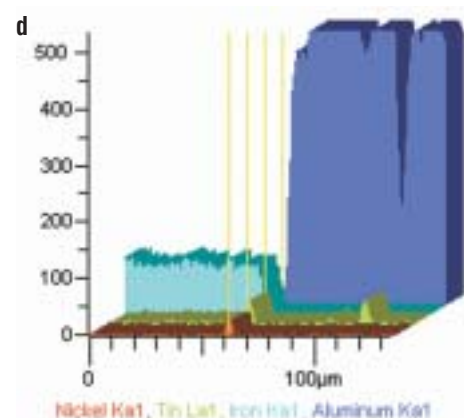
Two examples of bearing wear, VH-ODE (a, b). The microstructural differences between worn and undamaged bearings are shown in (c) worn and (e) undamaged. The distribution of tin at the interface between the steel backing and the aluminium–tin alloy interface is shown in the elemental linescans (d) worn, (f) undamaged

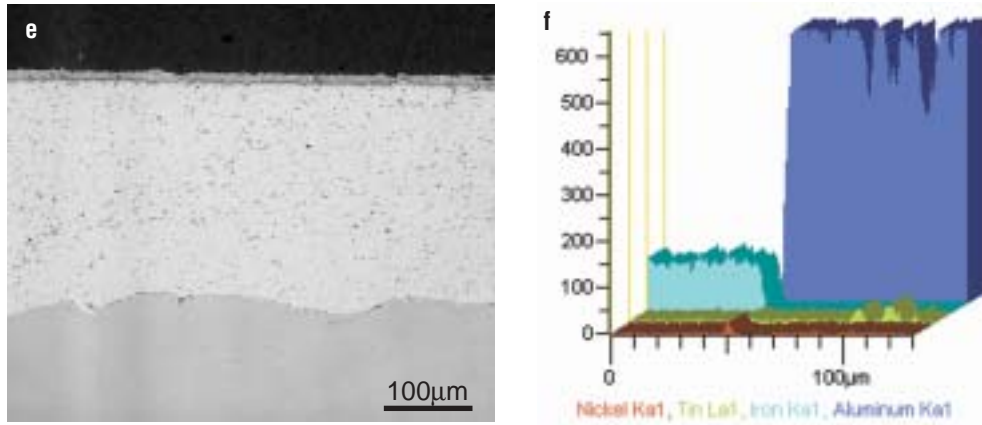
The nature of hydrodynamic oil film lubrication in the plain bearings of a reciprocating engine results in two limiting conditions that determine bearing life. One limit is the minimum oil film thickness, which is generally more critical under longer duration, inertia loads, created by the acceleration and deceleration of the connecting rods and pistons. These effects are generally evident on the cap side of a connecting rod big end bearing. The second limit is the maximum oil film pressure created by the applied loads being concentrated over a small area of the bearing. The pressure factor is at its highest for the short duration of gas firing load. The maximum oil pressure effect is usually evident on the rod side of the connecting rod big end bearing.

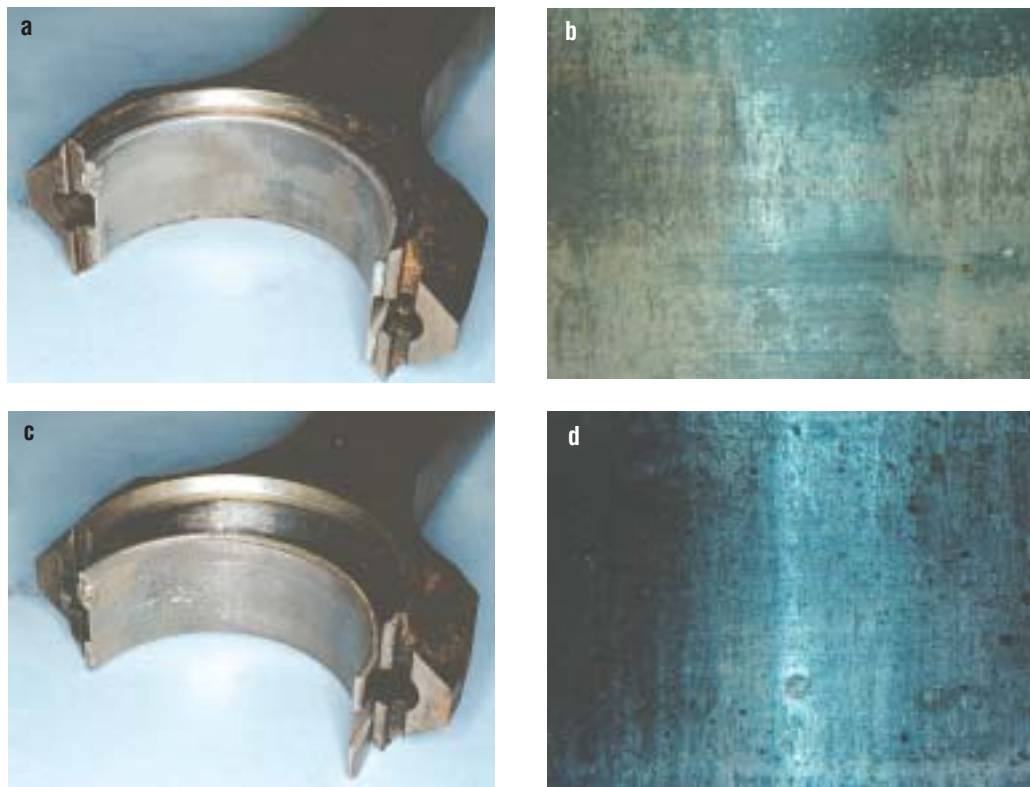
In addition to bearing surface distress, there was evidence that the bearing inserts had been sliding repeatedly, over small distances, against the bearing housing. An example of the evidence of repeated movement is the creation of a relief impression of the bearing identification marks on the housing surface (see fig. 44).

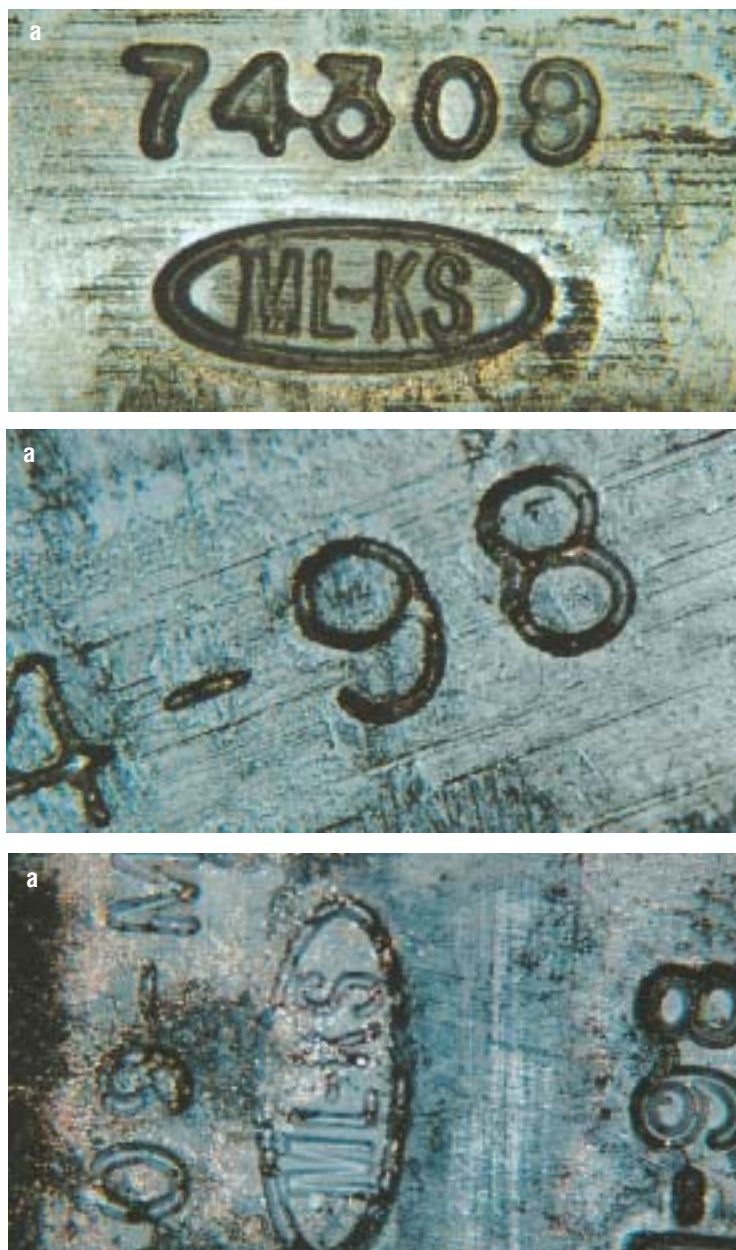
²⁴ Anti-galling compounds are also known as anti-seize lubricants. Copper-based formulations are characterised by suspensions of copper and graphite in a high quality grease.

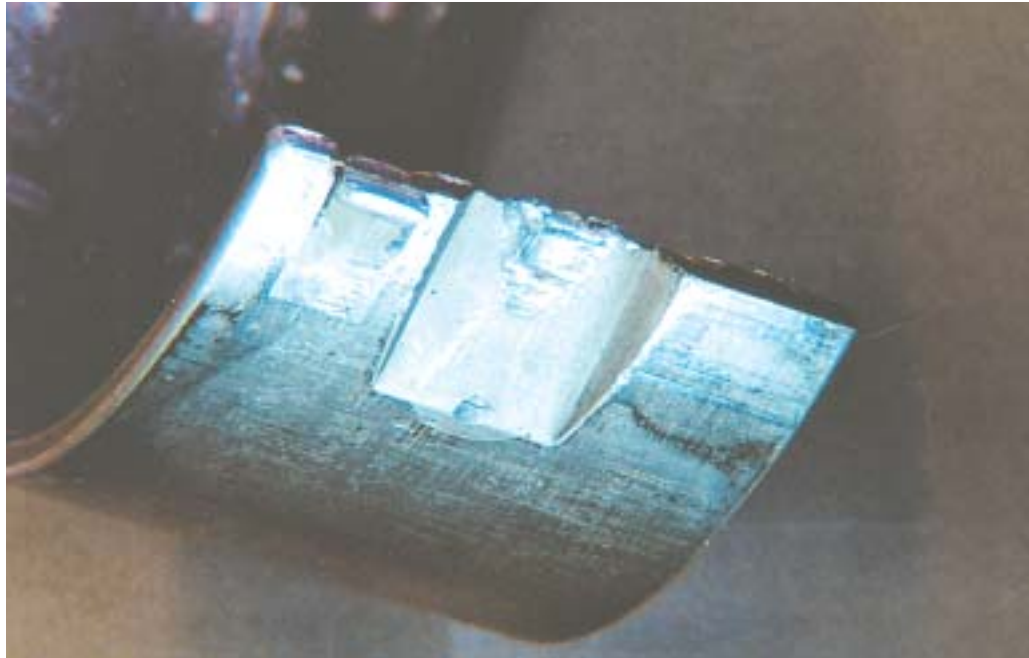
Other engine failures involving connecting rod bearings

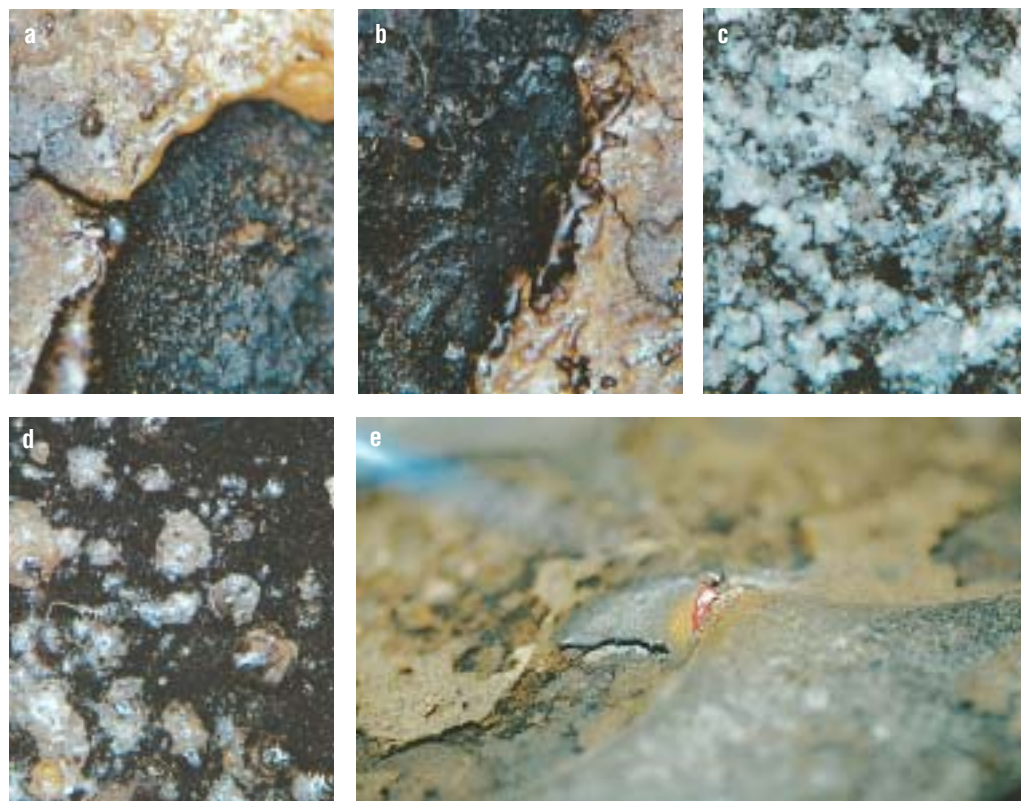
²⁸ Chemical Data Book, G H Aylward and T J V Findlay, 2nd Ed, Halstead Press Sydney, 1968, p 16.

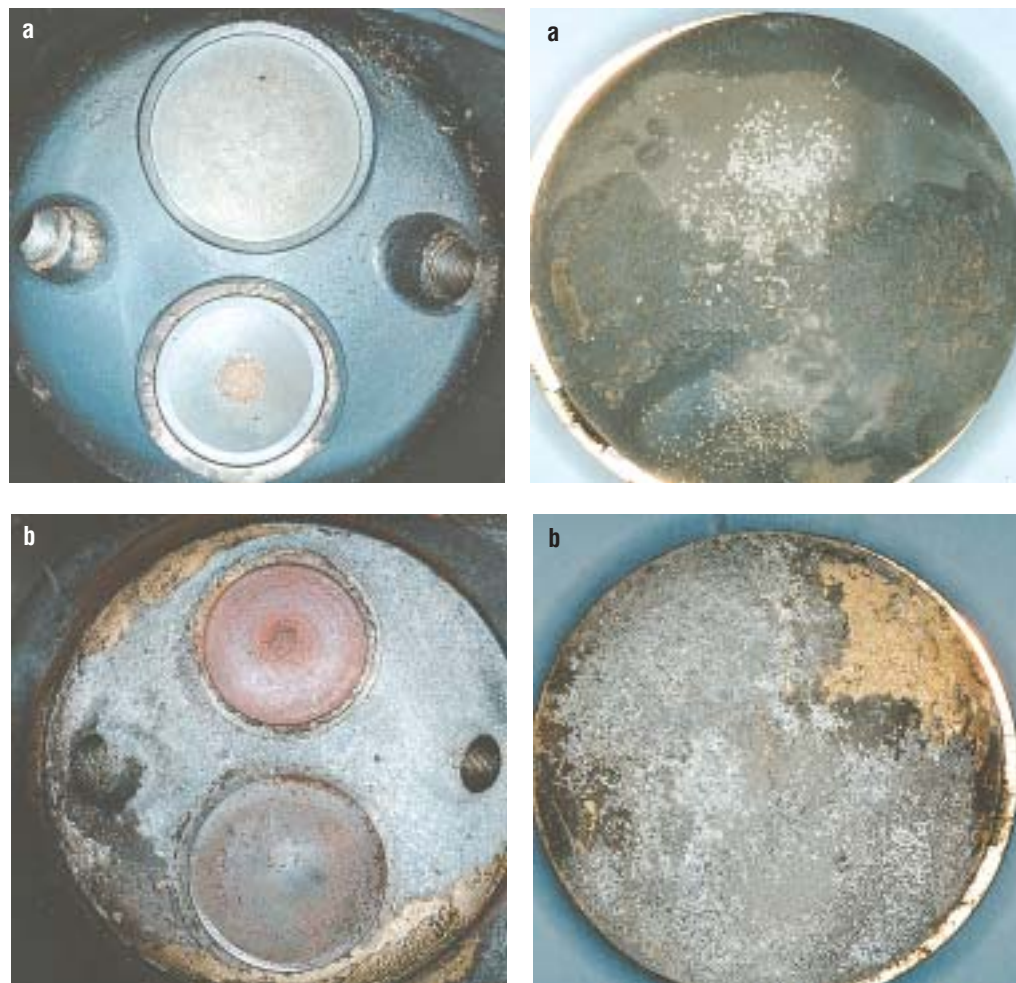
Reported engine problems related to the use of higher lead content fuels in low power aircraft piston engines³⁰ may also indicate a temperature dependency for the scavenge process. In low power engines the temperature of the fuel–air charge may be too low to allow for the reaction of lead oxide to lead bromide to proceed to completion in the time available for reaction.

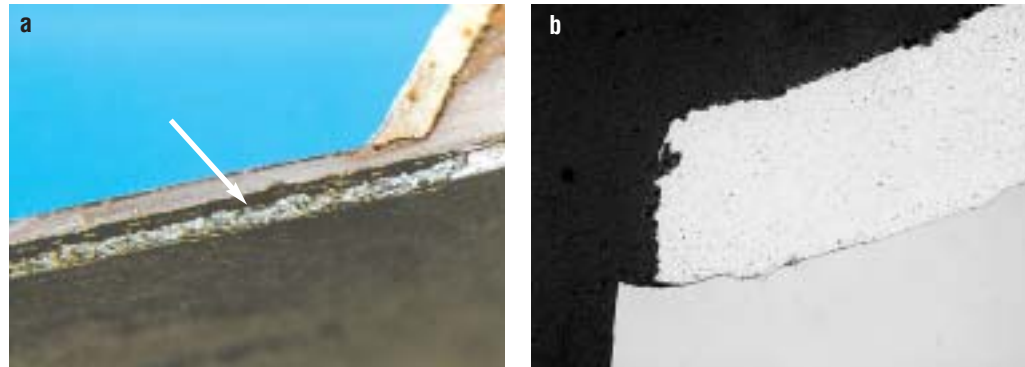
Surface deposits of lead oxide and lead oxybromide will affect the oxidation resistance of components subjected to high temperatures during engine operation. The presence of these compounds interferes with the normal oxide surface films that provide oxidation resistance (see fig. 50).

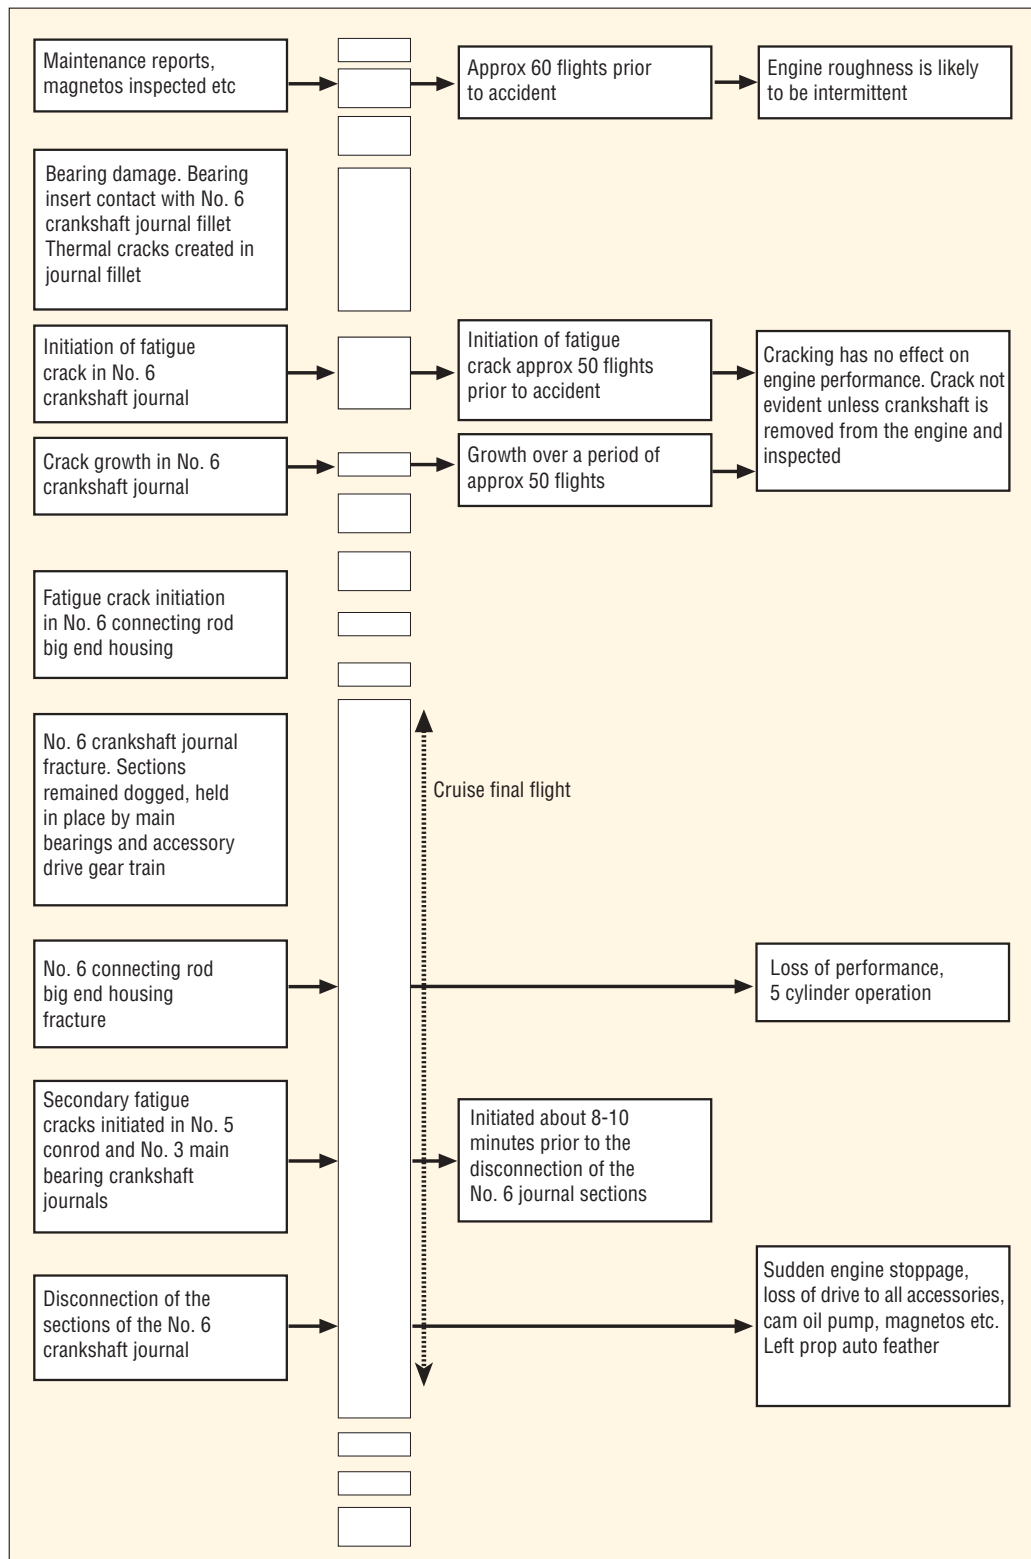
Figure 52:
Schematic showing the most likely sequence of events leading to the malfunction of the right engine MZK

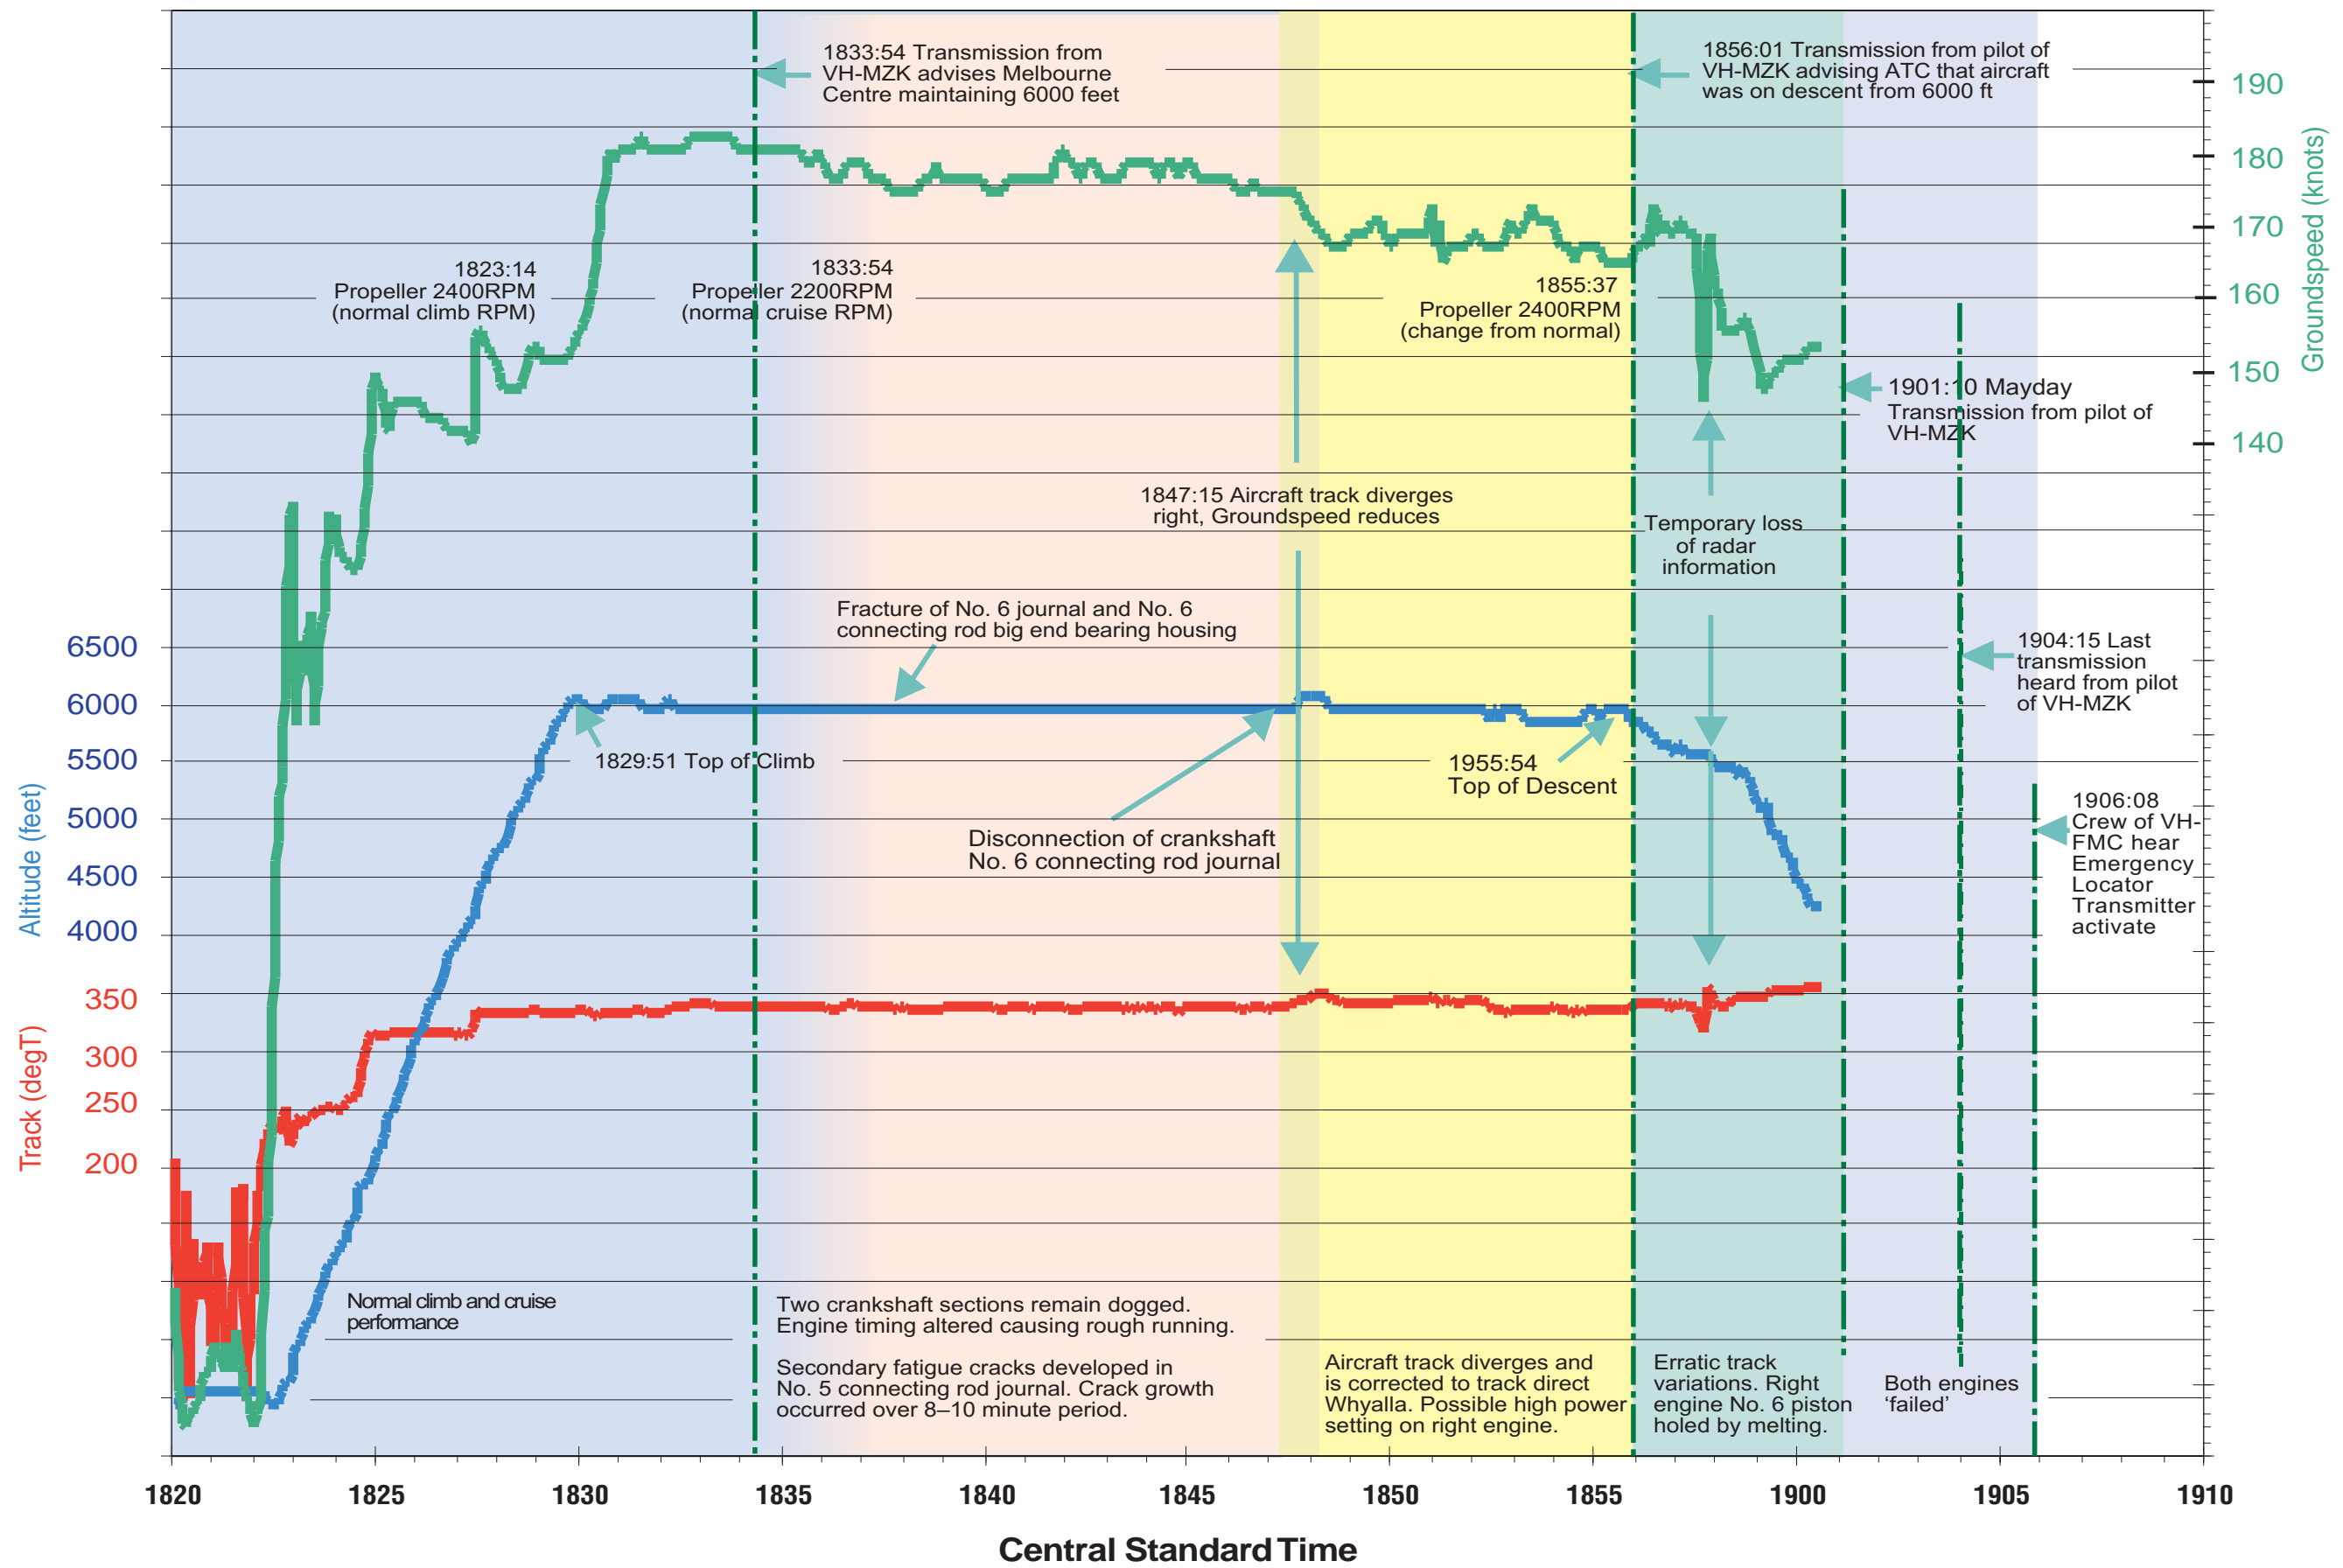
In explanation and amplification of the likely sequence of events, the following points are relevant:
