Accident Final Report

State File Number: Type of Occurrence: Date of Occurrence: Place of Occurrence: Aircraft Type: Registration: Operator: A13880431UPI6208 Accident July 22th 2009 I.R.IRAN - Mashhad IL-62M UP-I6208 Aria

Final Report

Type of occurrence:	Accident
Date:	24.Jul.2009
Location:	Mashhad International Airport/ I.R of Iran
Aircraft:	Airplane
Model:	IL-62M
Registration:	UP-I6208
Owner:	DETA Airline
Operator:	ARIA Airline
Date of Issue:	05 Jun 2010

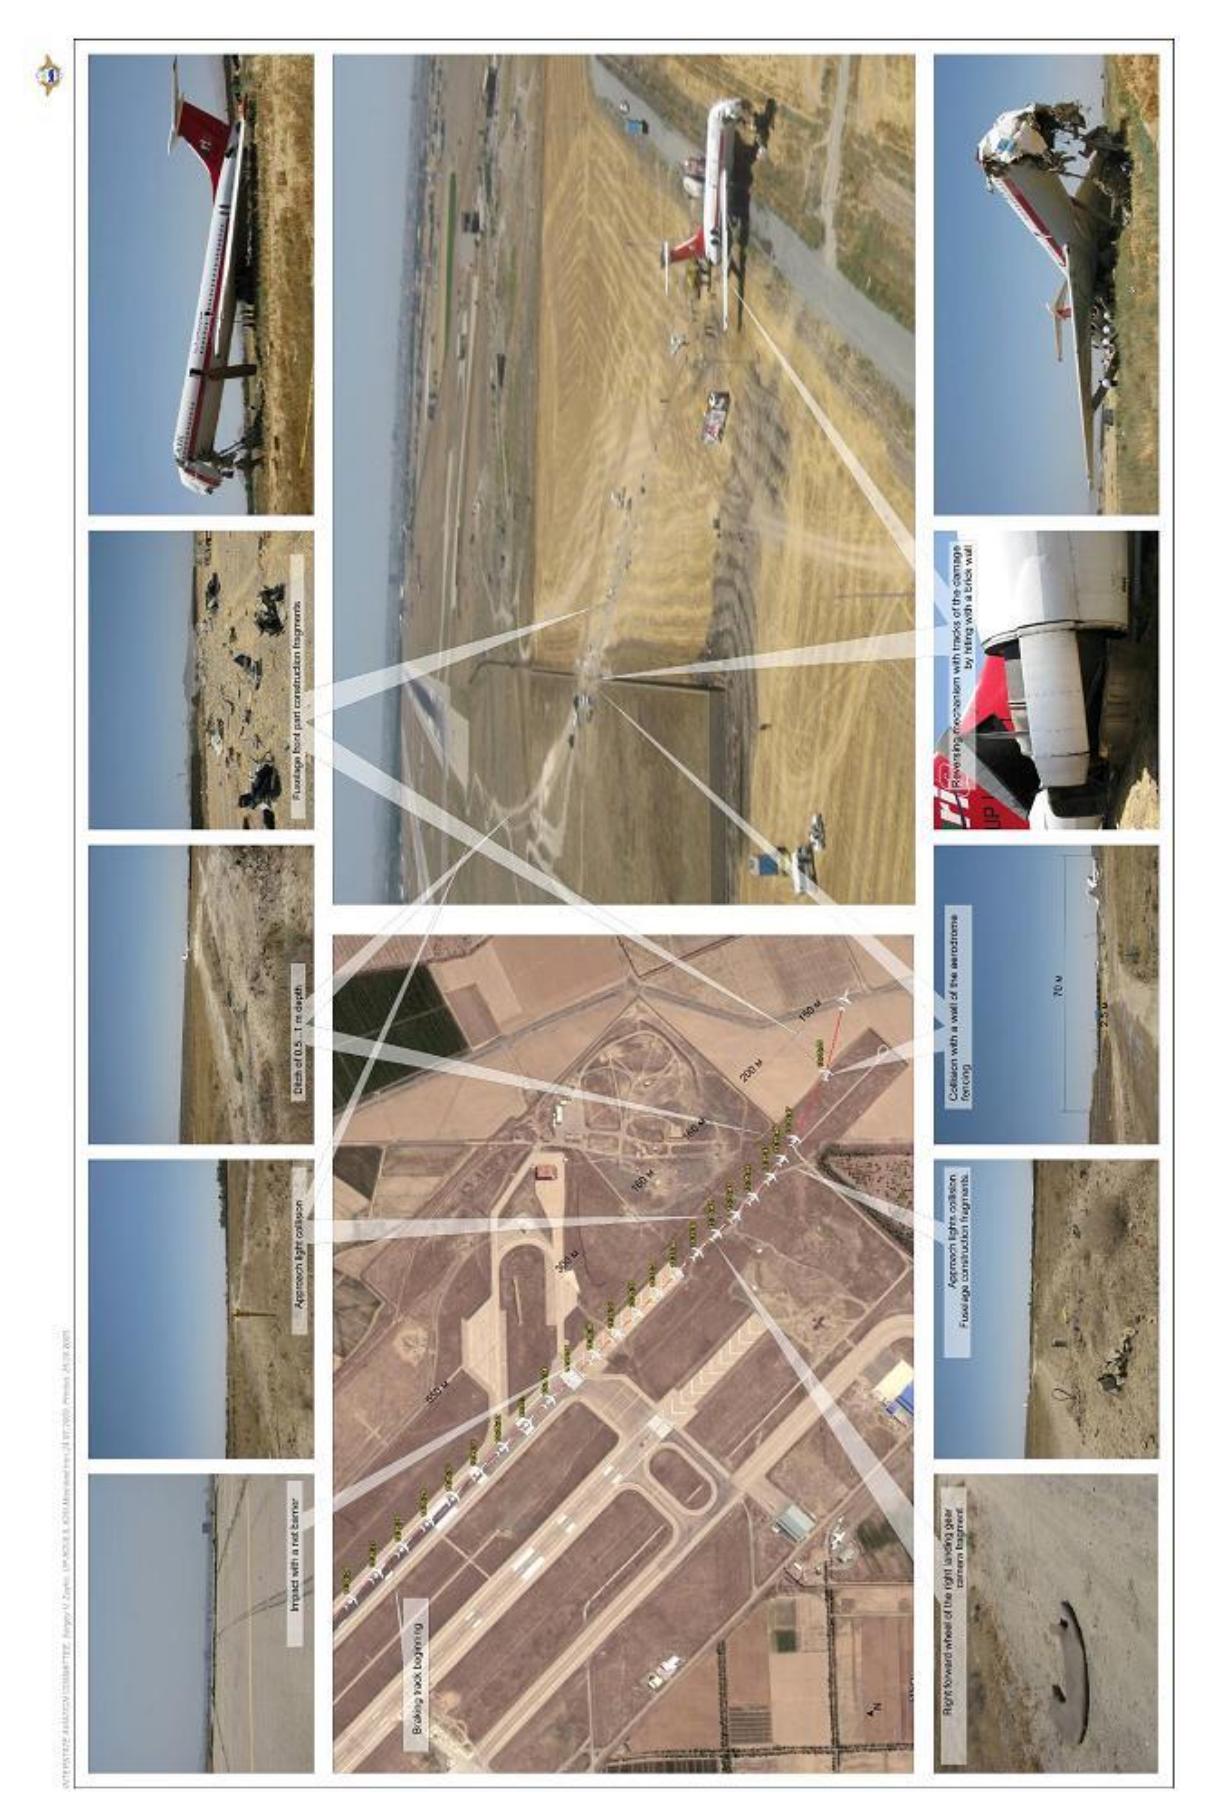
Layout of accident site:

The south-eastern part of the aerodrome was fenced with a brick wall of 2,5m high and 0,4m thick with a concrete strip foundation. It went along the RWY there. The aircraft collided with the fence at a distance of 820m from the departure threshold (520m past the stop way end) with a heading of 105 degrees. The fence was destroyed throughout 70m.

Debris of the nose part of the airframe, cockpit, passenger seats, aircraft cabin parts were found behind the fence. Earlier aerodrome employees, police and medical services found at the site and evacuated crew bodies, as well as killed and injured passengers. After the collision with the fence the aircraft kept moving for 160 m with a heading of 105 degrees and came to a stop at the road.

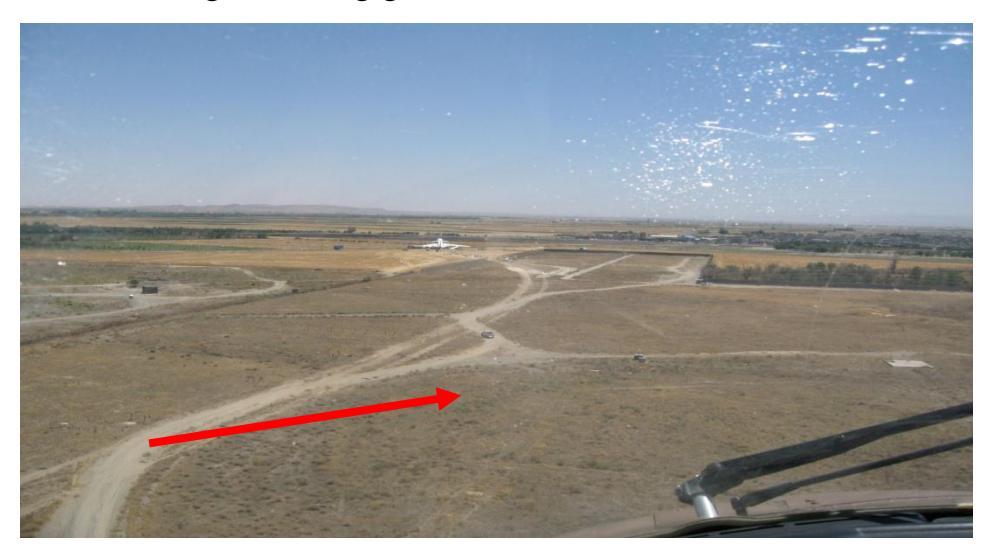
Photo 1. Tracks of aircraft movement over the dirt road after running over the RWY

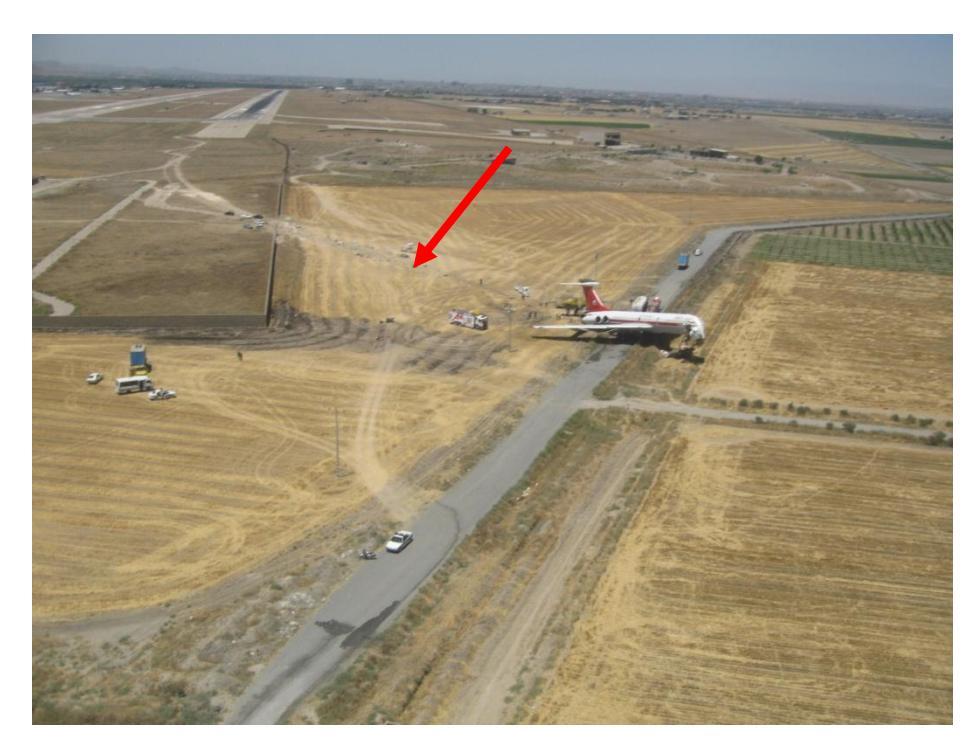
Photo 2. Tracks of aircraft movement over the dirt road after running over the RWY

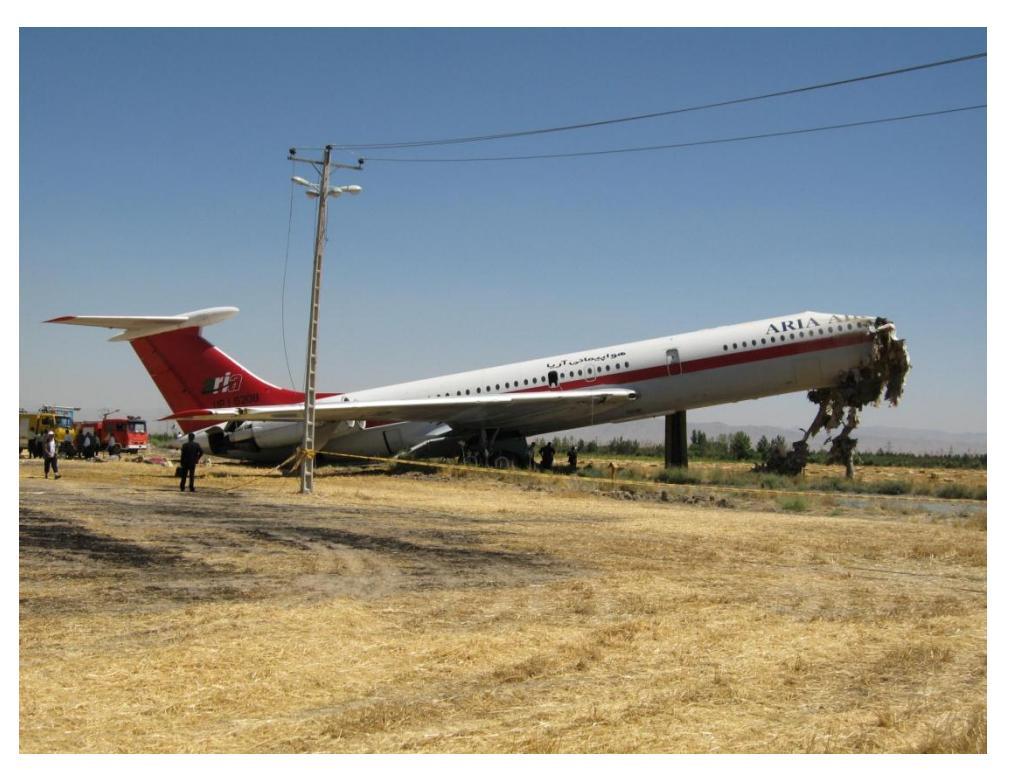
The aircraft leaned on the tail part of the airframe with a little bank to the port side. The flaps were fully extended, spoilers retracted, reverse flaps open; the stabilizer was set 1,8 degrees pitch up.

Photo 3. Aircraft post-accident overall view

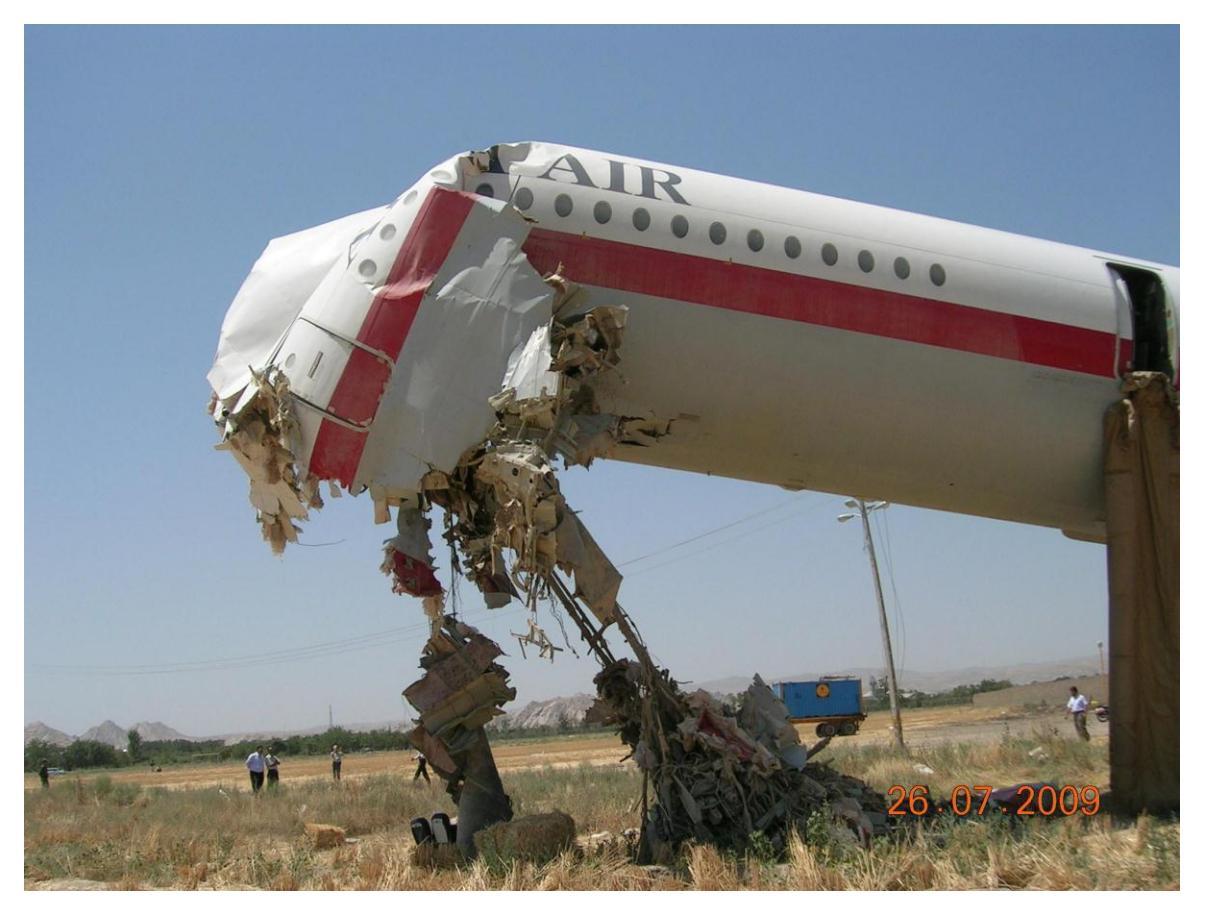
- The cockpit and the cabin up to the frame 22 (the 6^{th} seat row) were totally wrecked.

Photo 4. Airframe nose (destroyed up to frame 22)

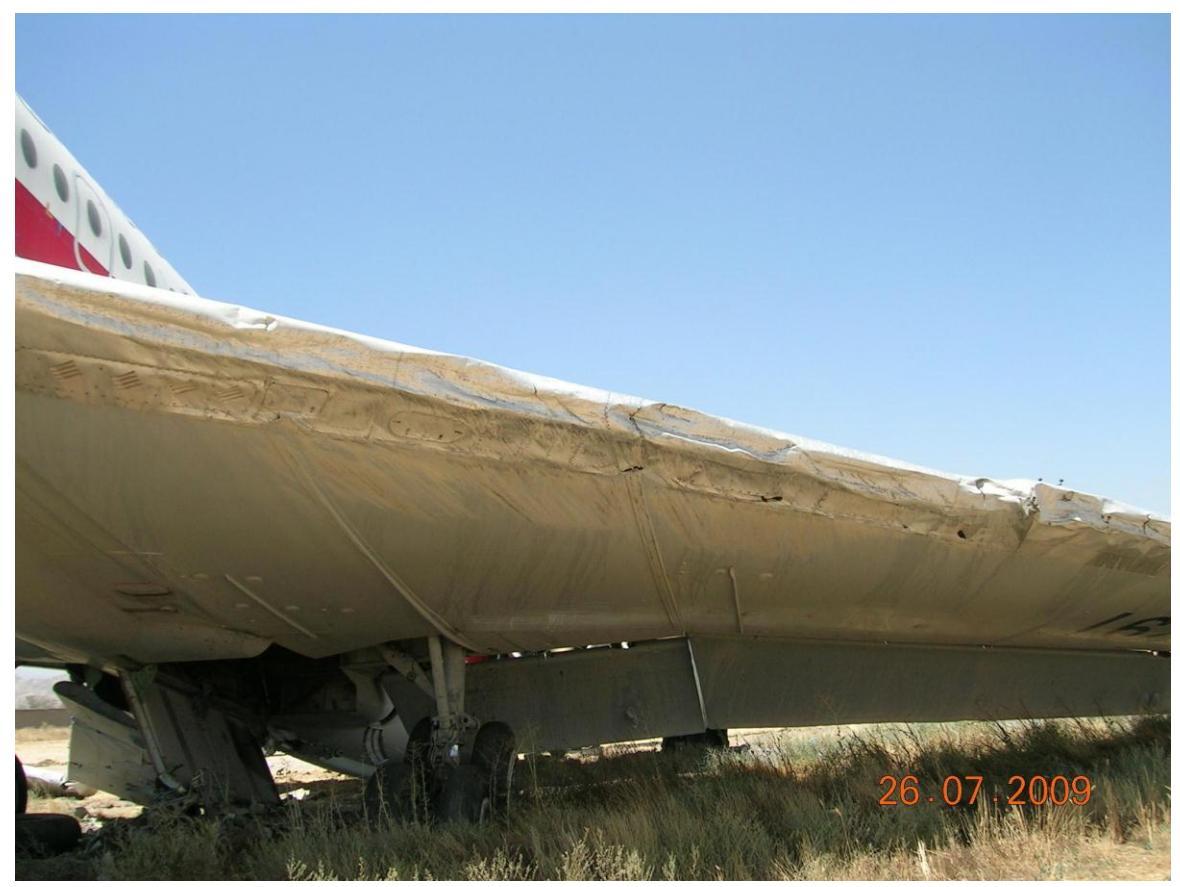
- The nose part and lower wing panels were heavily damaged.

- The left flap had got substantial damage.

Photo 5. Left wing structures damage

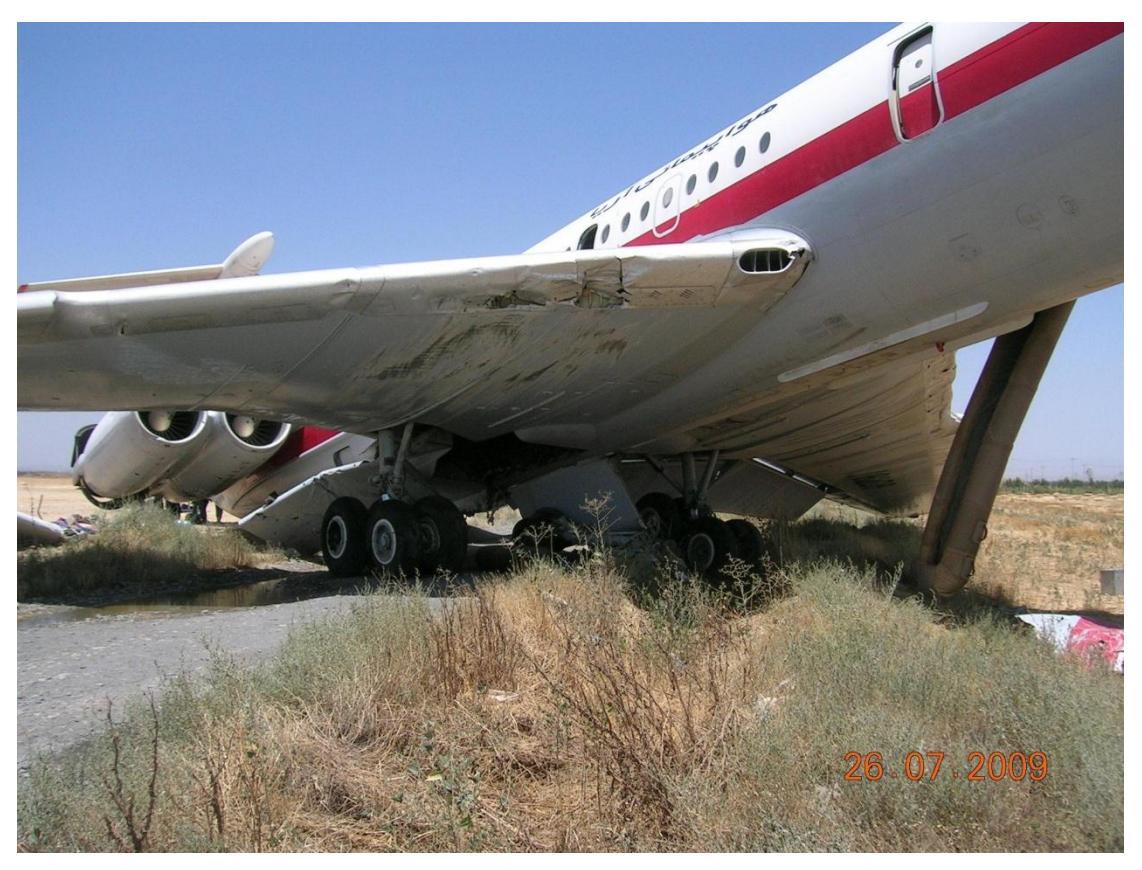
Photo 6. Right wing structures damage

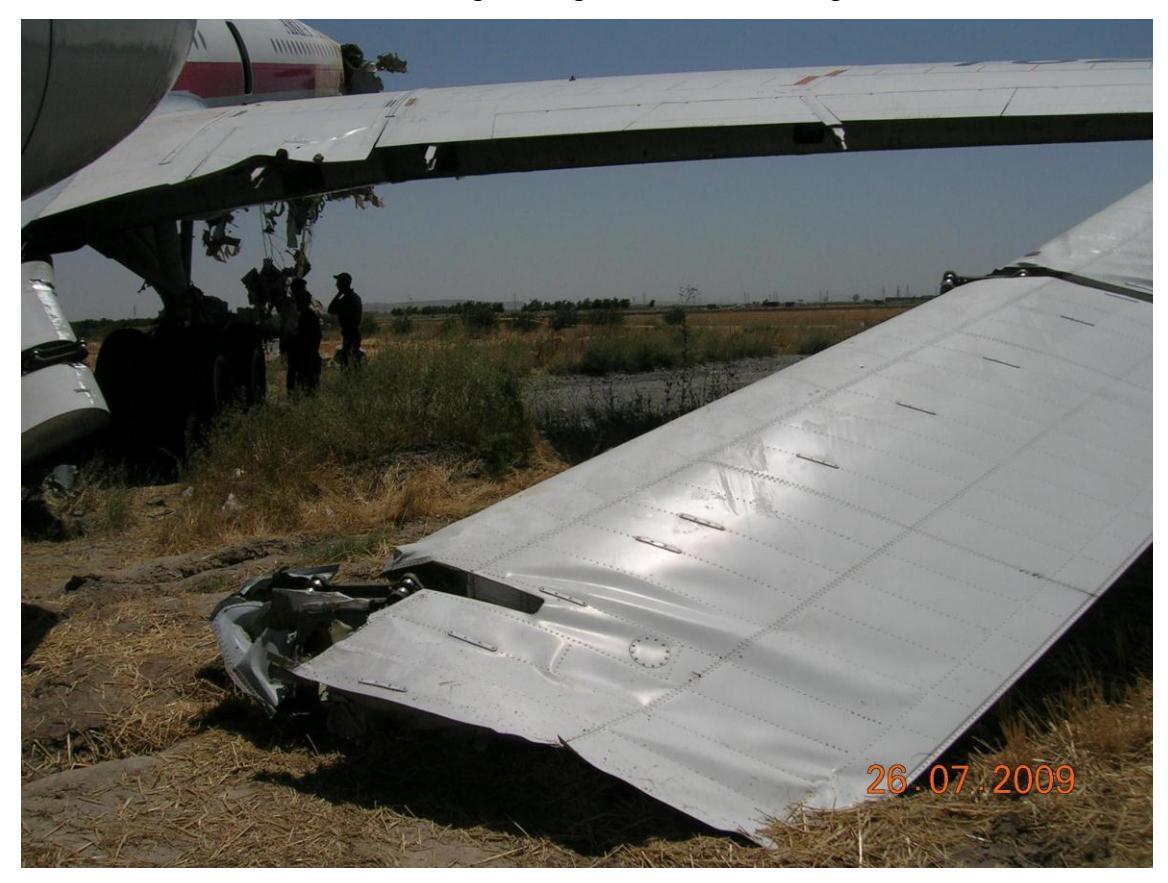
- The right flaps (inner and outer) were sheared off.

Photo 7. Right (outer) flap's damage

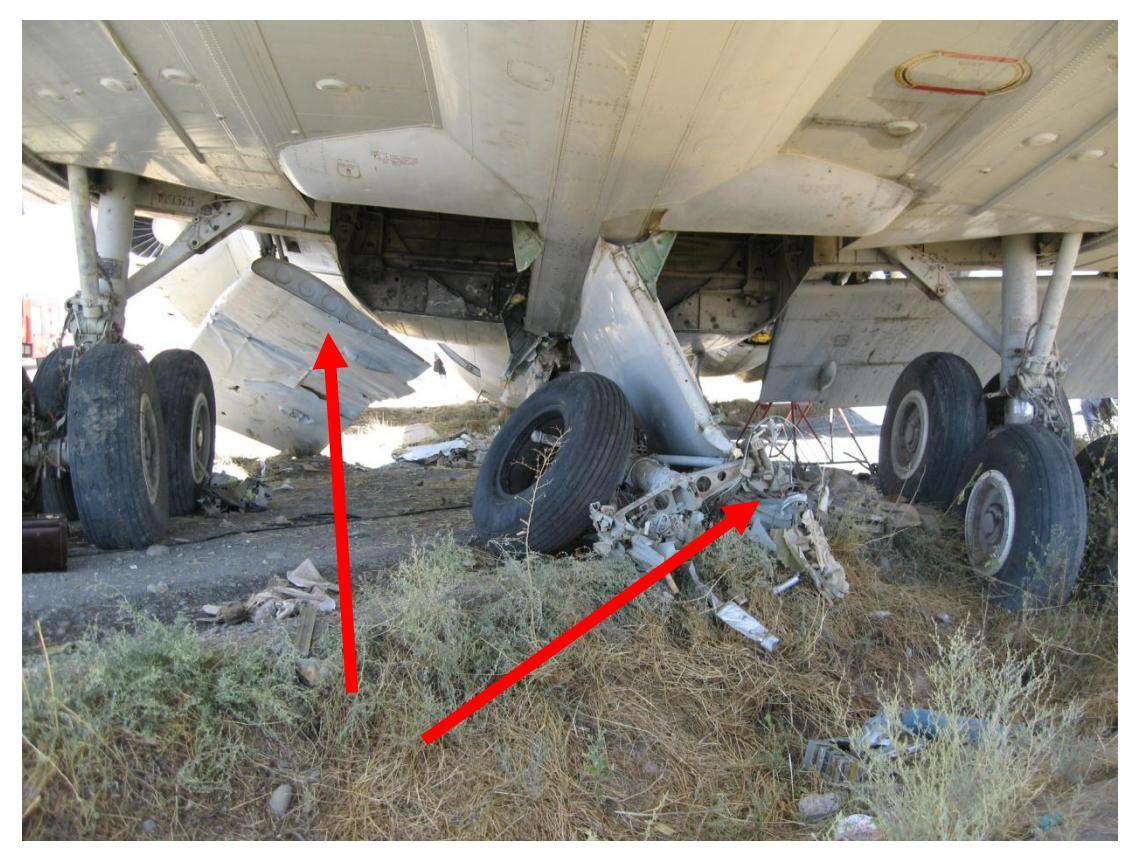
- The front gear was torn out from the attachment points, between main gears, between frames 58 and 62.

Photo 8. Front right gear (torn out of attachment points), destroyed right inner flap

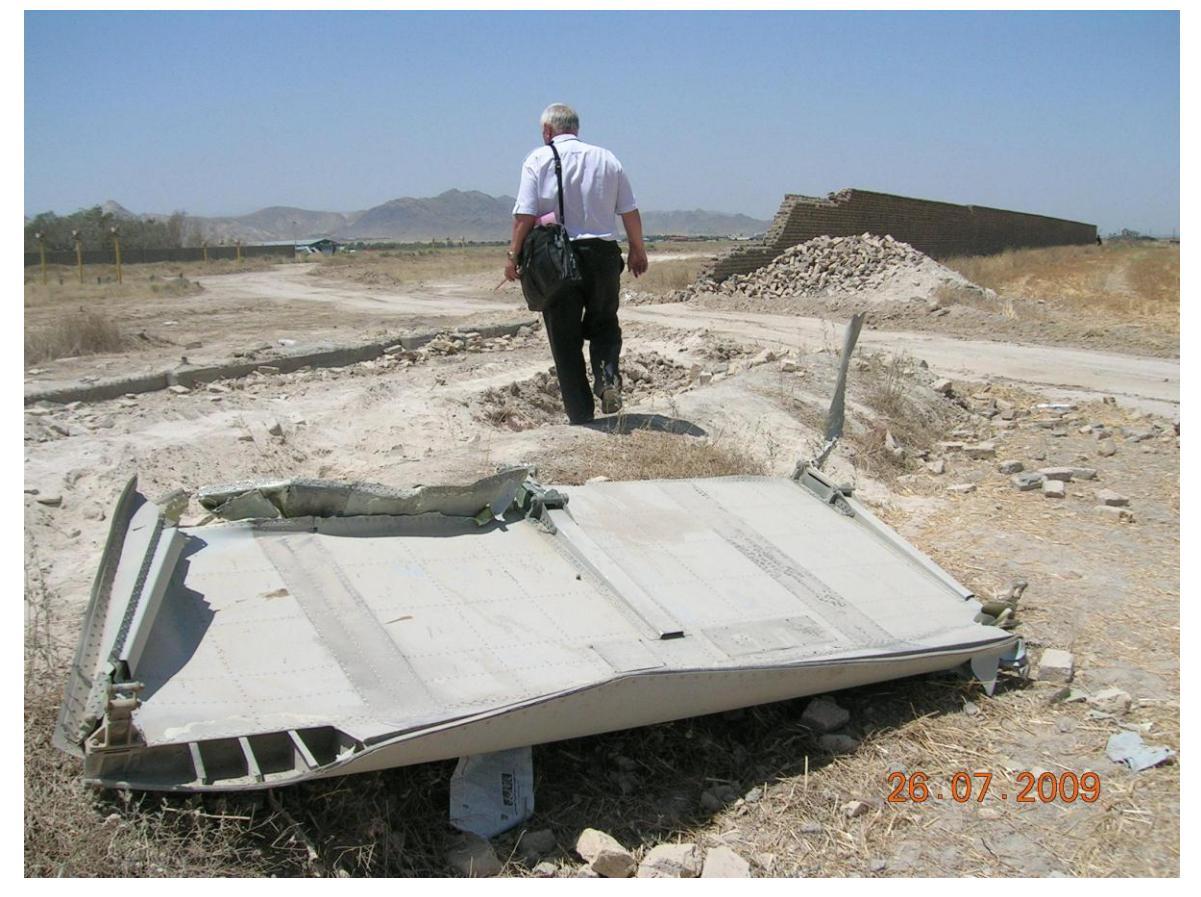
- The right main gear flap was sheared off.

Photo 9. Right main gear flap sheared off

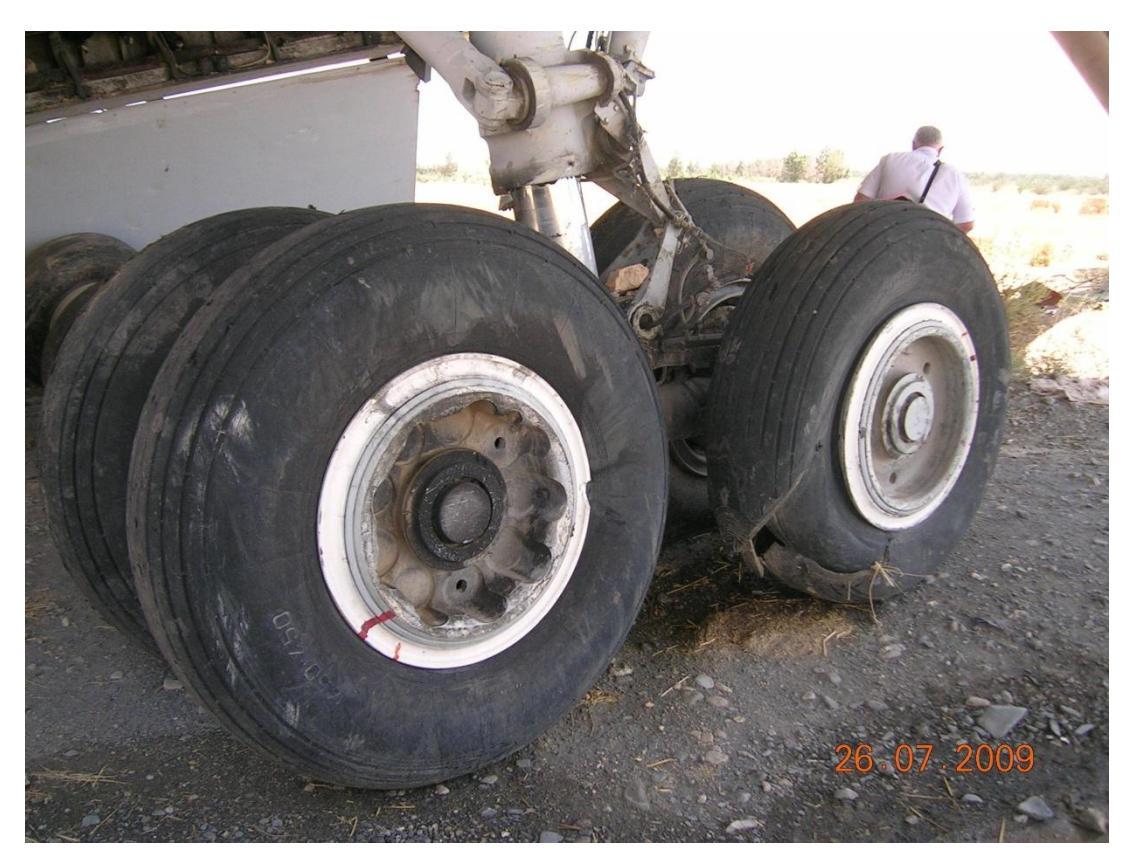
Due to emergency braking after running over the RWY the front right wheel of the right main gear was destroyed. The aircraft ran over the RWY at a speed of about 200 km per hour.

- Main gears had major damage and the right gear front right wheel was wrecked.

Photo 10. Right main gear destroyed wheel

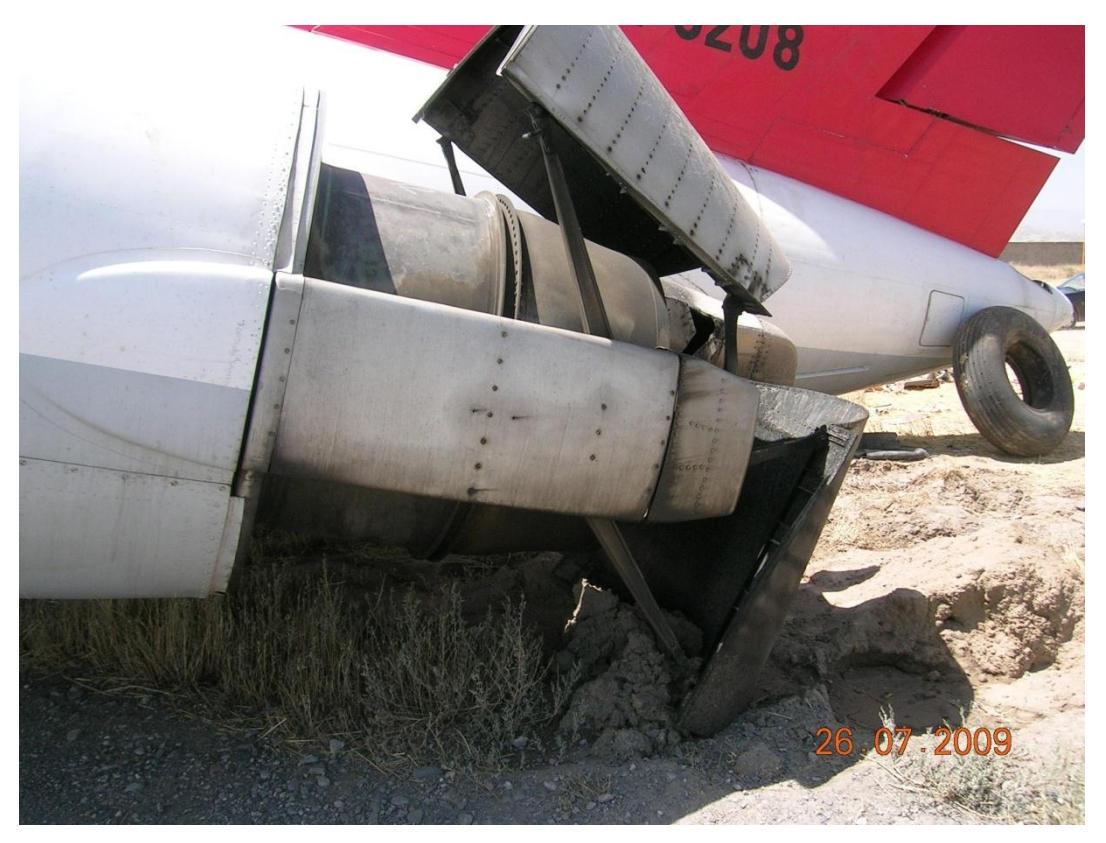
- Lower flaps of power units 1 and 4 and flap control elements had significant damage.

Photo 11. Power unit 1 reverse flaps

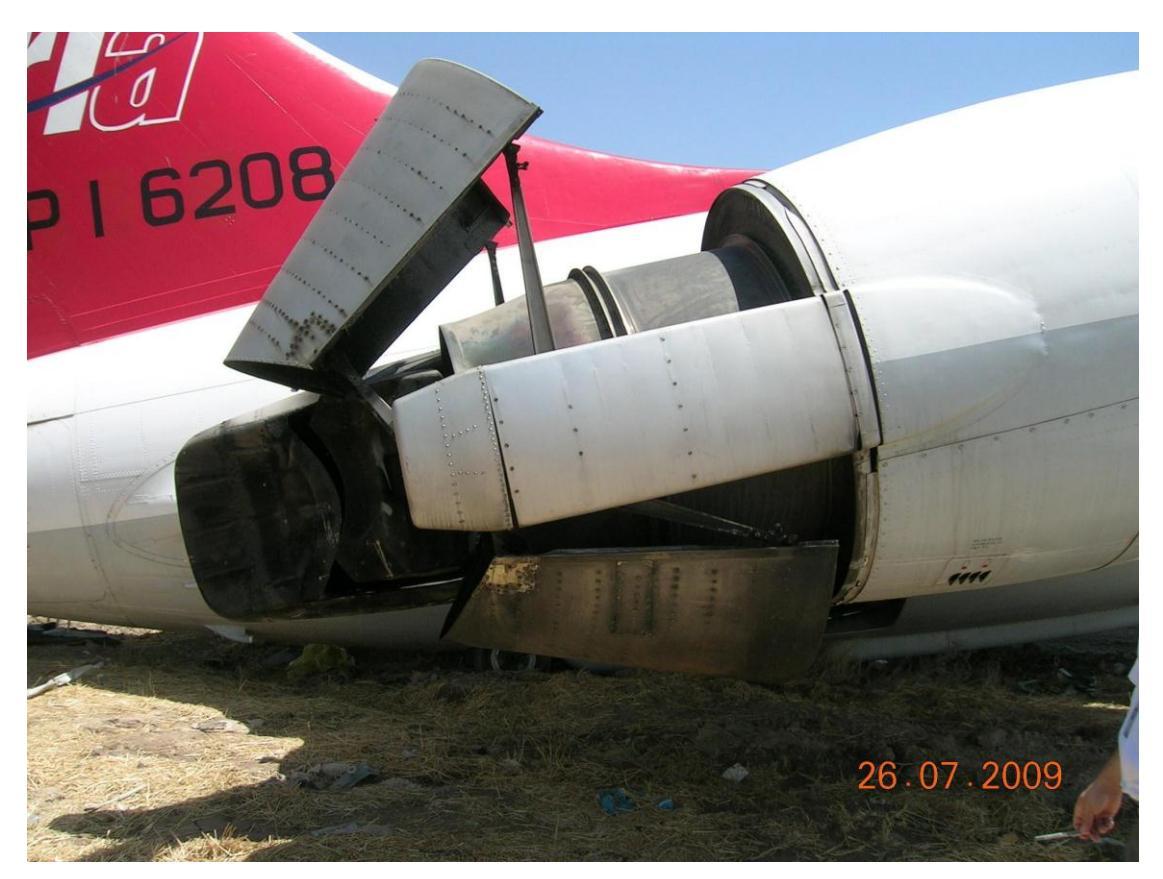
Photo 12. Power unit 4 reverse flaps

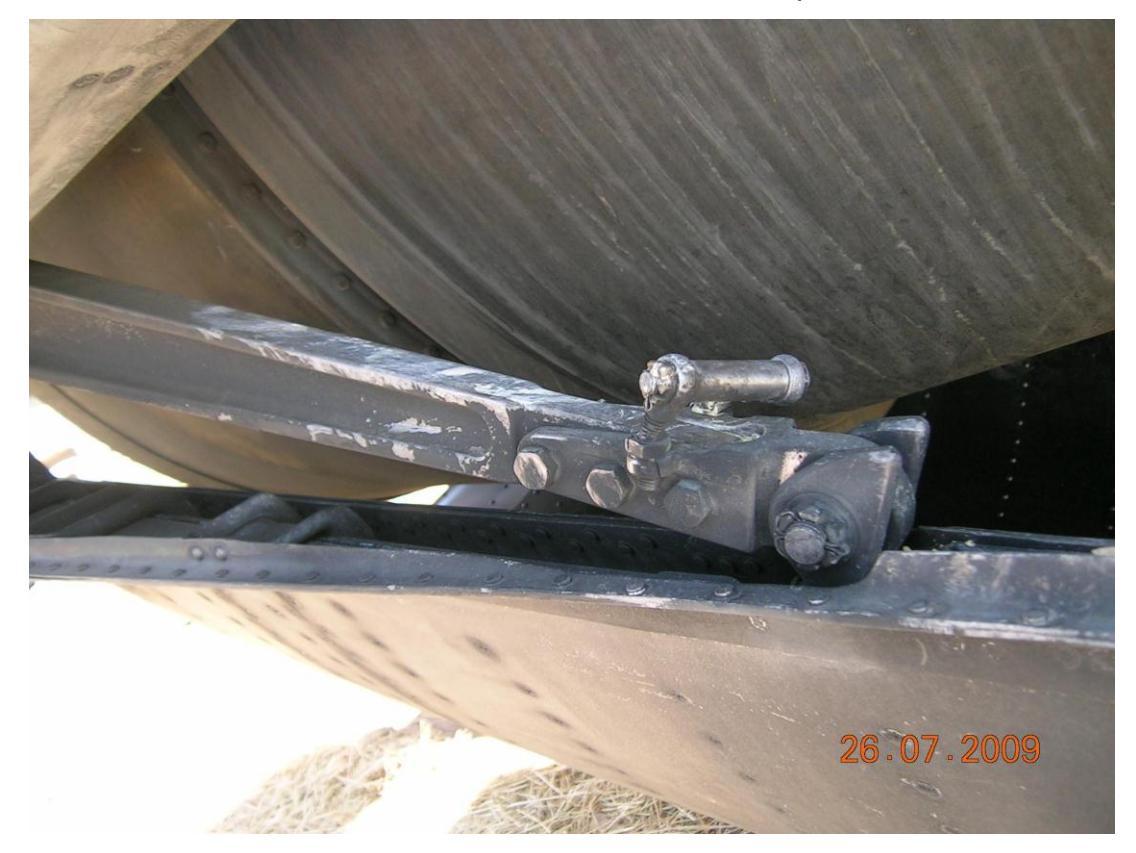
Photo 13. Power unit 4 front power lever

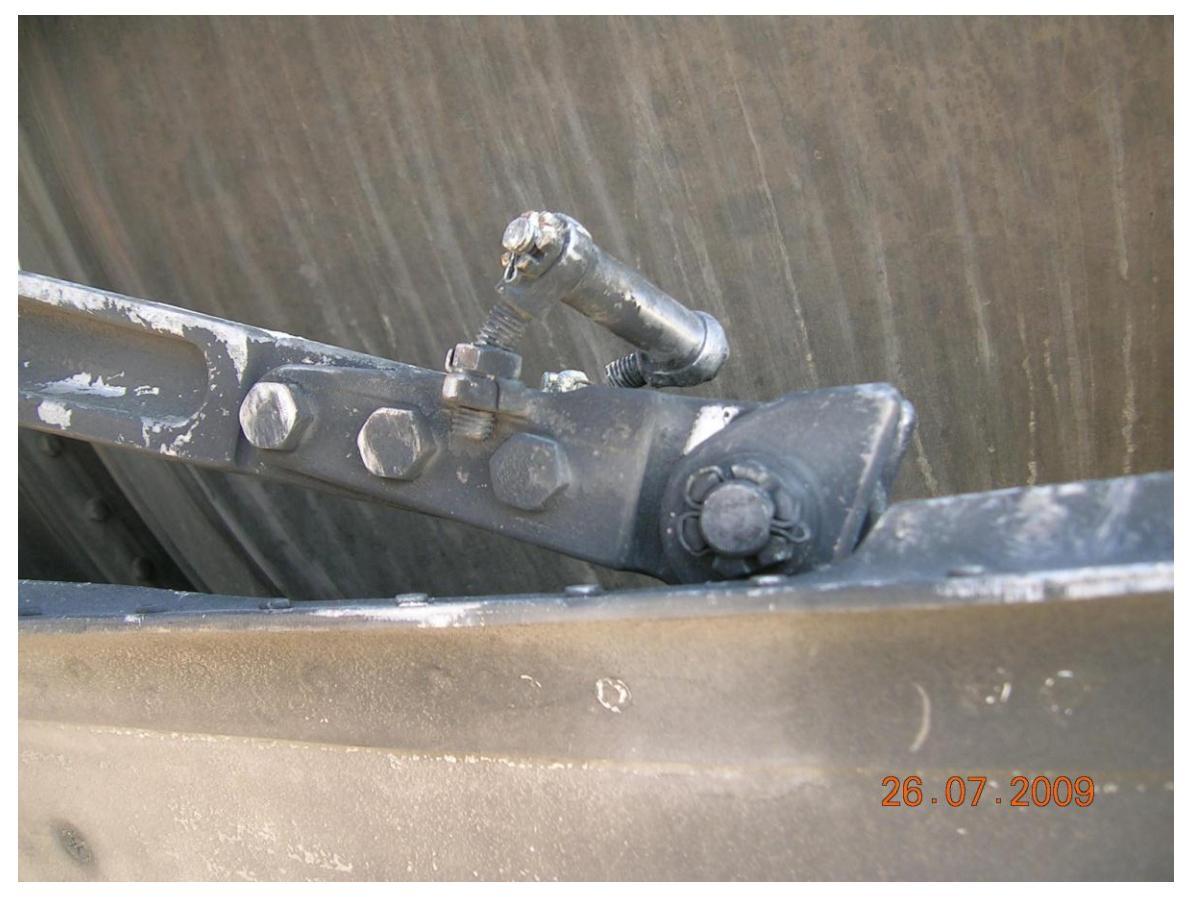
Photo 14. Power unit 4 rudder shackle of padlock

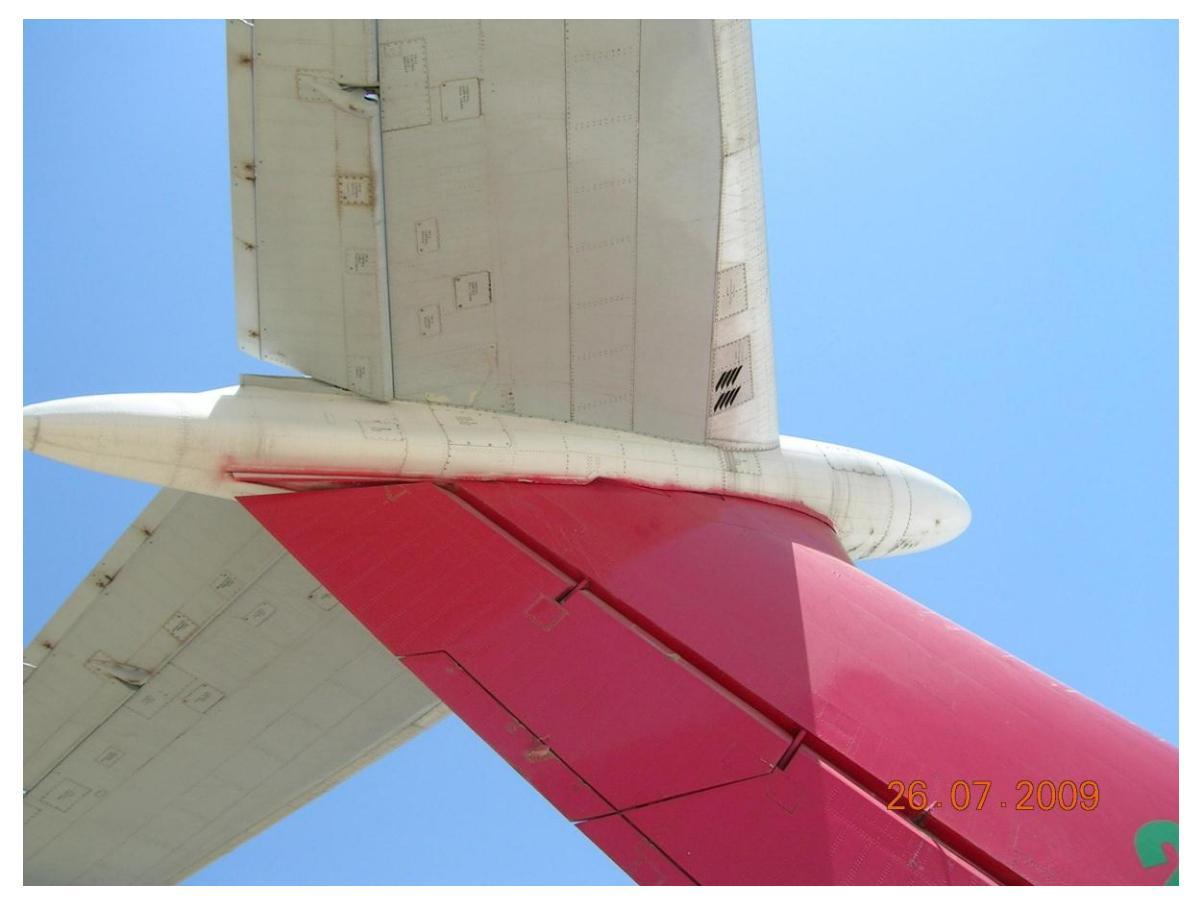
The aft fuselage had no visible damage. The stabilizer setting was changed by the crew during the landing run from 5,6 degrees pitch up to 1,8 degrees pitch up (according to the MSRP–64). The rudders were not fixed. There was no stabilizer position indication on the fin.

Photo 15. Stabilizer position – 1,8 degrees
