**FINAL REPORT**  
**A - 512/CENIPA/2016**

**PR-PSJ**

**EMB-145LU**

**25 AUG 2010**

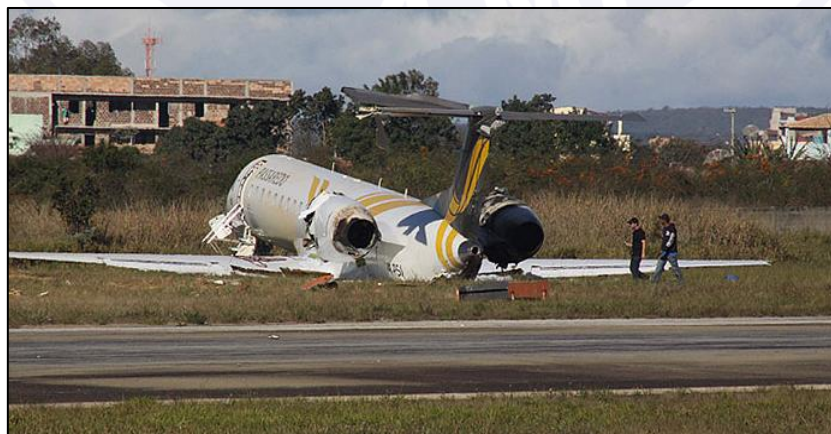
The aircraft sustained substantial damage to the engines, landing gear, fuselage, and horizontal stabilizer.

Figure 1 - Aircraft final position.

The aircraft collided with two of the three sets of VASIS back lights, and then came to a stop at a distance of 35 meters to the left of the runway.

The main landing gear collapsed, and there was substantial damage to the aircraft fuselage and wings.

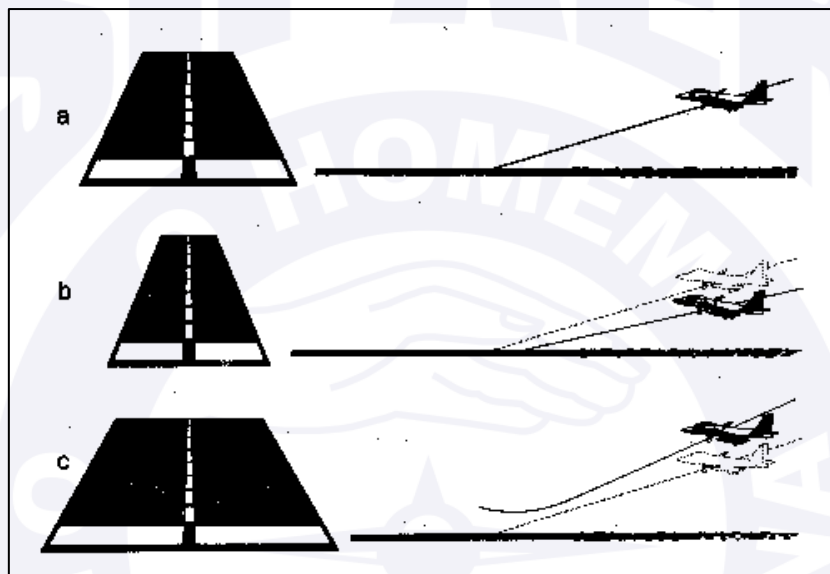
Thus, for the crew, a narrower runway would look as if it were a 45m-wide runway seen from a higher position. Such illusion leads the crew to “correcting” the altitude for an approach slope that, in reality, is lower than the 3<sup>o</sup>-standard. Figure 2 shows the effect of runway width on the pilot’s perception.

Figure 2 - Comparison of the crew's sighting of the runway with their respective position in relation to the ideal approach slope, considering different runway widths.

Figure 2 shows the image of a runway with “normal” width (which, for most of the company pilots, would be 45 meters), as seen by the pilots from the cockpit, forming the trapezoidal shape observed in letter “a”. In figure “b”, the runway is narrower, creating in the crew the illusion that they are flying along a higher approach slope, and a tendency to “correct” to a lower one. Letter “c” shows an approach to a wider-than-normal runway, which would create the opposite effect, that is, the crew would have the illusion of low approach, and would have the tendency to “correct” to a higher approach.

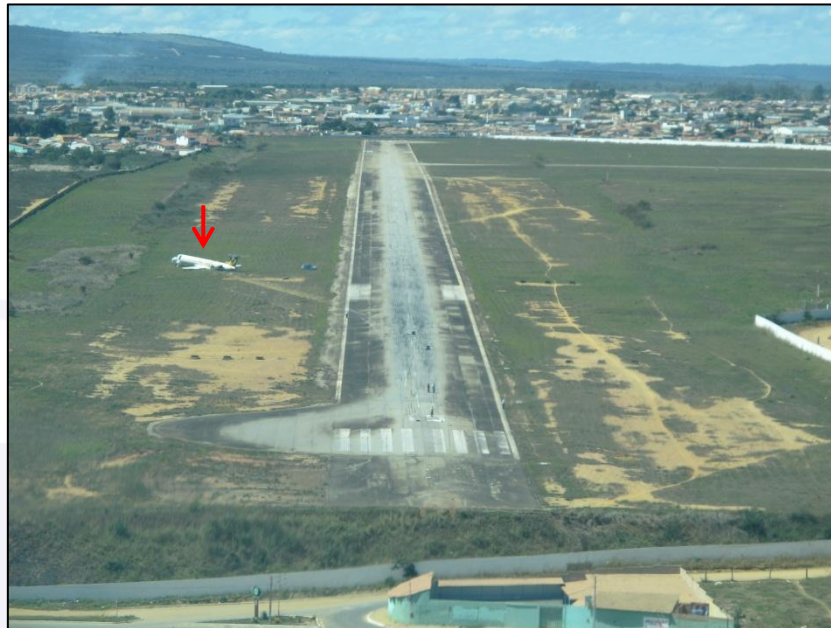
Another aspect worth pointing out is that the runway 15 in SBQV presented a pronounced acclivity approximately 1,000 meters long, as measured from the threshold in the direction of the departure end.

Figure 3 - Final approach to runway 15. (the arrow indicates the position where the aircraft came to a stop).

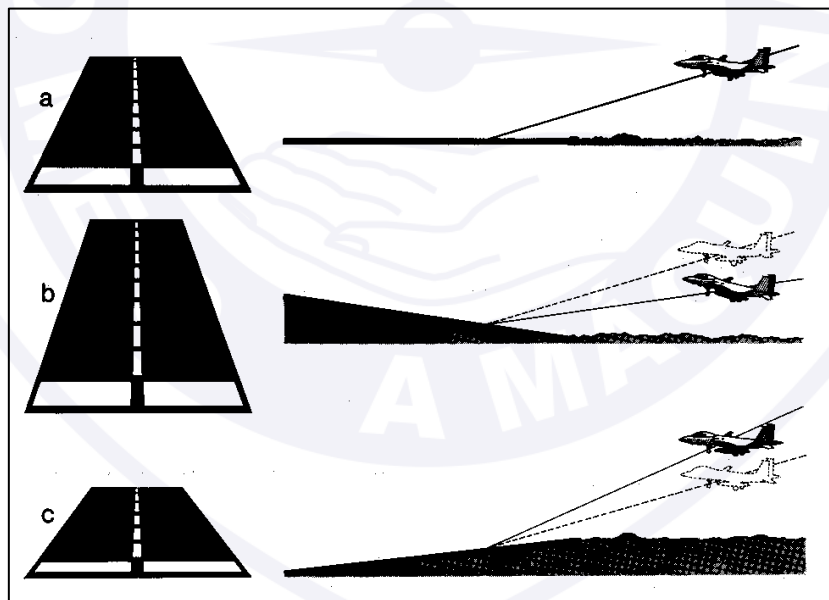
In Figure 4, it is possible to relate the crew's sighting of the runway to the corresponding position of the aircraft in relation to the ideal approach slope for runways with different types of gradient. Letter "a" shows a level runway as seen by the pilot from the cockpit, with the aircraft stabilized on the ideal approach slope; letter "b" depicts a runway with an acclivity, leading the crew to the illusion that they would be flying above the ideal approach slope; and letter "c" shows the approach to a runway having a declivity, creating in the crew the illusion that they would be making a low approach, leading them to "correct" toward a higher approach.

Figure 4 - Different runway slopes and position of the aircraft relative to the ideal approach slope.

Such characteristic of the SBQV runway could lead the pilots to mistakenly believe that the aircraft was above the ideal approach slope, even though it was at the correct altitude. Thus, the pilots would have the tendency to "correct" the aircraft toward a smaller angle of approach. To avoid being deceived by the illusion, they would have to pay close

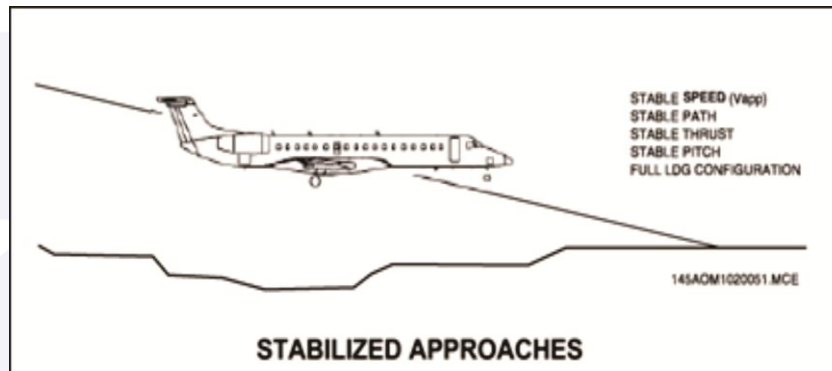
The aircraft manufacturer's manual states that the pilots are supposed to be on a stabilized approach (on course, on glide path, at the selected speed, and at landing configuration) on a 3-mile final. The stabilized final approach is to be maintained in order to allow more precision at landing. Otherwise, the crew runs the risk of having to resort to either excessive sink-rates or to excessive "fluctuation" (during the flare) for touching down on the runway.

Figure 6 - Illustration of a stabilized final according to the manufacturer's manual.
